Flood Investigation Report

Flooding affecting the areas of

Borough Green Road and Busty Lane, Ightham

On the 25th June 2016

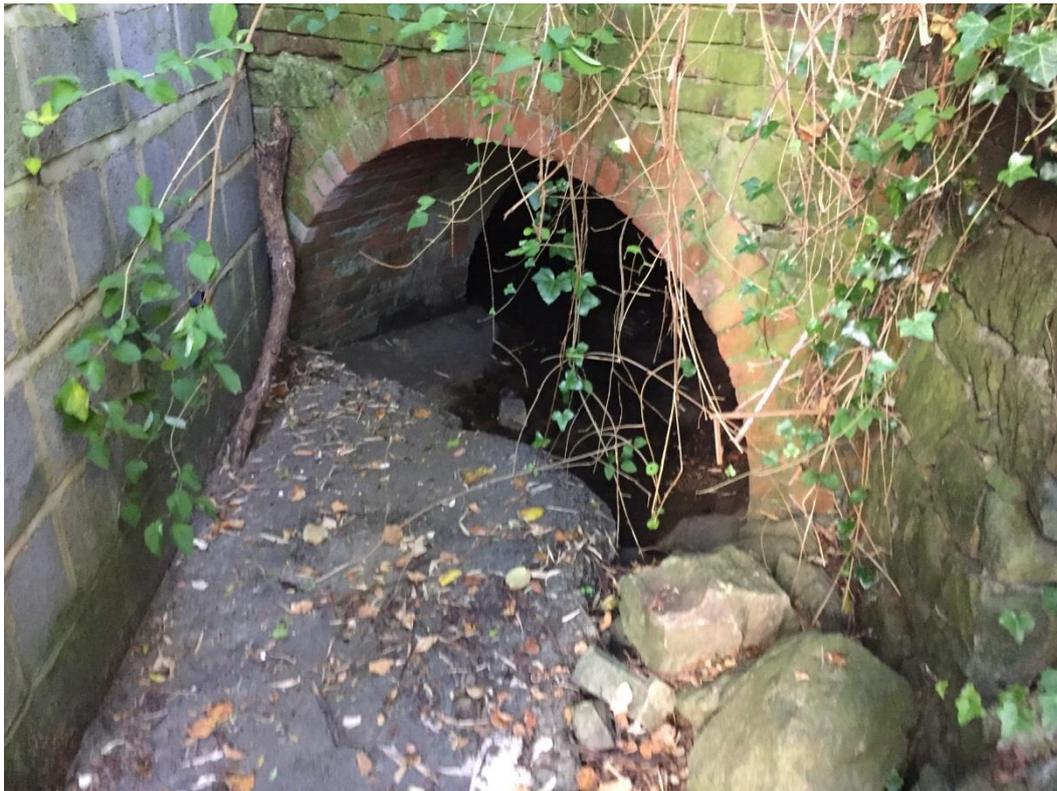
It then flows through a brick arch culvert below Ezel Villas, shown in Photo 1. The culvert turns through 90 degrees to flow due north for a few metres and then 90 degrees again to flow east parallel with Borough Green Road. The culvert has been constructed in a several stages, which now form one continuous structure.

Photo 1 View of the entrance to the culvert during inspection on 28th October 2016

The capacity of the culverts is found to be smallest at the entrance to the culvert at Ezel Villas, which is a brick arch culvert 1.8 m wide 1.2 m high. The dimensions of the culvert are shown in Table 1.

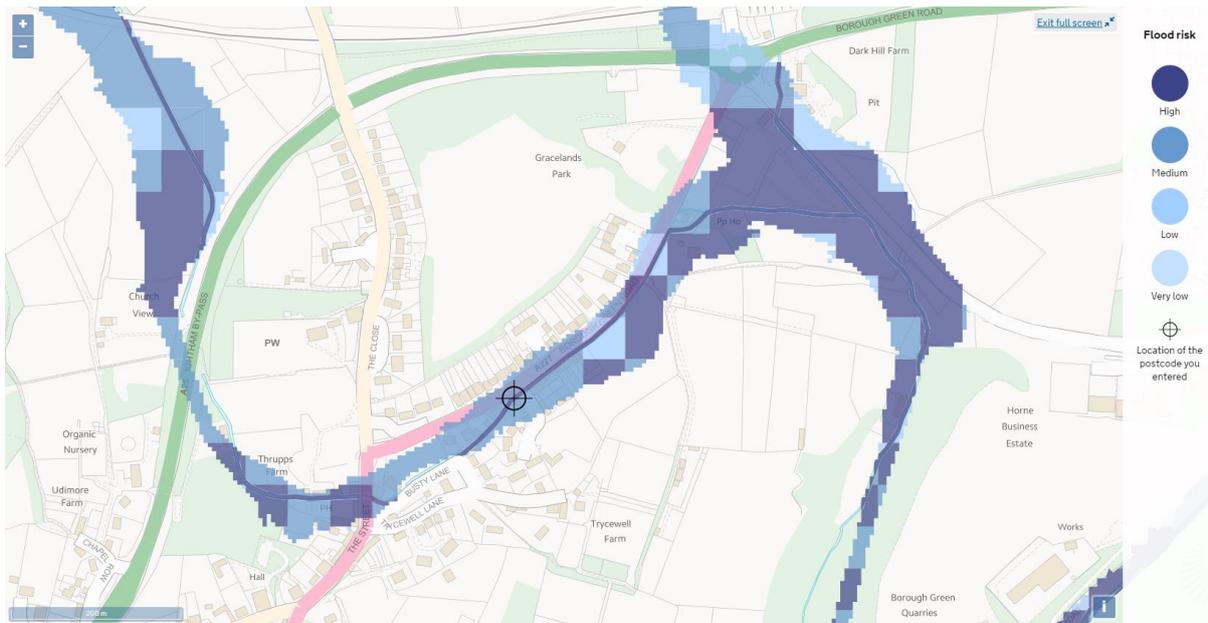
Figure 3 Risk of Flooding from Rivers or the Sea

The area adjacent to the Busty Stream is defined in the mapping as being at a medium to high risk of fluvial flooding, meaning there is between a 1% (1in100) and greater than 3.3% (1in30) risk of flooding occurring in any one year.

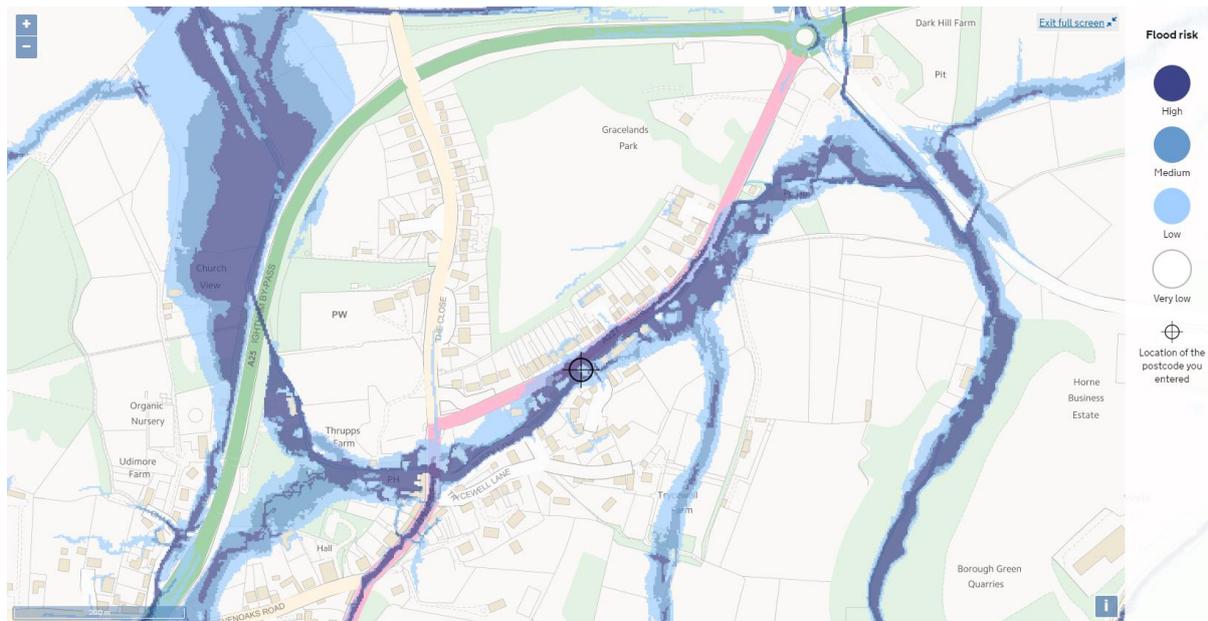
Figure 4 Risk of Flooding from Surface Water

The mapping indicates that many areas local to the Busty Stream are at a high risk of surface water flooding. High risk means that each year this area has a chance of flooding of greater than 3.3% (1in30).

It is noted that the mapping indicates a risk of out of bank flows travelling along Borough Green Road and through the fields to the road due to the topography. Additional sources of overland flow are indicated by this mapping where rainfall could naturally flow over the ground surface should it be unable to soak into the soil. The amount of water following off fields and other areas can substantially increase when the ground has become waterlogged through earlier rainfall or prolonged wet weather.

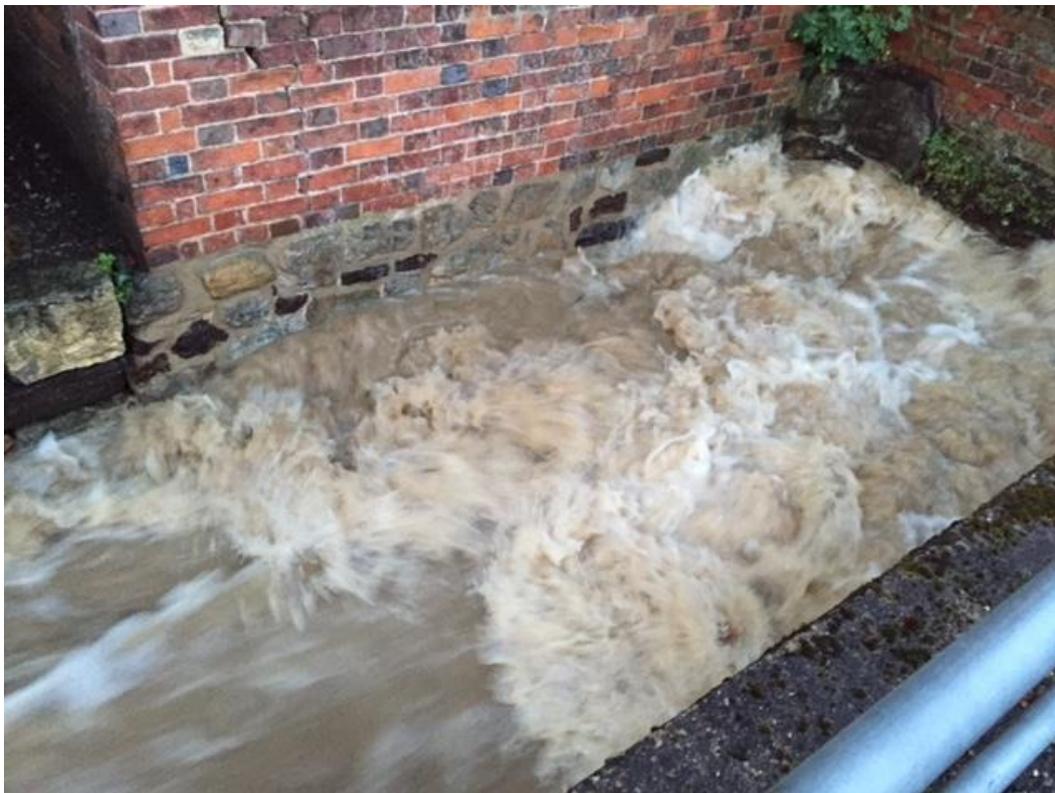
High water flows were experienced in the channel of the Busty Stream. These remained within the banks of the watercourse where it crosses the A227 (as shown in photograph 2) with an approximate depth of fast flowing water of 1.2 metres.

Photo 2 High flow in Busty Stream at the junction of A227 and Busty Lane on 25th June 2016.

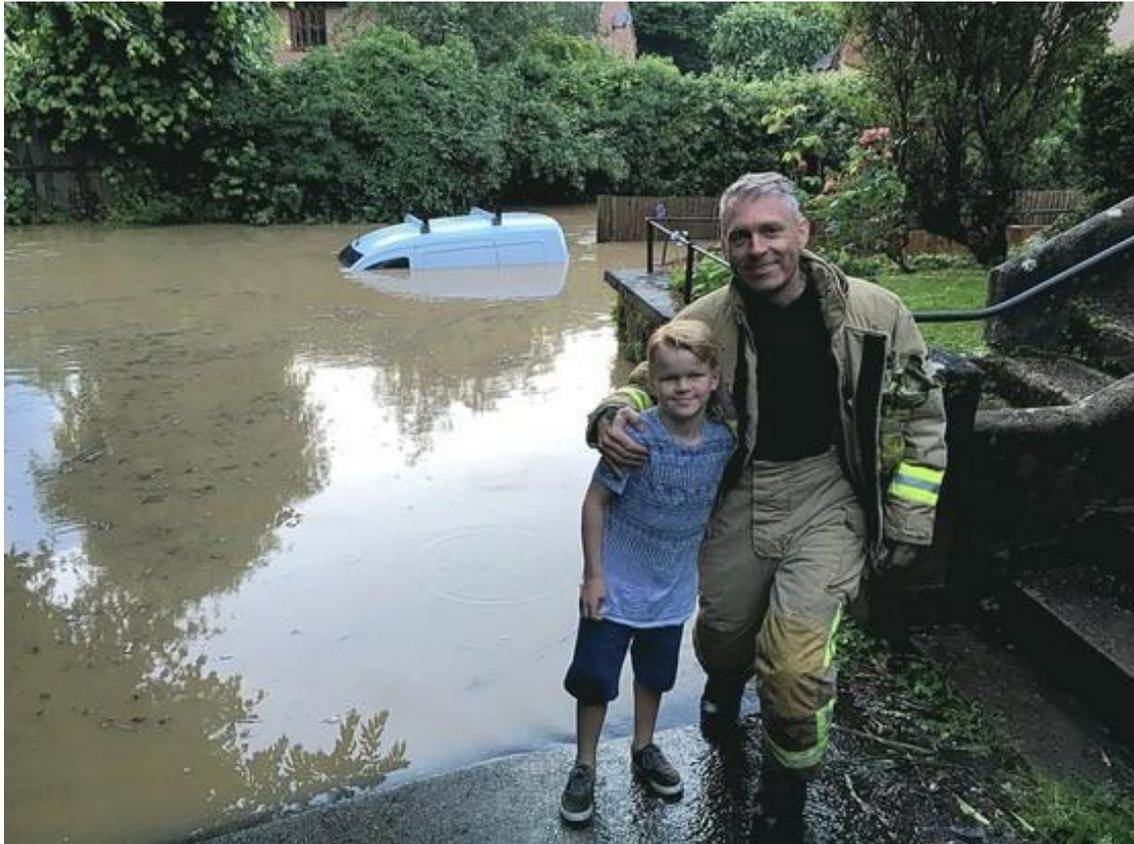
During the flood event the high flows of water were unable to drain through the watercourse and culvert downstream of Busty Lane as quickly as the water was flowing in from the higher ground. A significant depth of water backed up between the lower part of Busty Lane and the culvert entrance. It is estimated the maximum depth of flood water was approximately 2 metres as illustrated by the depth of water around a parked van shown in Photograph 3.

Photo 3 Extent of flooding at Busty Lane (published by Sevenoaks Chronicle).

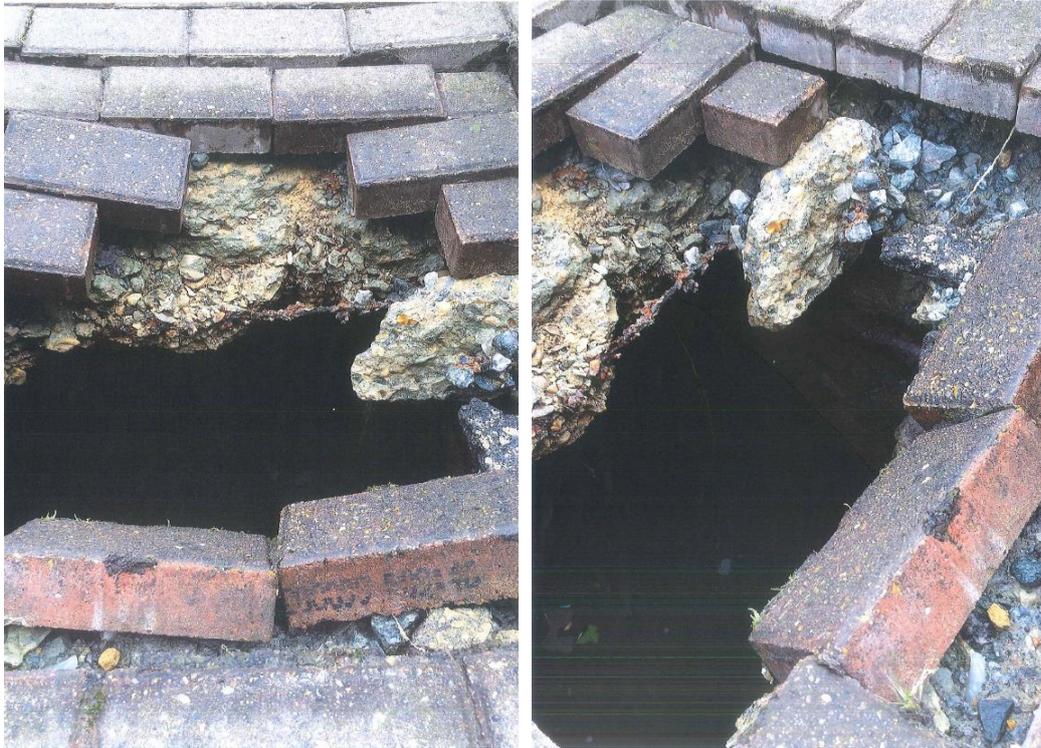
Local residents commented that water was continuing to discharge from the culvert during the event; however the force of water was sufficient to cause a small part of a driveway above the watercourse to collapse as shown in Photograph 5.

Photo 4 Localised damage to driveway at the downstream end of the culvert

The survey results show that the culvert is in a sound structural condition throughout. Two areas are noted to have timber roofs; this is likely to be the formwork used to construct cast insitu concrete slabs above. The small area that collapsed at the downstream end of the culvert has been repaired; it is not clear from the CCTV survey why there was a localised failure at this point during the event.

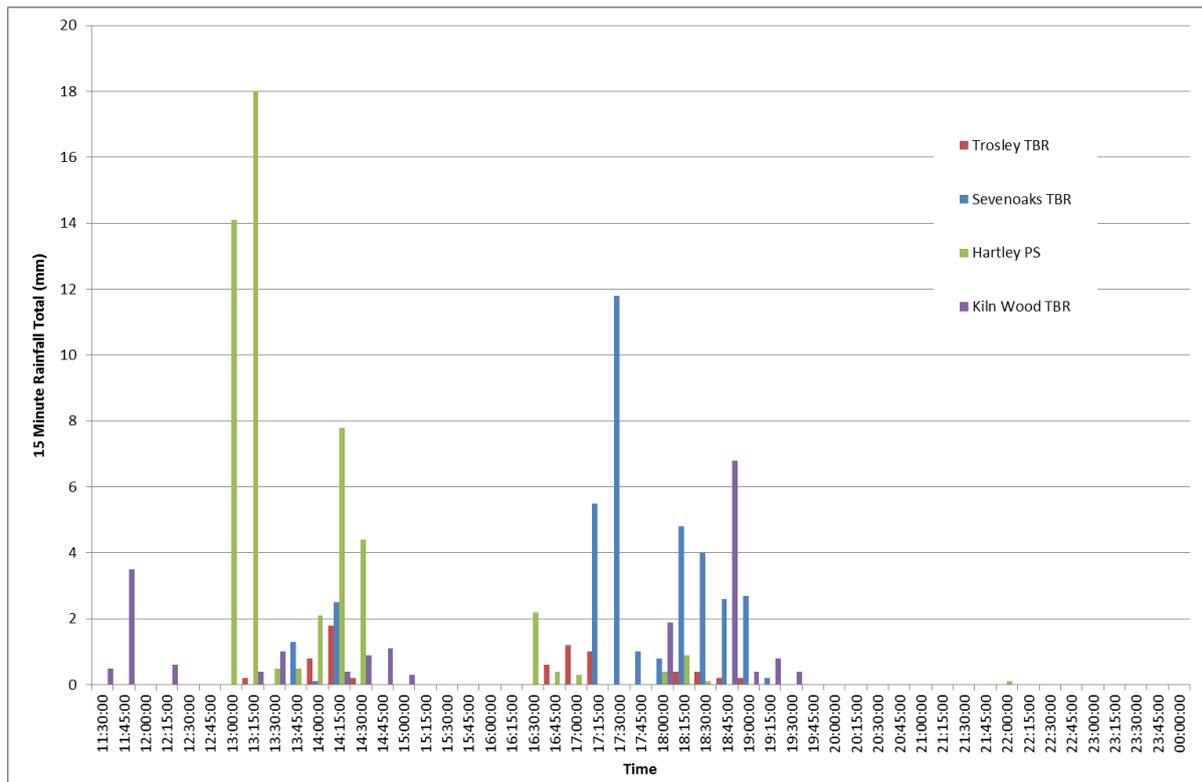
Figure 6 Data from rain gauges within 10km of Ightham

The Sevenoaks rain gauge recorded 33.4mm of rain between 17:15 and 19:15, of which 17.3mm fell in less than half an hour (from 17:15). The exact time of peak flows being experienced within the Busty Stream is unclear; it appears to have occurred between approximately 2 to 3 hours after the initial heavy rainfall was recorded at the Sevenoaks rain gauge. This reflects the time required for the storm to move from the west to Ightham and for the rainfall to runoff the catchment surface and collect in the watercourse at Ightham.

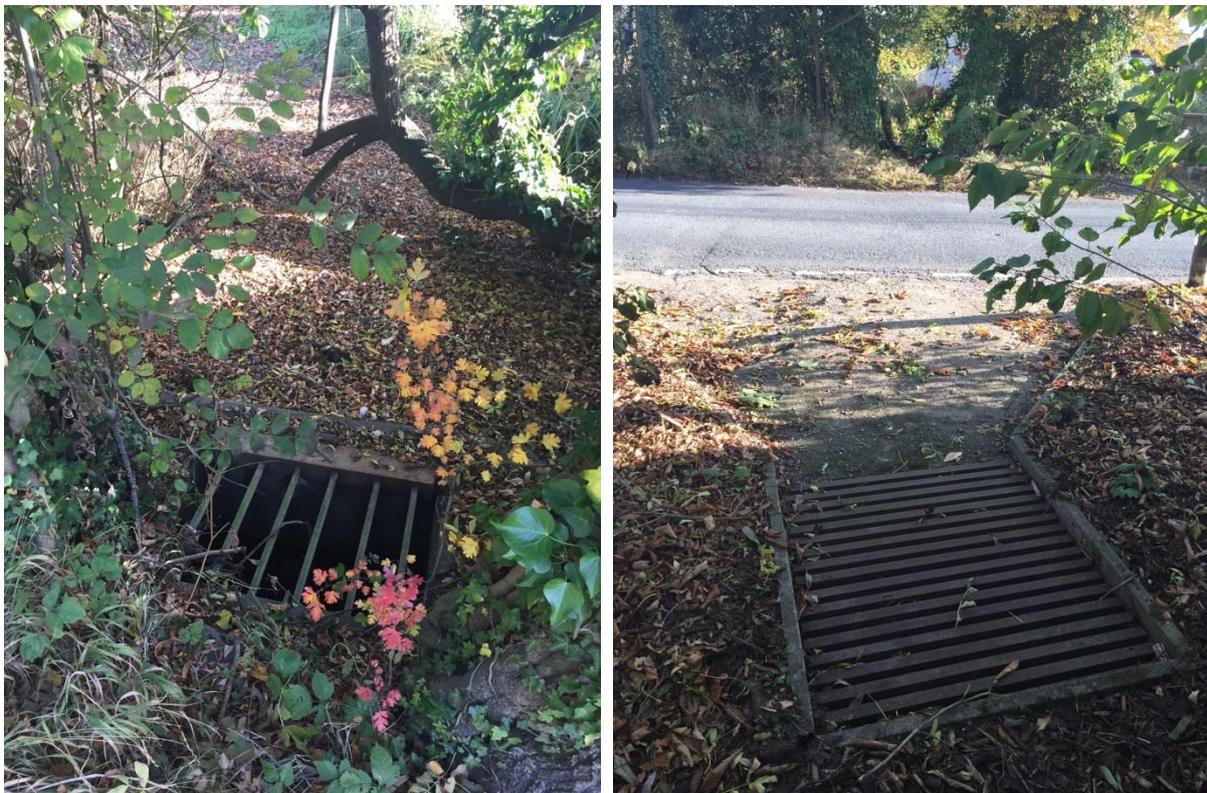
The site was inspected on 28th October by officers from the KCC Flood and Water Management Team. All inlets and outlets to the culvert under the road appeared to be clear at the time of the visit as shown in the photographs below, although this was some time since the flood event. It is assumed high flows exceeded the watercourse culvert capacity causing water to flow overland.

Photo 5 Upstream entrance to culvert (left) and downstream end manhole /road gully

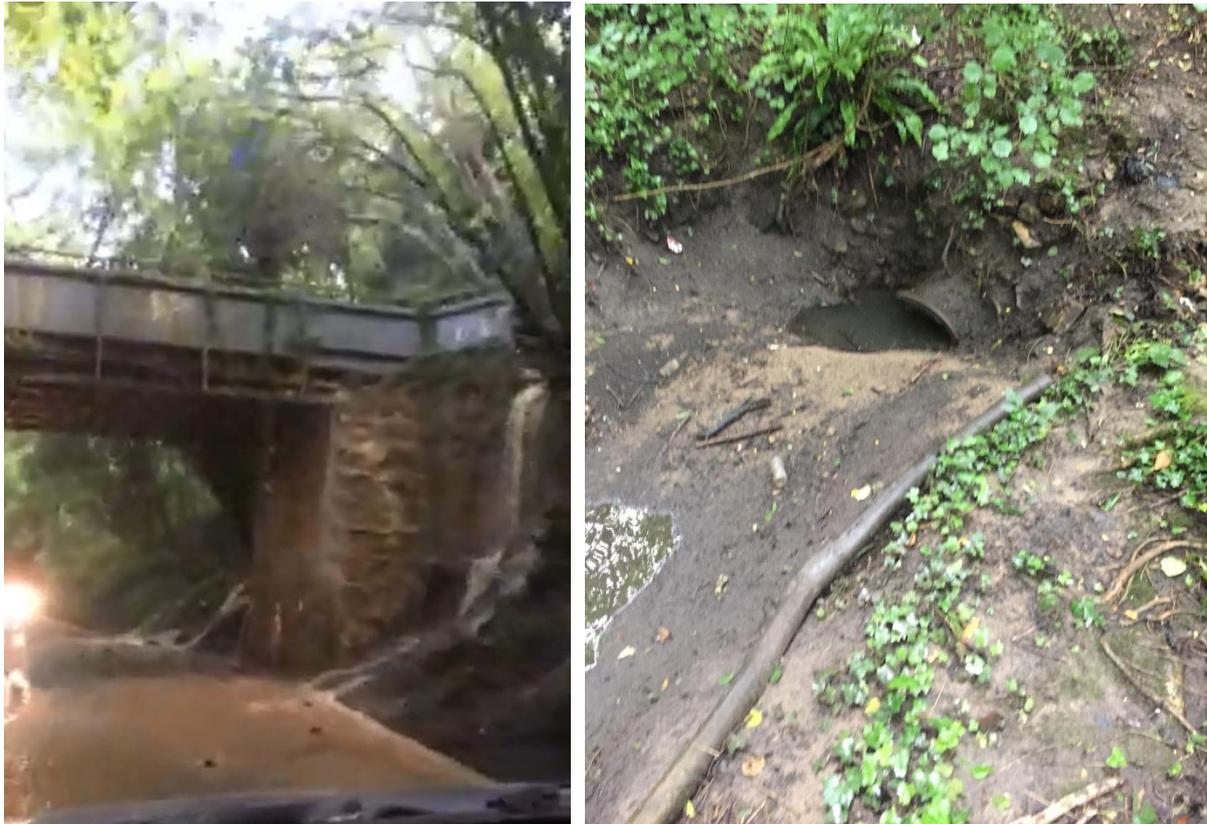
Flooding of the highway occurred due to exceedance of adjacent watercourse which is part of the River Bourne. Flows out of the bank ran out onto the road adjacent to an old bridge which formally joined the quarries in the area. The road was flooded to a depth sufficient that it was impassable except for high vehicles and 4x4s. The culvert under the bridge abutment was noted to be blocked with mud and silt. This flooding was reported to KCC Highways by several parties. Photographs of the water exceedance flow during the event and a view of the blocked culvert from subsequent inspection are shown below.

Photo 6 Out of bank flow adjacent to bridge (left) and view of blocked culvert entrance (right)

Issues with the watercourse have been discussed with the Environment Agency (as the watercourse is designated 'main river'). The site is part of a future housing development currently seeking planning permission. The developer of the adjacent housing site has demolished the bridge since the flooding occurred and reinstated the watercourse channel as part of their works as shown in photograph 8. Further improvements to the watercourse have been proposed within the current planning permission which will further reduce the likelihood of a recurrence of this flooding. The developer has undertaken discussion with the Environment Agency regarding these proposals and with KCC as the Lead Local Flood Authority regarding the disposal of surface water generated on the site.

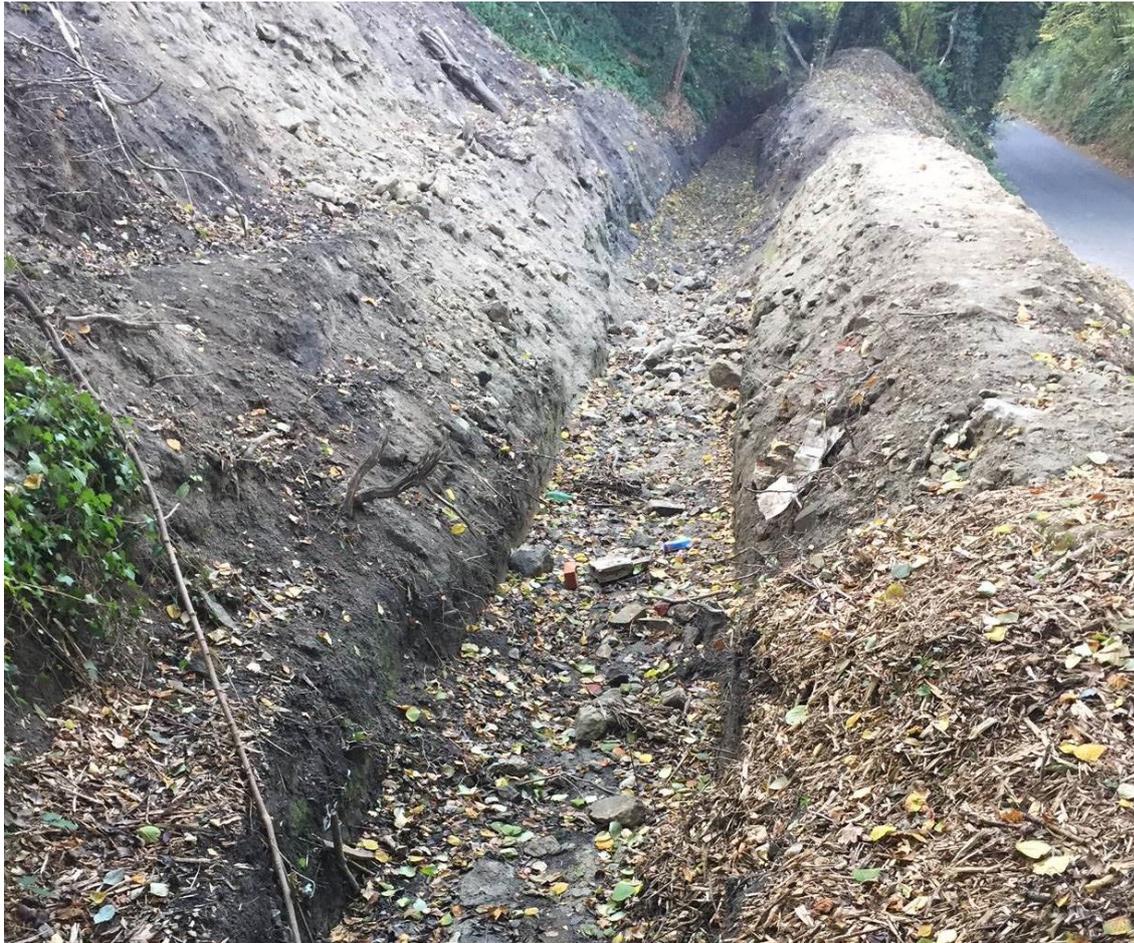
Photo 7 Reinstated watercourse at the site of the former bridge on 28th October 2016
