Flood Investigation Report

Steeds Close, Kingsnorth, Ashford

This report outlines the mechanisms behind the flood events that occurred on 9th November 2014 and 8th January 2015 at Steeds Close, Kingsnorth and will make recommendations to reduce the likelihood of similar events in the future. Two properties were internally inundated during these flood events.

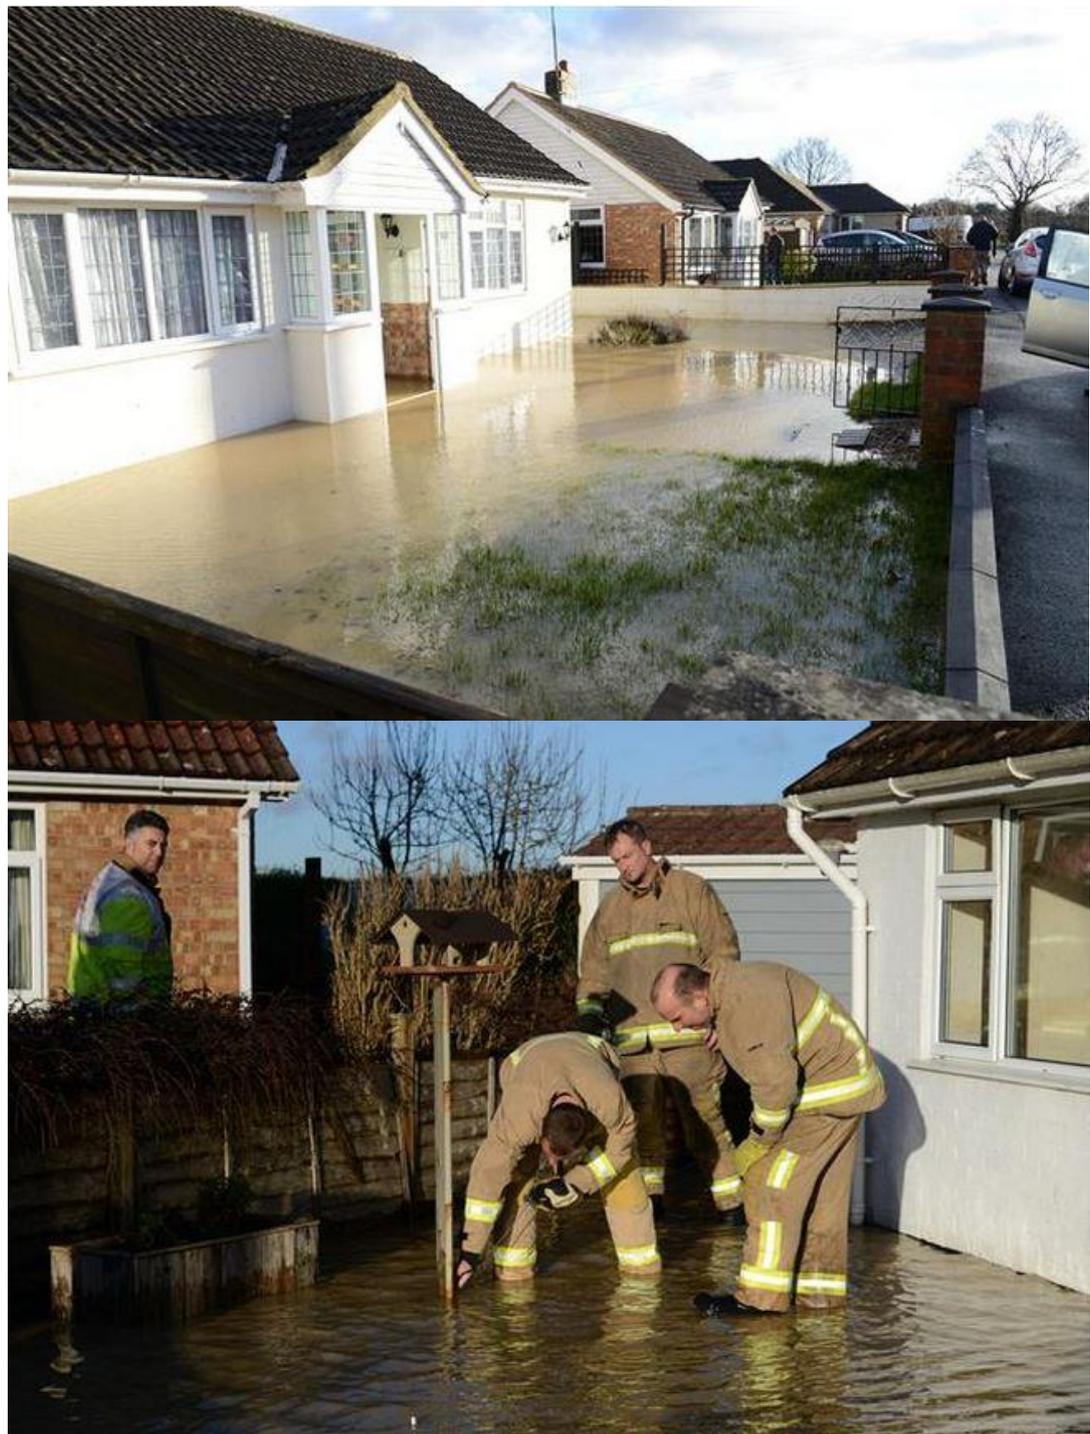
On the 9th November 2014 and 8th January 2015 it was reported to Kent County Council that two properties and gardens at Steeds Close, Kingsnorth had flooded. Figure 2 depicts the flooding that was experienced during the January event.

Figure 2. Flooding at Steeds Close on 8th January 2015 (Kentonline.co.uk)

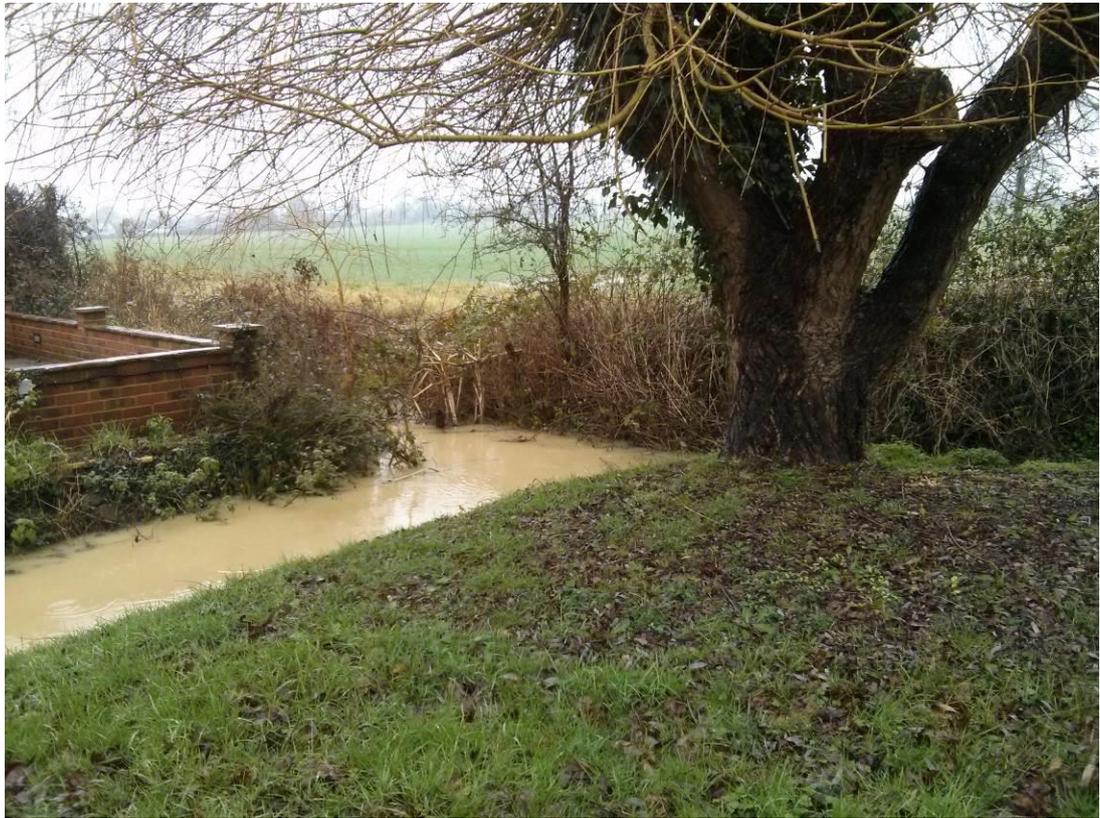
Figure 3. Ditch to the rear of 3 Bond Lane (facing north-west)

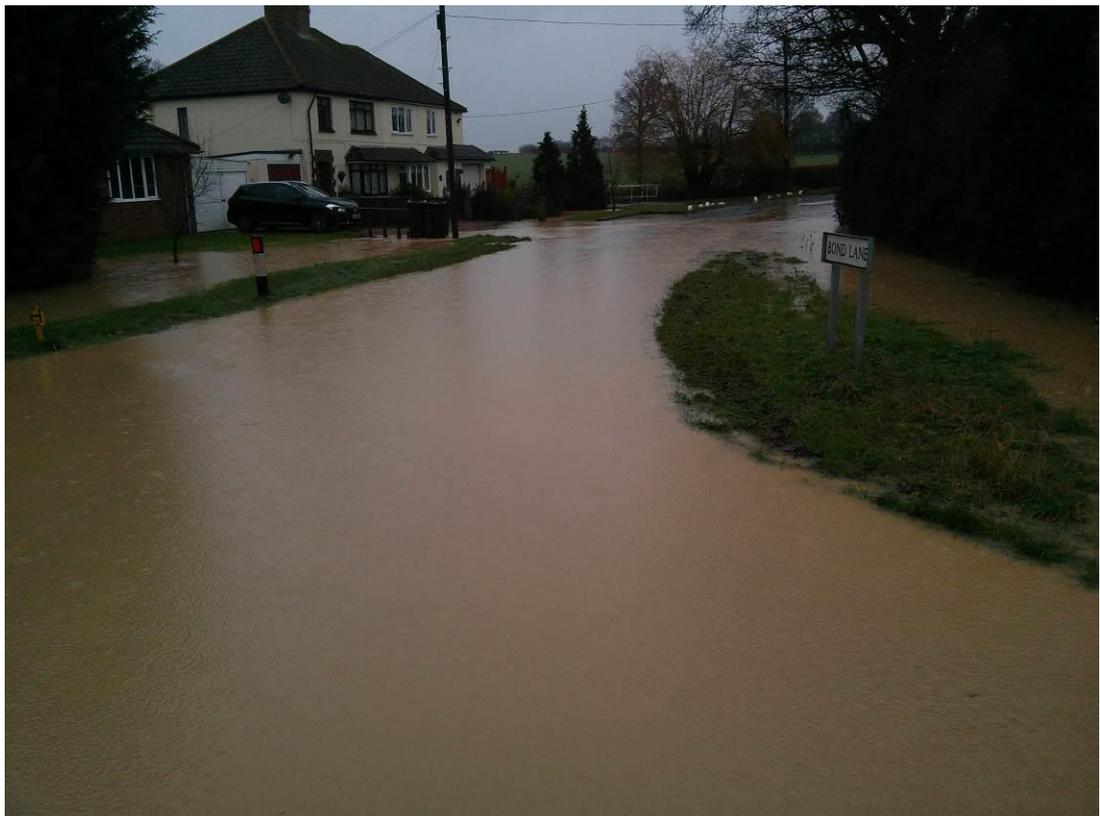
Figure 4. Junction of Bond Land and Steeds Lane (facing north)

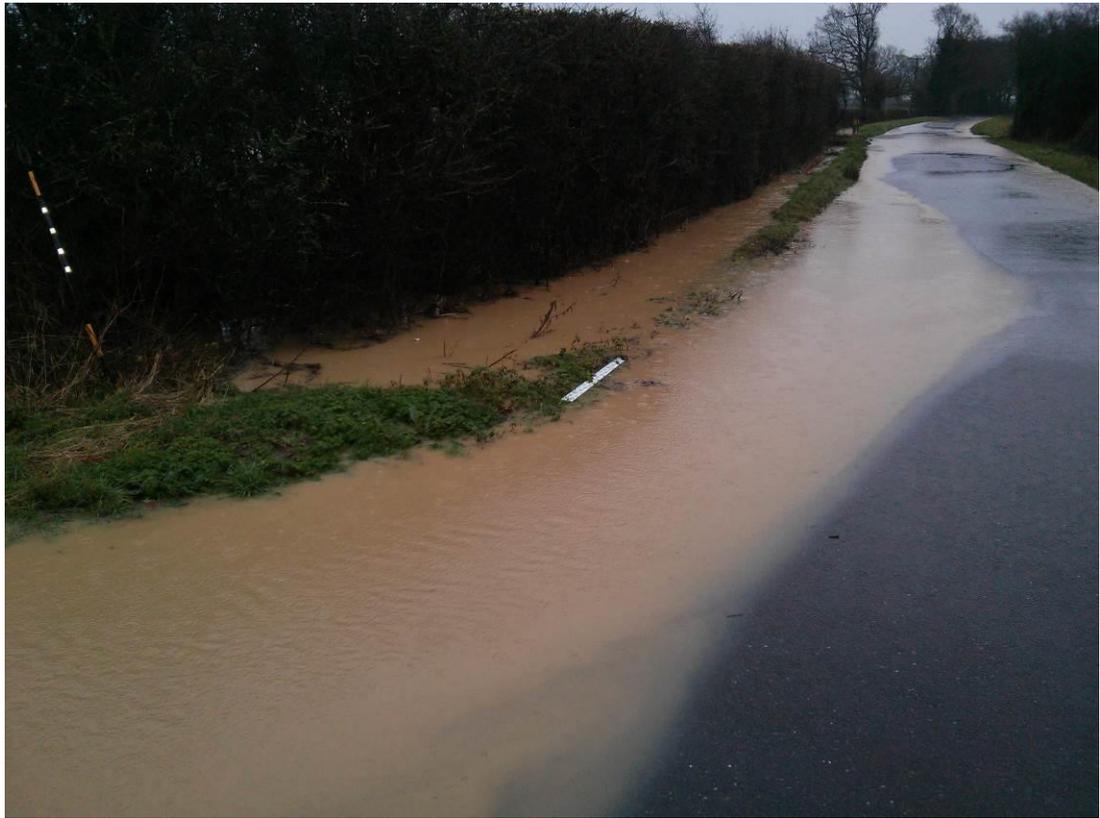
Figure 5. Junction of Bond Lane and Steeds Lane (facing east)

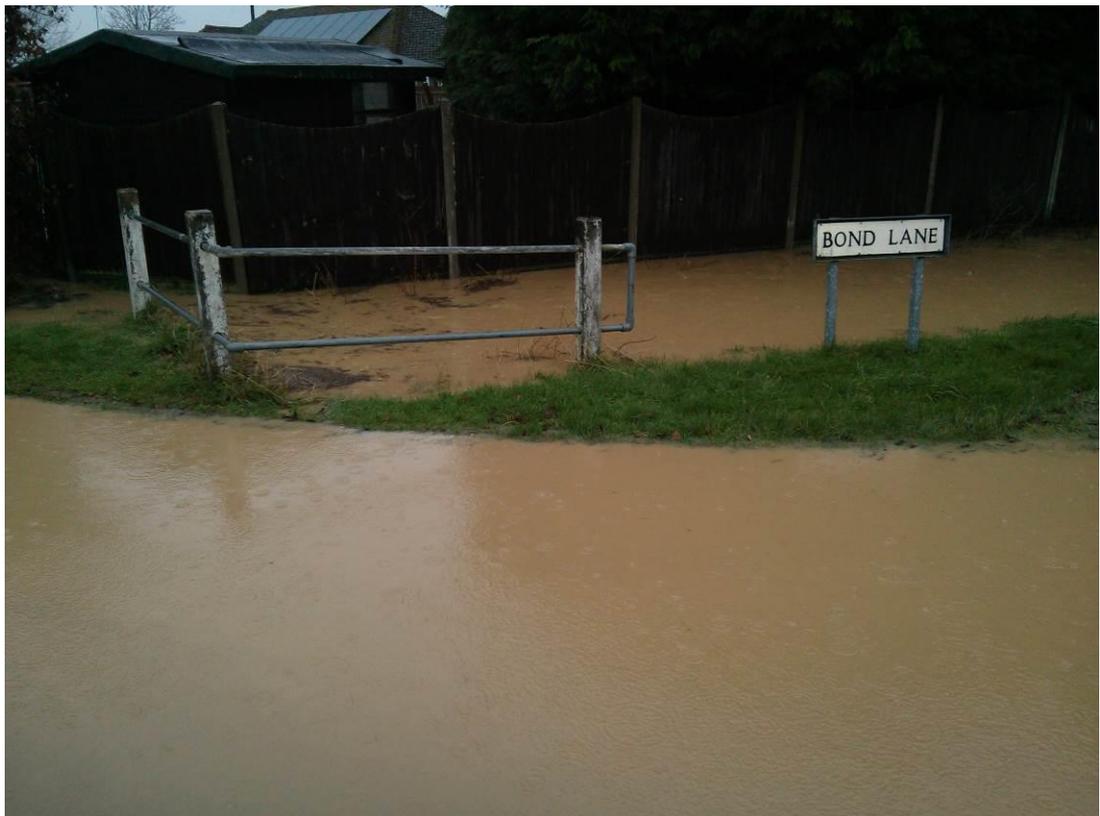
Figure 6. Junction of Bond Lane and Steeds Lane. Culvert beneath Steeds Lane behind railings (facing west)

One half of the twin-culvert beneath Steeds Lane is believed to be obstructed. Again, this is unlikely to have had a significant impact on the properties, but could cause or exacerbate highway flooding.

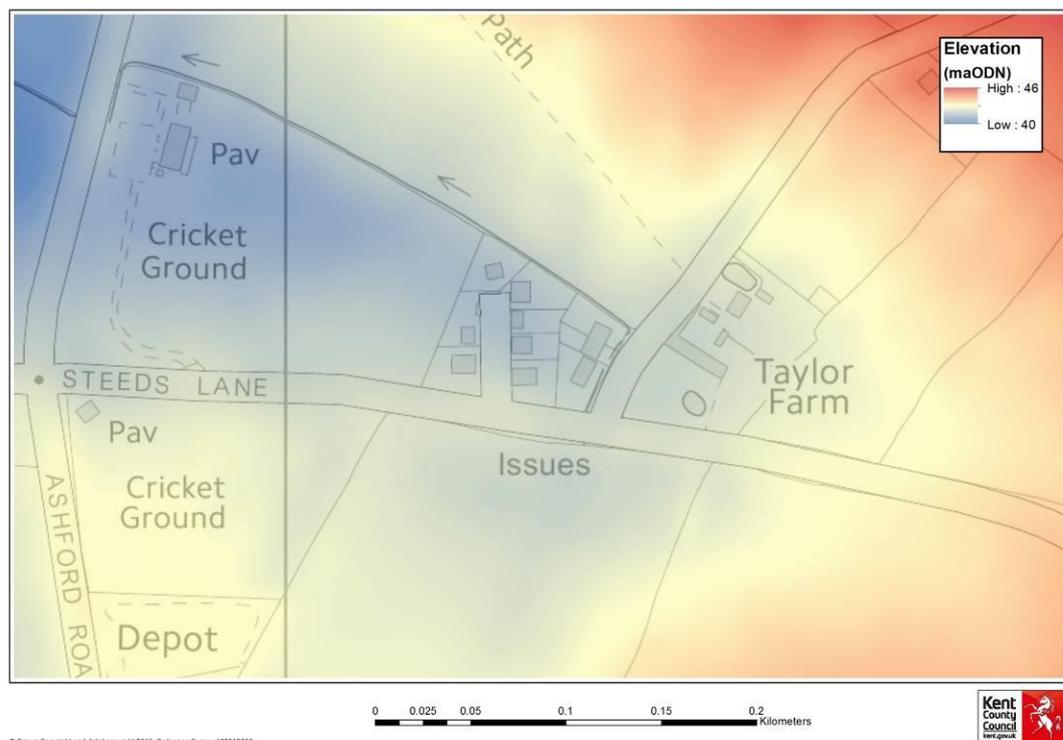
Figure 7. Topography (red indicates high ground, blue indicates lower ground).

The properties and land at risk from flooding lie below the level of these adjacent highways and the surrounding agricultural land (Figure 7).

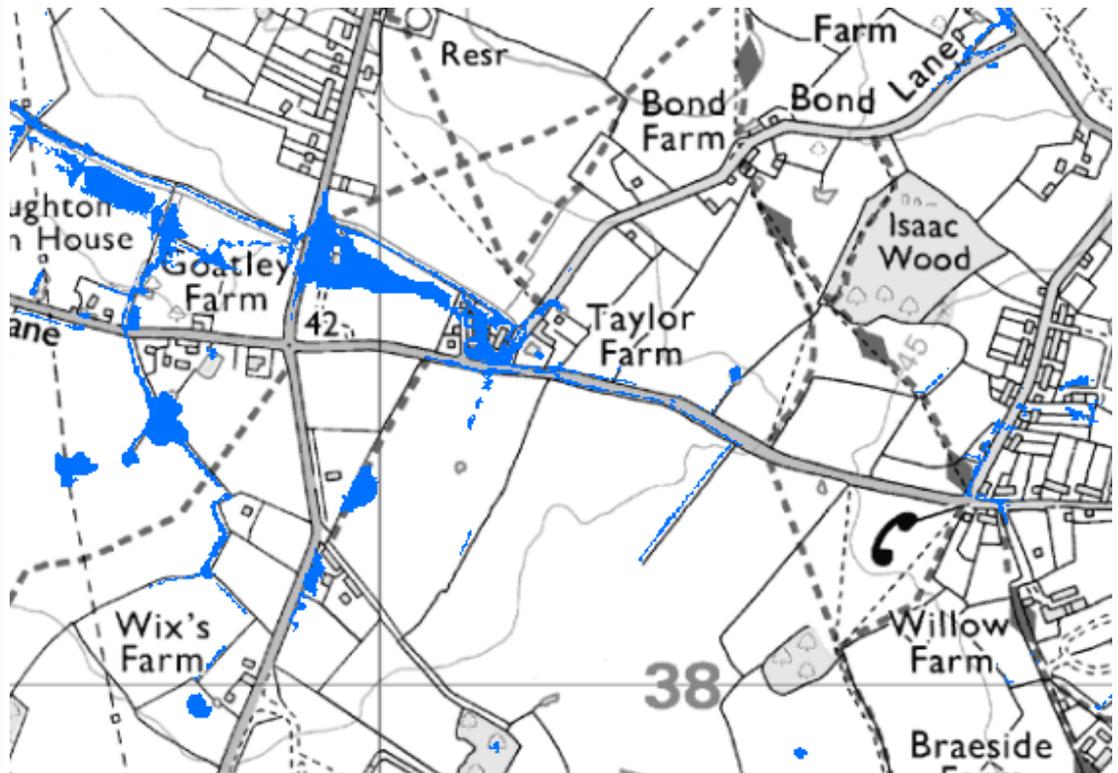
Figure 8. Updated Flood Map for Surface Water (1 in 30yr event)

Although the area is at low risk of flooding from rivers and the sea (Flood Zone 1), the extract from the Environment Agency's updated Flood Map for Surface Water (figure 8) depicts the area as being at risk from accumulation of surface water during '1 in 30yr' rainfall events (as well as during events more extreme than this). The lower land levels in this area and the difficulty in effectively conveying water away will be the key contributing factors.
