Flood Investigation Report

Location of Investigation: Snodland

Date of incident: 10 June 2019

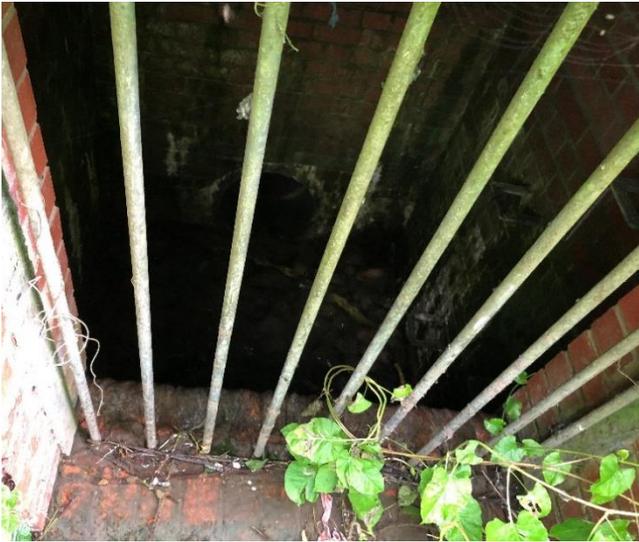
Photo 1 Inlet to the culvert at Paddlesworth Lake (18/06/2019)

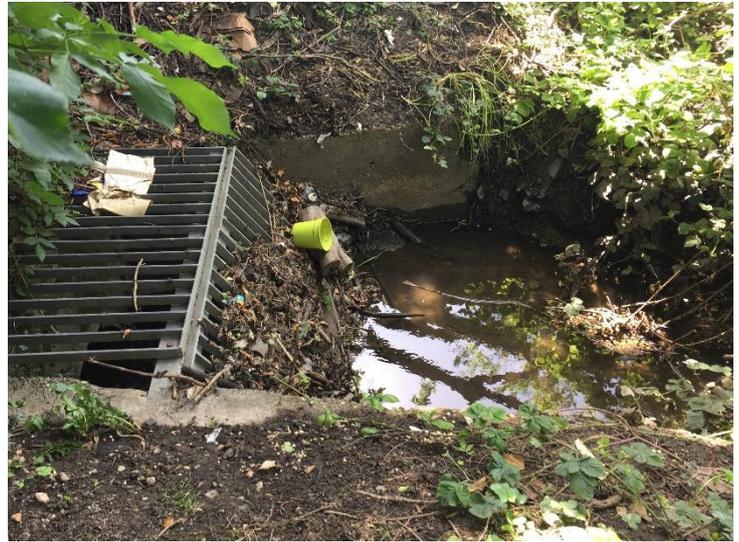
Photo 2 Inlet to the culvert at Birling Road (27/06/2019)

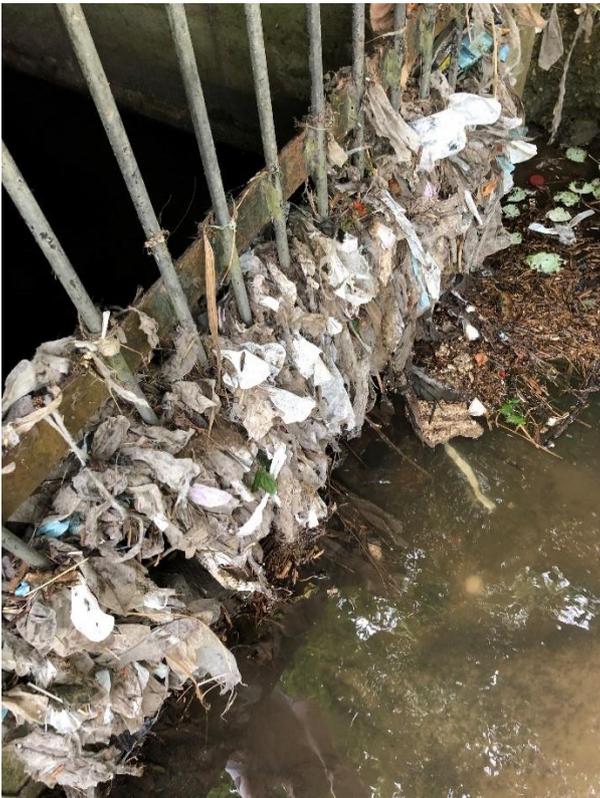
Photo 4 Security screen on outlet of pipe at Saltings Way (18/06/2019)

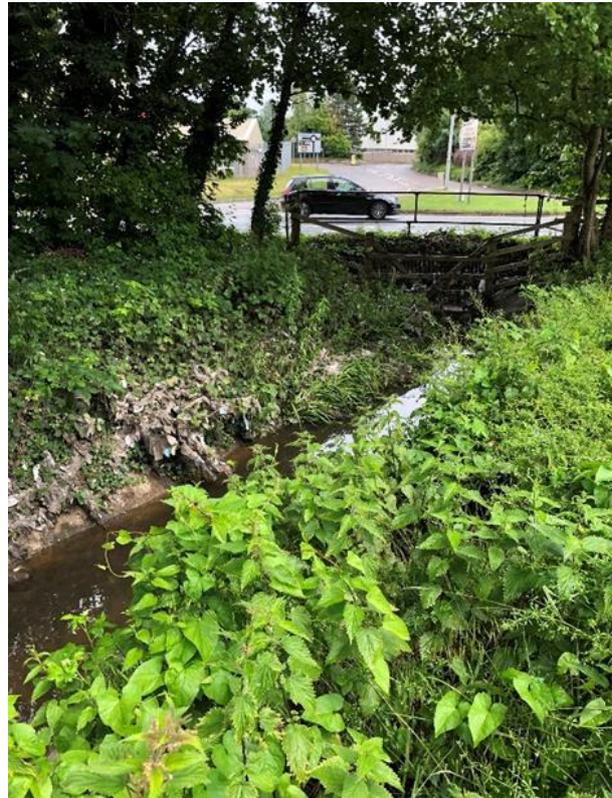
Photo 3 Open channel between Salting Road and the A228 (18/06/2019)

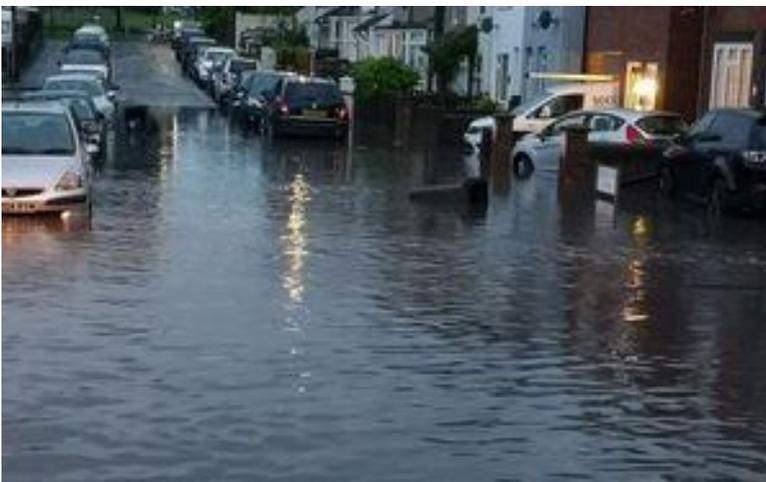
As the intensity of the rainfall increased significant overland flows from the built areas began to drain towards the culverted watercourse and collect within the topographical low points. Recreational Avenue, Rectory Lane and Saltings Road suffered deep surface water flooding as the volume of water collected at a faster rate than the drainage system could discharge it.

Photo 5 Flooding at Rectory Lane (Source: Downs Mail)
