# Flood Investigation Report

Location of Investigation: Ulcombe

Date of incident: 01 August 2021

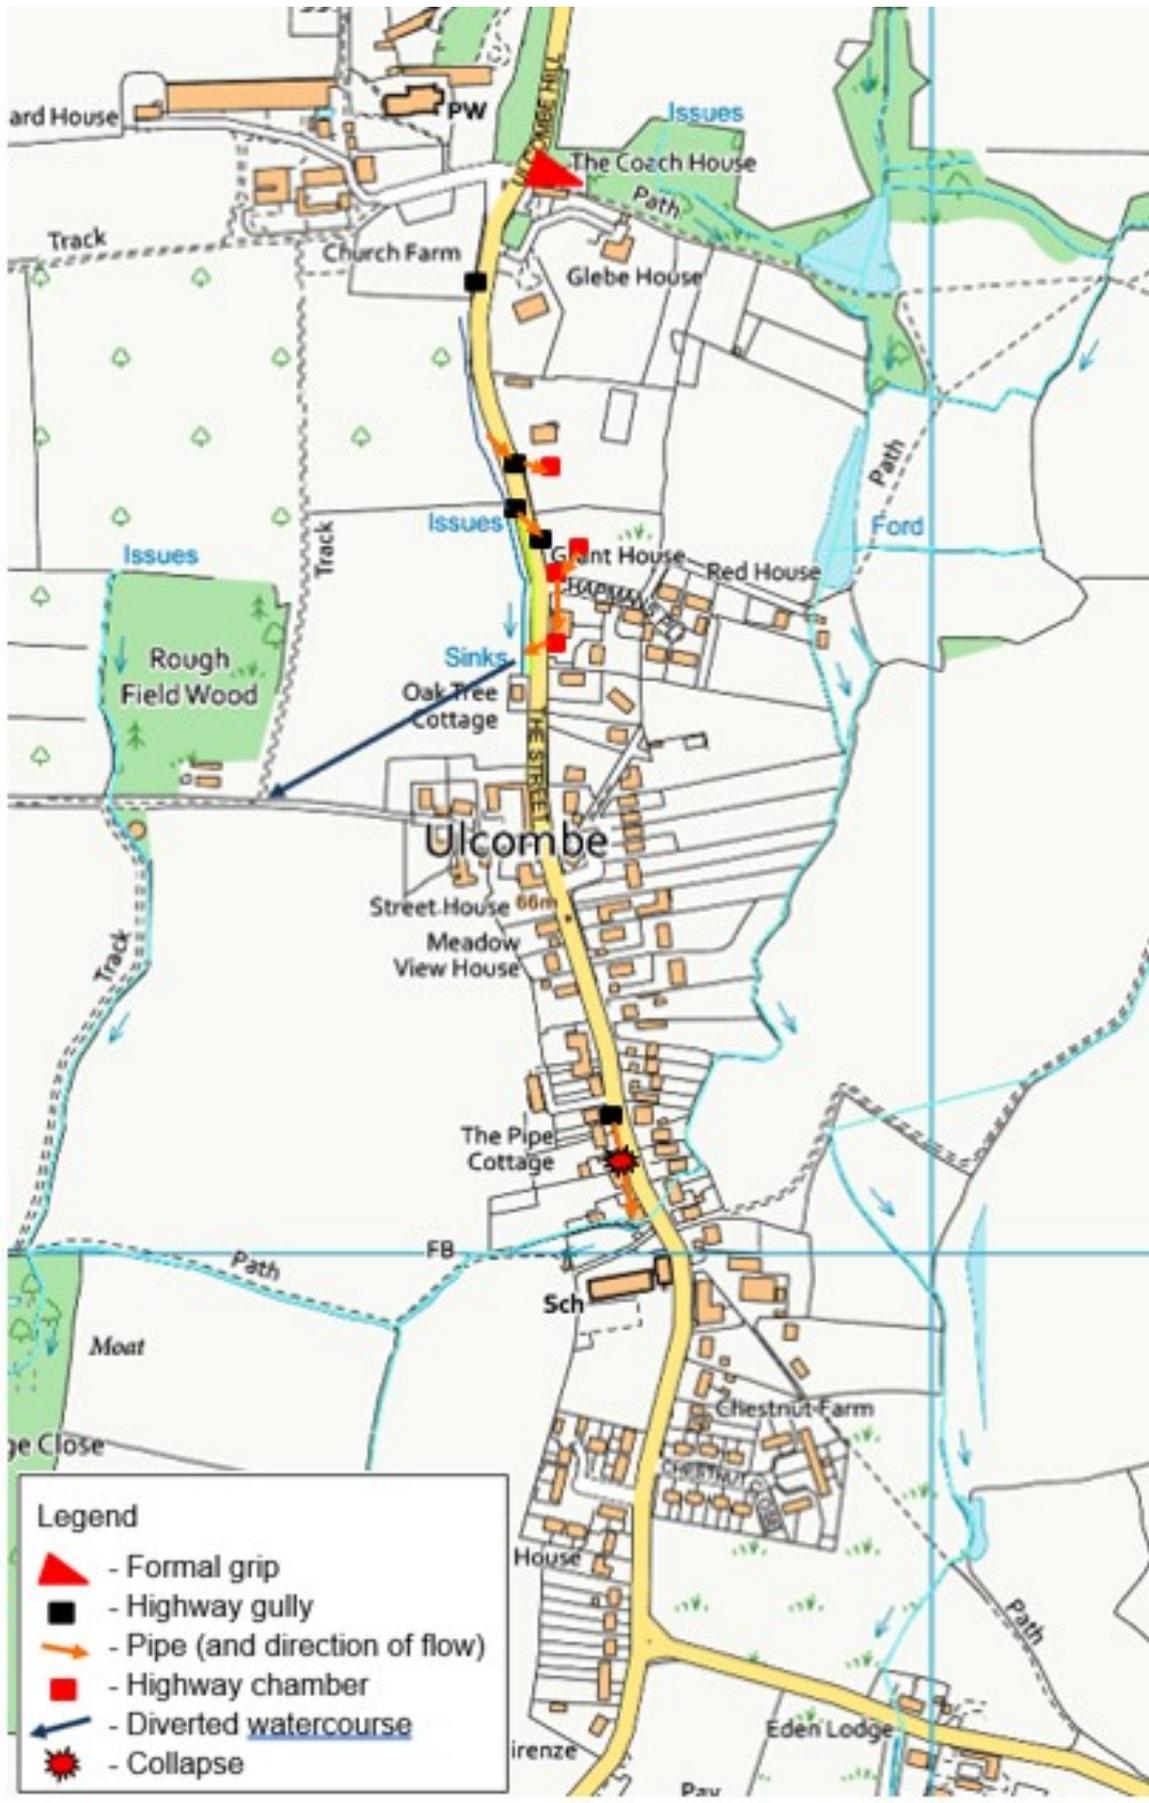
Figure 1 Map of Ulcombe and highway drainage

The ponds along the course of the watercourse, to the east of Ulcombe Hill and The Street (see Figure1), were reported by KCC as being silted and therefore the capacity of both ponds to slow water was reduced.

The 500mm culvert, under The Street was overwhelmed by the volume of water and surcharged, causing flooding in the vicinity of the culvert, this may have contributed to an increase in the flooding upstream.

The highway drainage system on Ulcombe Hill was overwhelmed during this event and the outfall was ineffective. KCC reported that on the 1<sup>st</sup> of August the gip alongside The Coach House, was full of mud, which likely accumulated during the event, the highway runoff would have continued to flow down the carriageway once this was blocked.

Prior to the event, the ditch on the west of Ulcombe Hill, discharged into a pipe under Oak Tree Cottage however this had collapsed. This collapse caused surface water to flow back onto the highway rather than continuing south to ultimately discharge into The Street watercourse.

Since the flood incident on the 1<sup>st</sup> August 2021, the drainage ditches that were blocked during the flood event have been cleared by local residents. The landowner west of Ulcombe Hill was given land drainage consent to undertake works to divert the watercourse, running parallel to Ulcombe Hill, to cross the field and ultimately outfall further downstream in the watercourse to the west of Ulcombe.

KCC Highways have undertaken a number of works since the flood event including cleansing the gullies located on Streetfield. KCC Highways and South East Water have rectified the breakages in the 150mm pipe at the bottom of Ulcombe Hill.

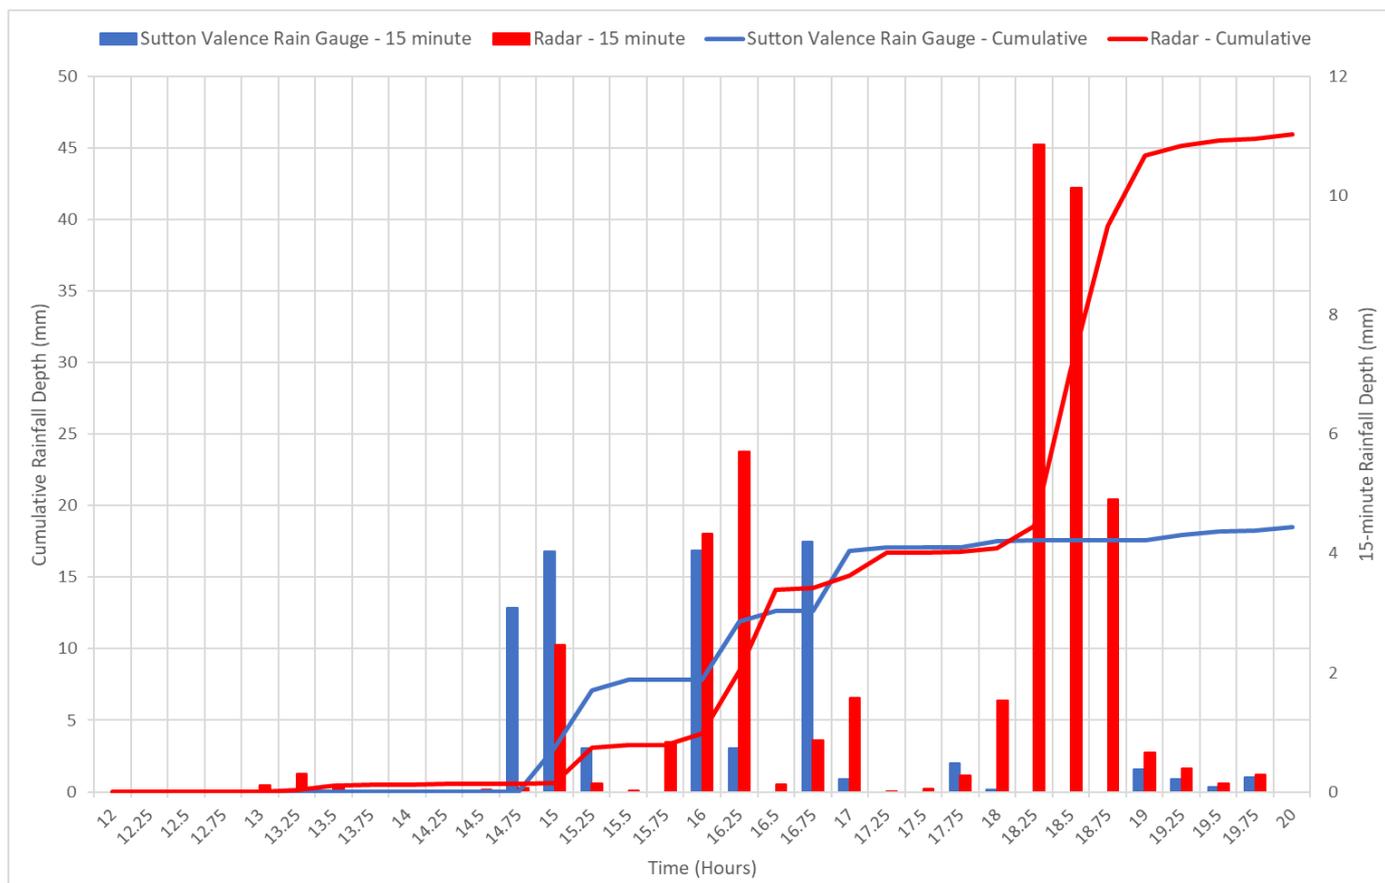
Figure 2 Comparison of measured rainfall between the Sutton Valence rain gauge data (blue) and the radar data (red).

**Error! Reference source not found.**2 compares rain gauge data with the with rainfall radar data for 1<sup>st</sup> August 2021. As can be seen, both data sources measure broadly comparable rainfall occurring between 15:00 and 17:00. However, the radar also measures a significant later burst of rainfall occurring between 18:00 to 19:00. Considering the timing of the reported flood event, between 19:00 and 21:00, it seems likely that this later rainfall was the main cause and indicates that this later storm was highly localised and not experienced at the rain gauge location.

Due to the significant distance of the rain gauge from Ulcombe and the localised nature of intense rainfall events, it appears the rain gauge data does not accurately represent the rainfall in this event. For this assessment rainfall estimates have been derived from the radar data only.

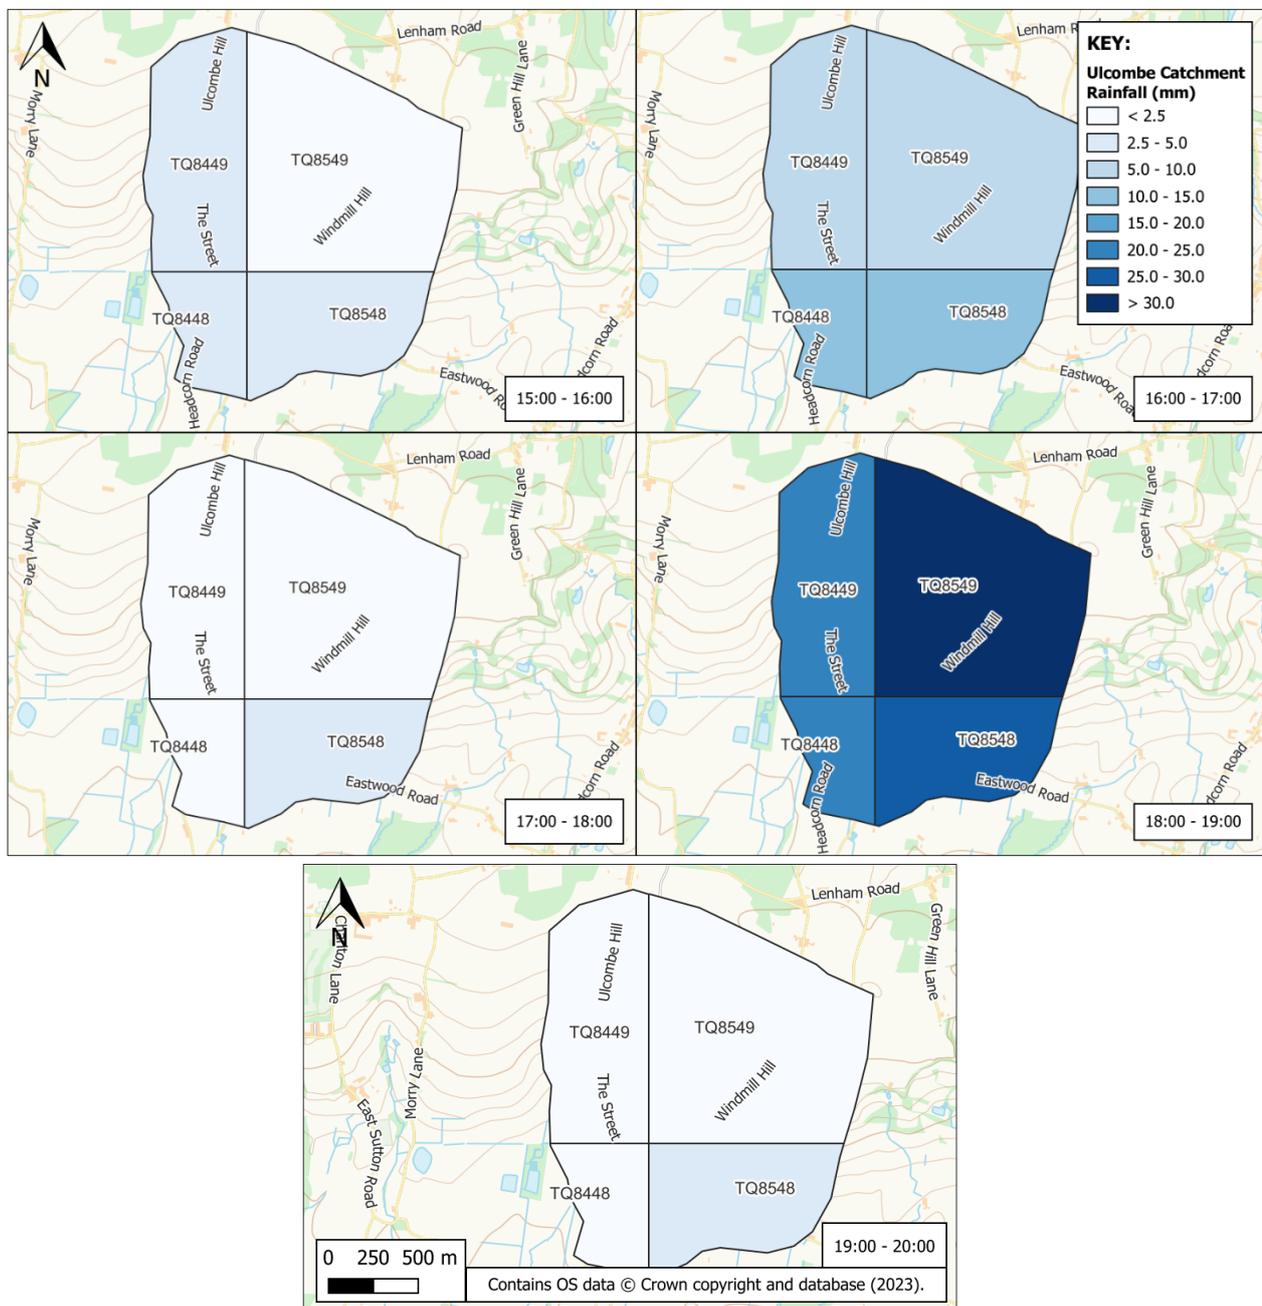
Figure 3 Hourly rainfall radar data from the Met Office from 15:00 - 20:00 across the approximate Ulcombe catchment.

The majority of the rainfall occurred between 16:00 and 19:00 with 41.73mm falling, this corresponds to local reports and a privately owned rain gauge which recorded 42mm of rainfall during the event and was located at the top of the Ulcombe catchment. During the event a more

intensive period of rainfall occurred with 29.66mm falling in an hour, the return period for this intensive burst of rain is a 1 in 29-years and is likely to have generated the most significant volumes of surface water runoff.

The rainfall radar data below clearly shows the period of intense rainfall between 18:00 and 19:00 and that it fell to the north-east of the Ulcombe directly over the watercourse catchment area.

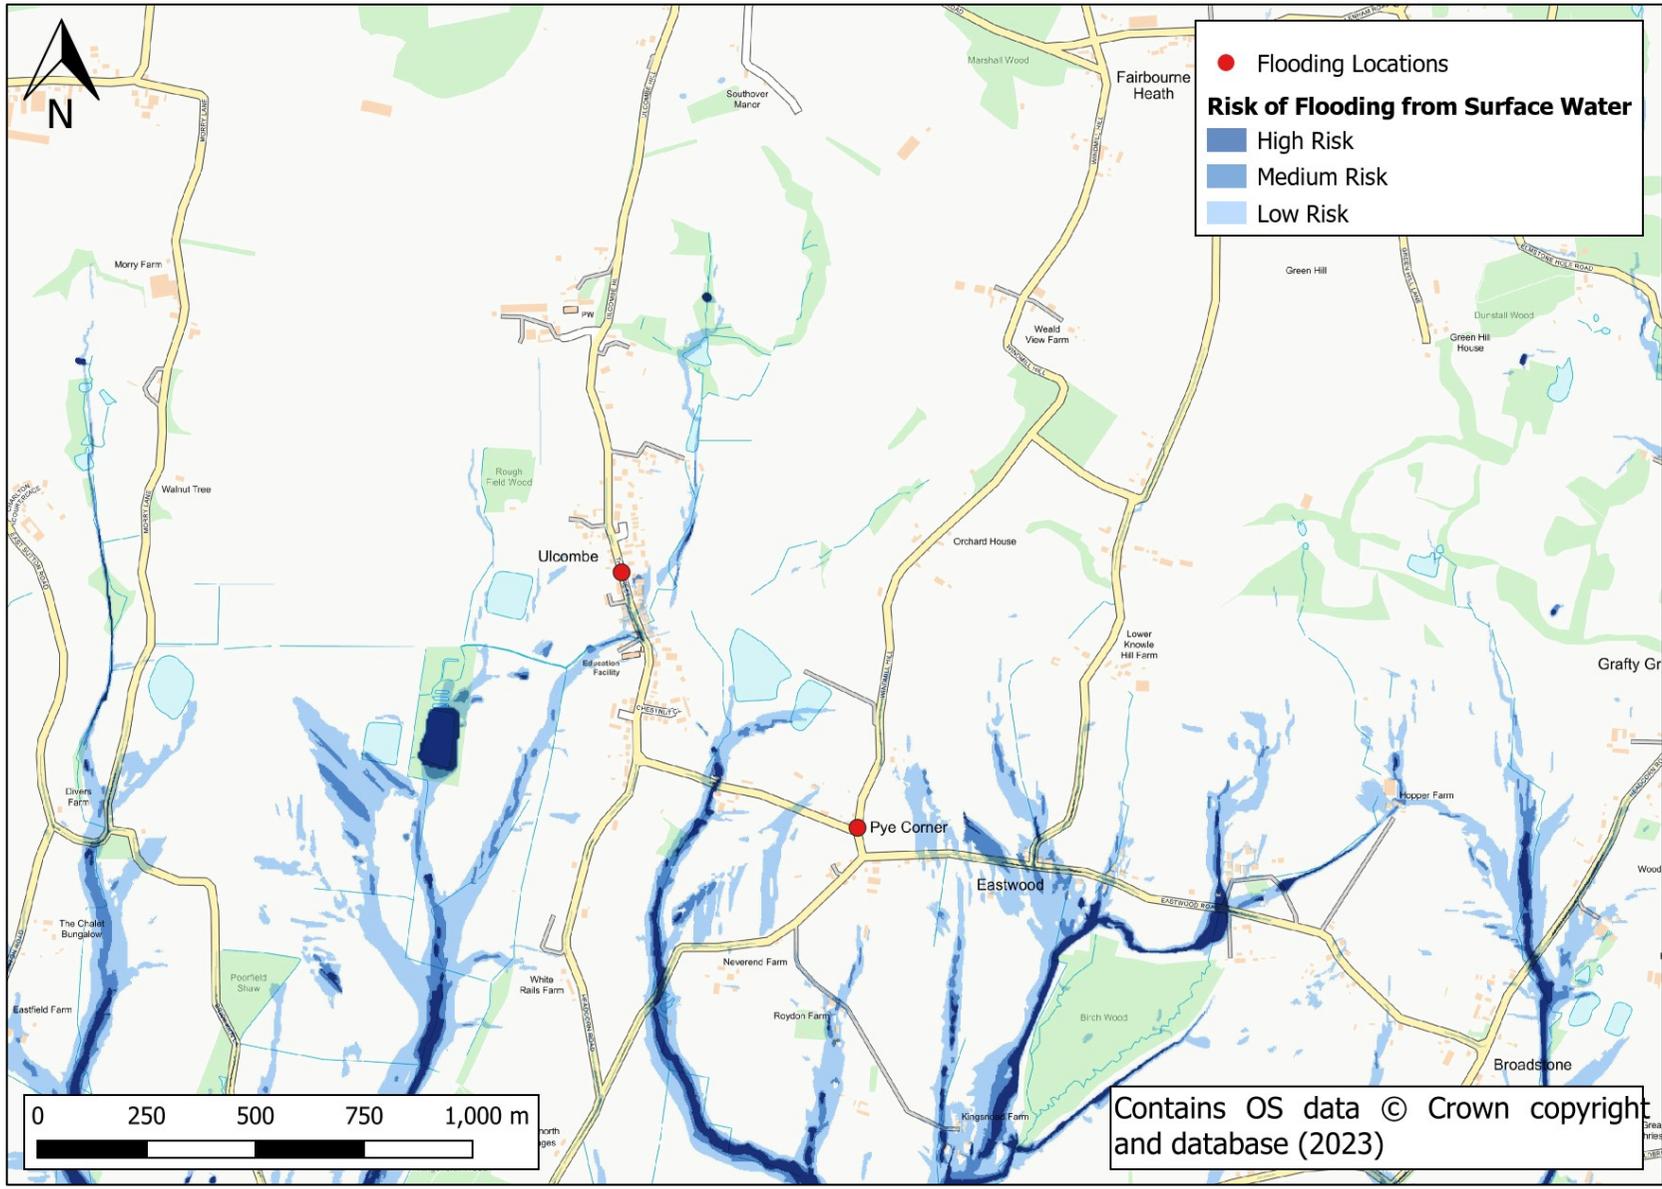
Annex 1 - Extract from the Environment Agency's Flood Risk from Surface Water map

Annex 1 at the end of the report shows an extract from the Environment Agency's Flood Risk from Surface Water map. Flooding from surface water is typically associated with natural overland flow paths (including the unnamed tributaries of the River Beult) and local depressions in topography where surface water runoff can accumulate during or following heavy rainfall events. The Environment Agency's map indicates that the areas at a high risk of flooding from surface water sources are associated with the unnamed tributaries of the River Beult, in particular the tributary that flows beneath The Street<sup>3</sup>. The areas indicated to be a high risk of flooding from surface water sources are consistent with the locations of reported properties affected by the flood event.
