Flood Investigation Report

Location of Investigation: Vigo Village and Culverstone

Date of incident: 10 June 2019

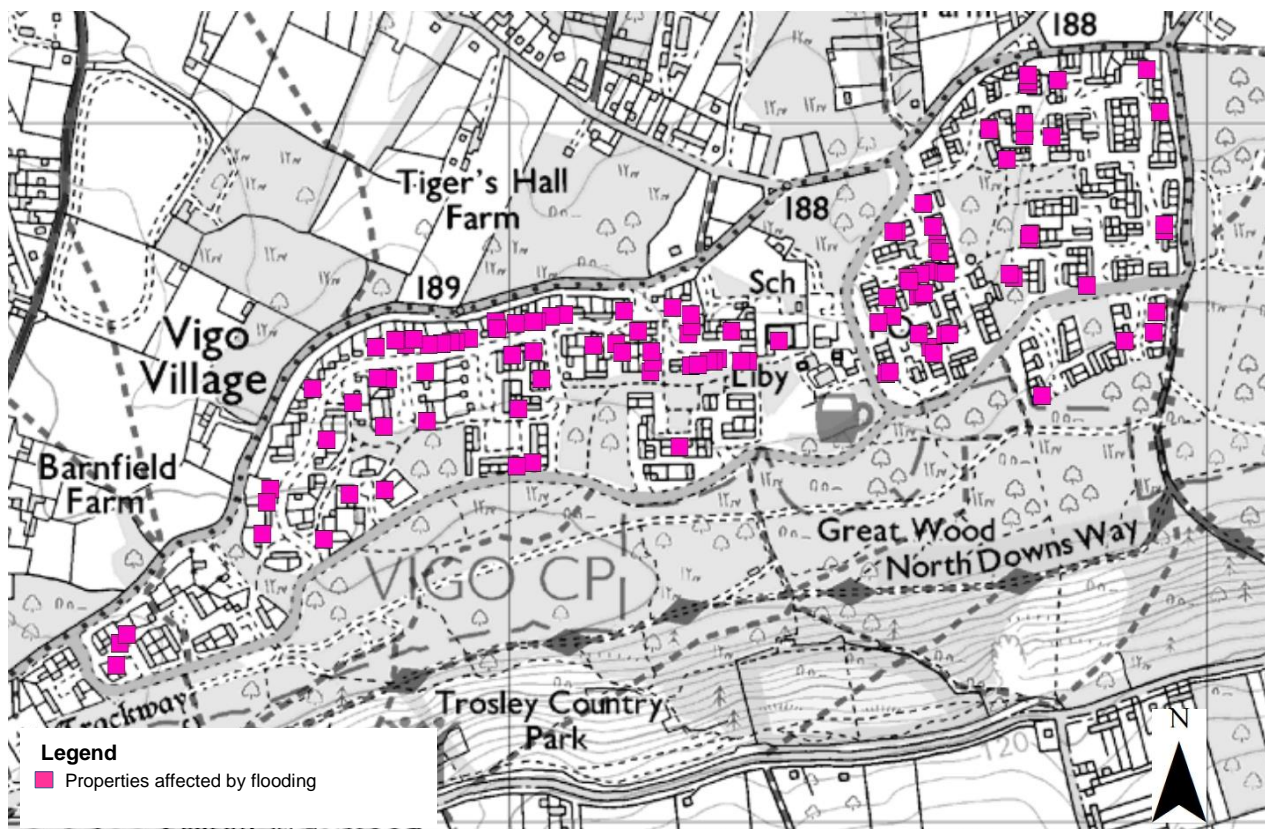
Figure 1 Location of properties in Vigo Village affected by flooding

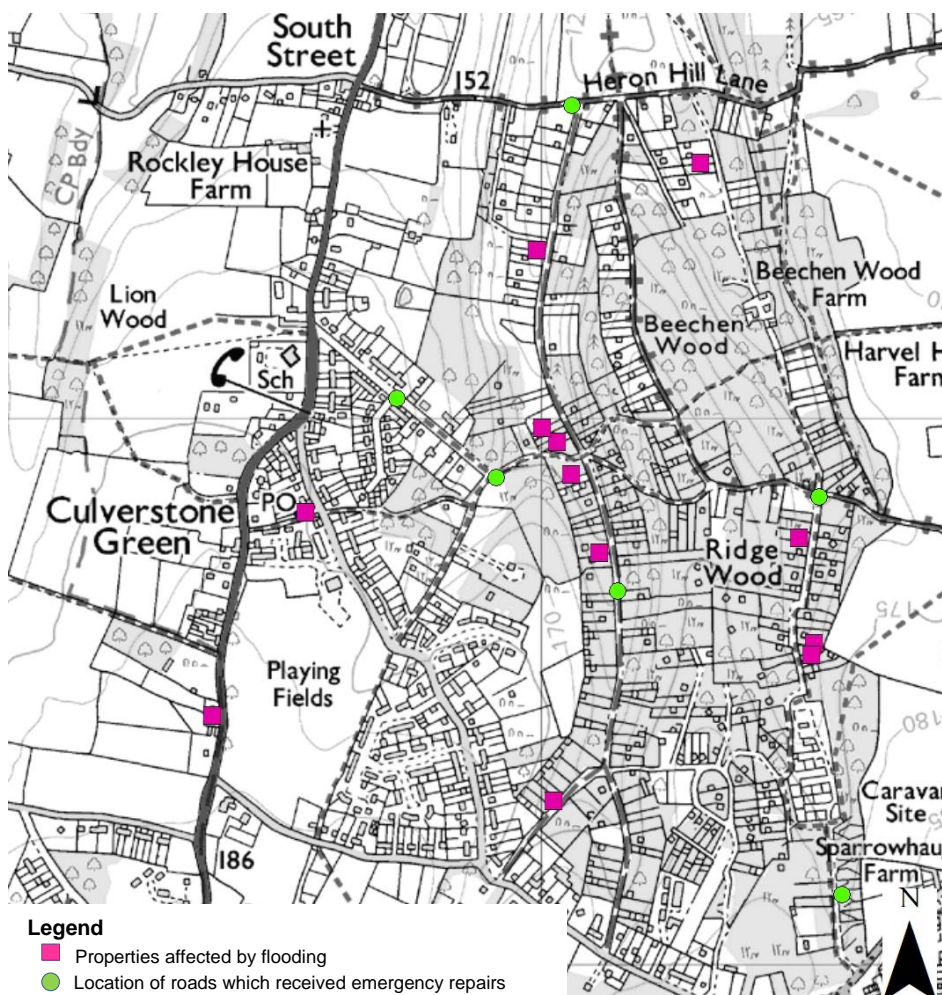
Figure 2 Location of properties and roads in Culverstone affected by flooding

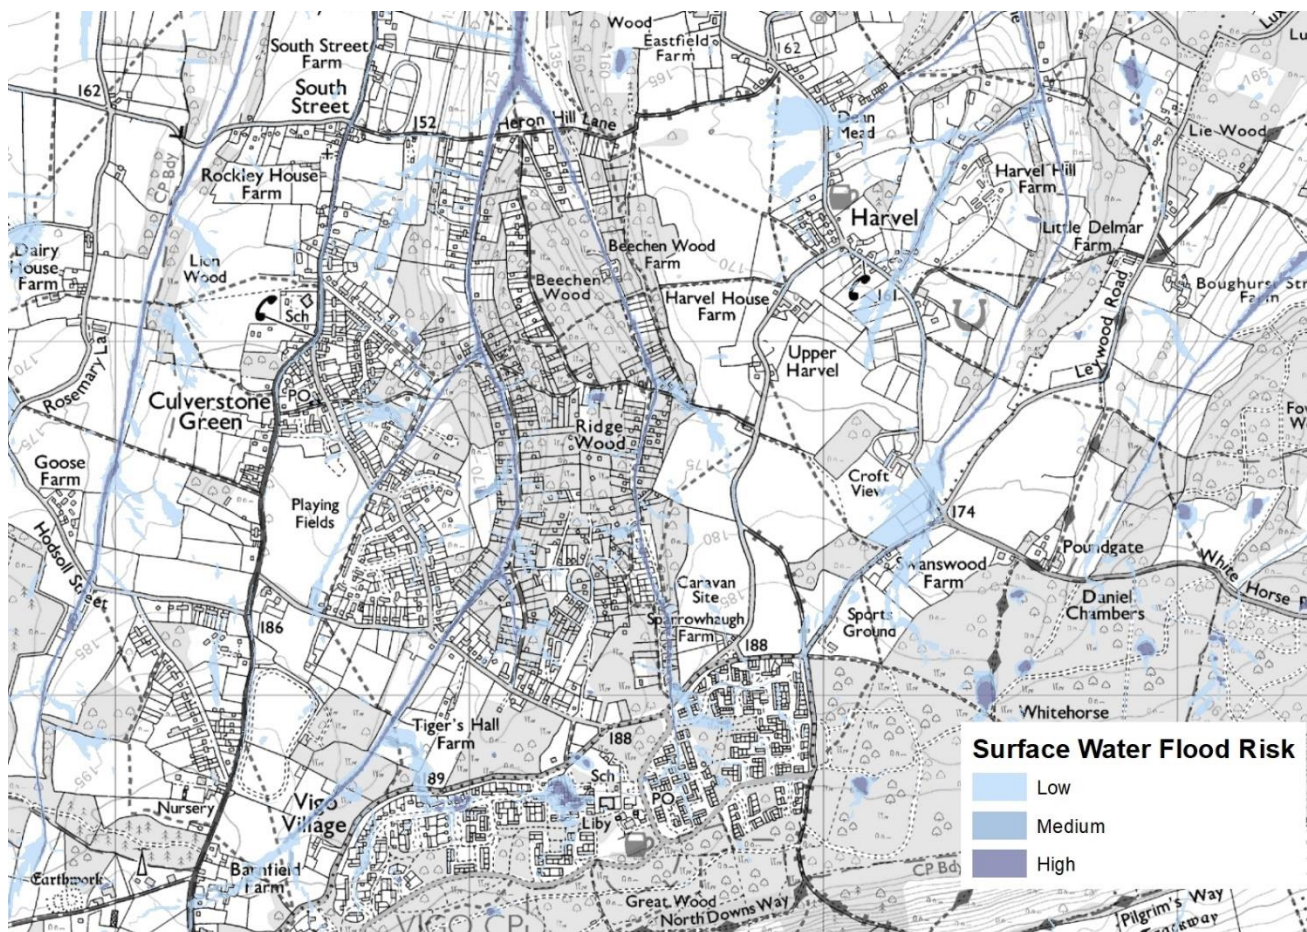
The national surface water flood map provided by the Environment Agency on the gov.uk long term flood risk information map indicates topographical low points and these valley features to be at a medium to high risk of surface water flooding. Medium and high risk means that these areas have a chance of flooding of between 1% and 3.3% or greater in any one year. An extract from the surface water flood map is shown in Figure 2. It should be noted that all information shown by this mapping, particularly the likelihood of surface water flooding, is a general indicator of an area's flood risk, it is not suitable for identifying whether an individual property will flood.

Figure 3 Environment Agency Surface Water Flood Risk Map
