# Flood Investigation Report

Location of Investigation: Horsmonden

Date of incident: 25 July 2021

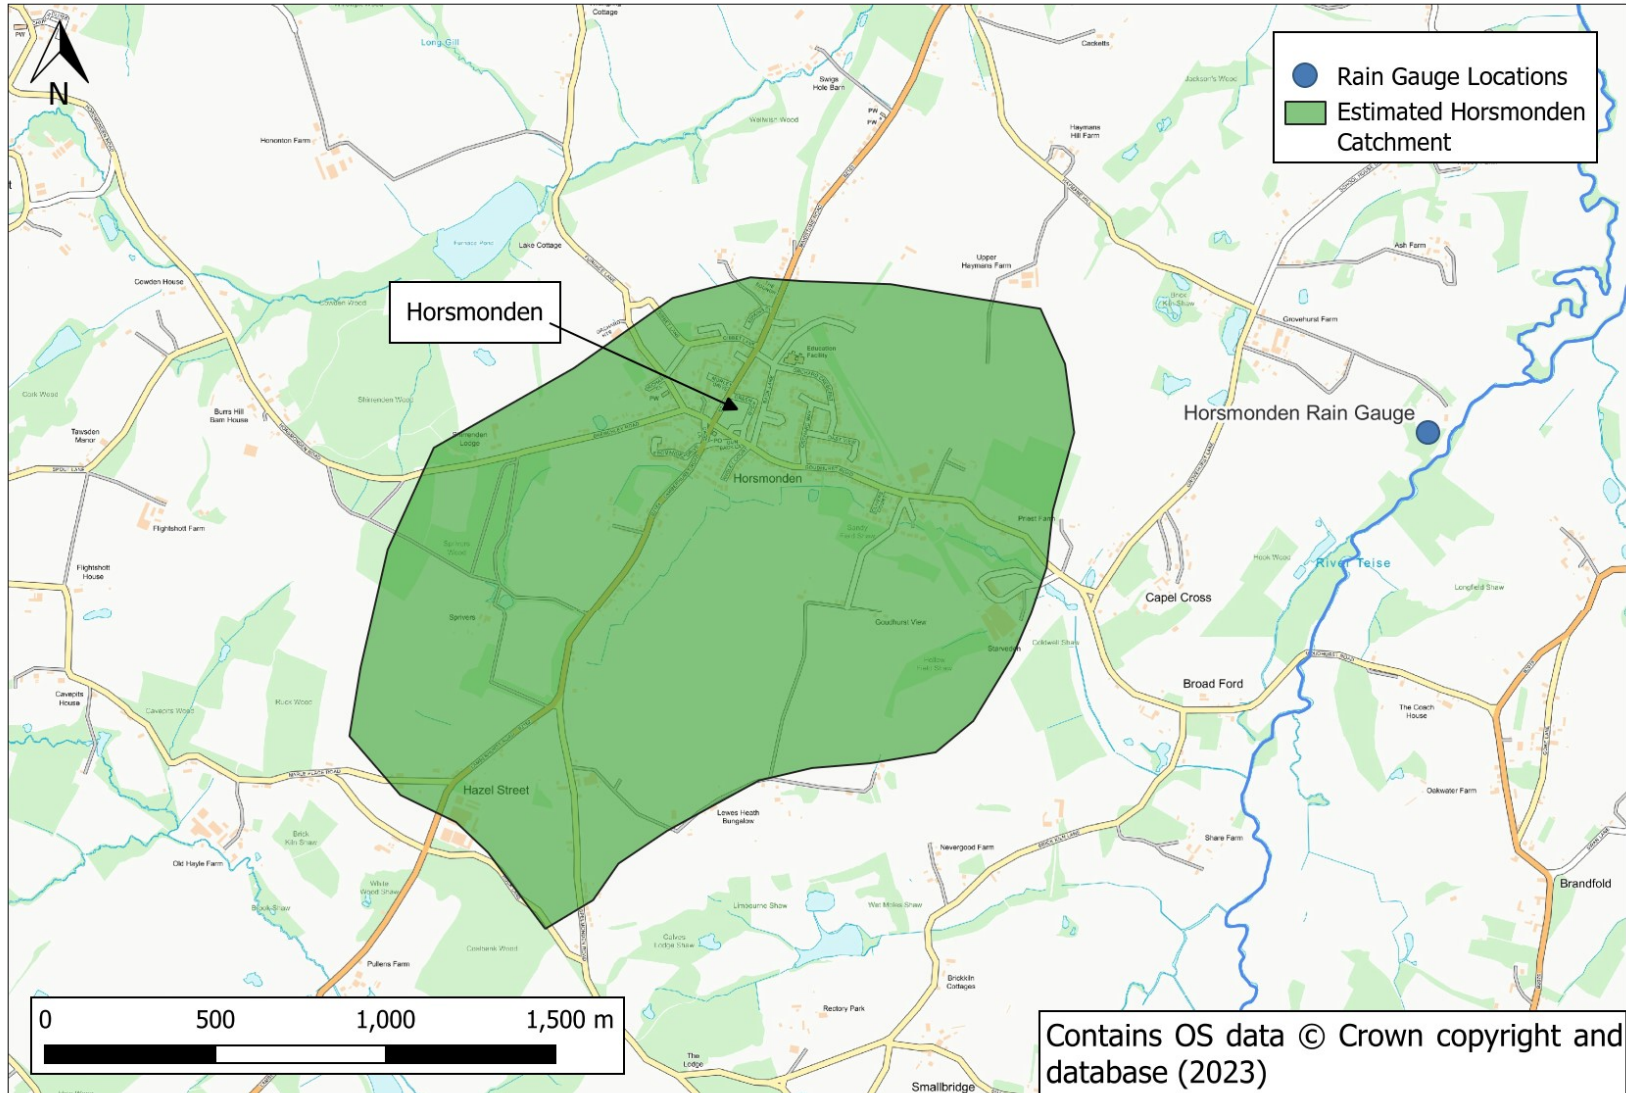
*Annex 3 – Estimated Horsmonden catchment and location of Horsmonden rain gauge*

The closest Environment Agency rainfall gauge is located in Horsmonden, approximately 2 km to the east of the village and approximately 1 km to the east of the edge of the estimated surface water runoff catchment for Horsmonden (no other rain gauges were considered to be appropriate to be used due to the significant distances from Horsmonden). Annex 3 at the end of the report shows the location of the Horsmonden rain gauge and the estimated Horsmonden catchment.
