May 2016

Kent County Council

Flood Investigation Report

Flooding affecting the Tunbridge Wells Area on
24th August 2015

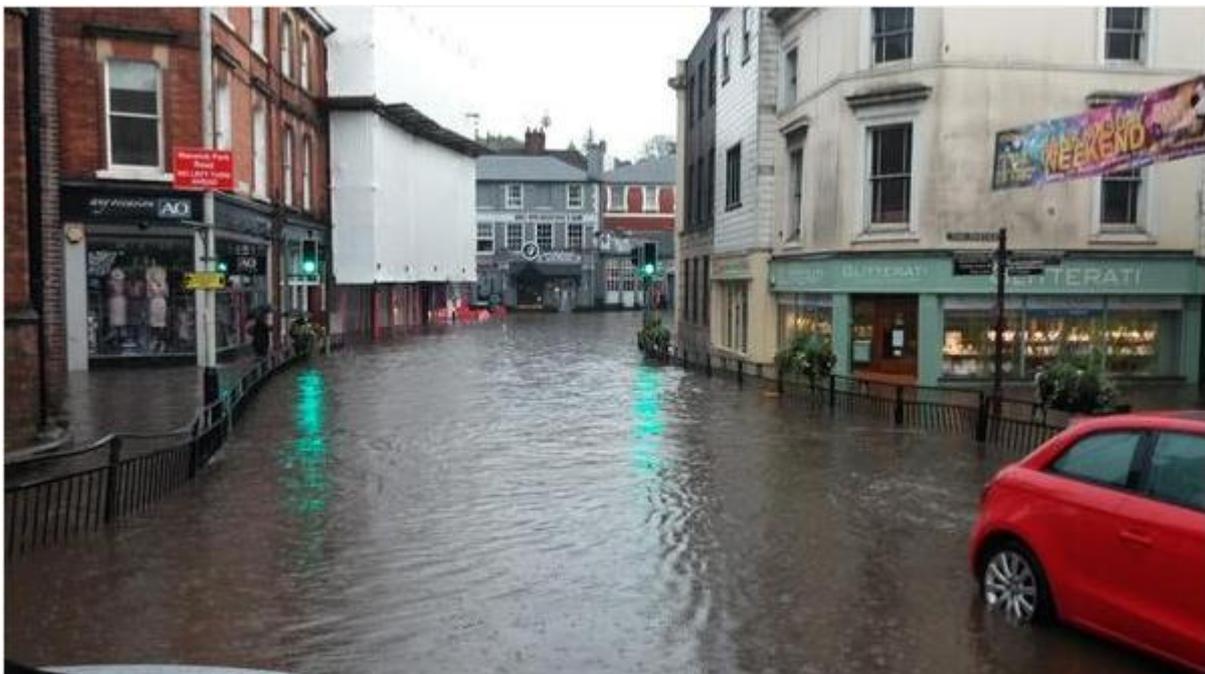
Two residential properties and four commercial properties are known to have flooded internally. Flooding was also reported in Market Street due to an accumulation of surface water at its low point, resulting in the flooding of two properties. Flooding of one residential property was also reported in Sussex Mews but is a separate incidence of flooding.

Photo 1 Flooding in Nevill Street (Source: Kent and Sussex Courier)

The primary cause of the flooding was excessive rainfall which exceeded the capacity of the drainage systems in this area. The intensity of the rainfall meant that surface water was unable to enter the sewer network fast enough and accumulated in the topographical low points, which reached sufficient depths to enter property in some locations. This heavy rainfall also caused surcharging (backing up) of the combined sewer network at Nevill Street causing the drains to back up into properties.

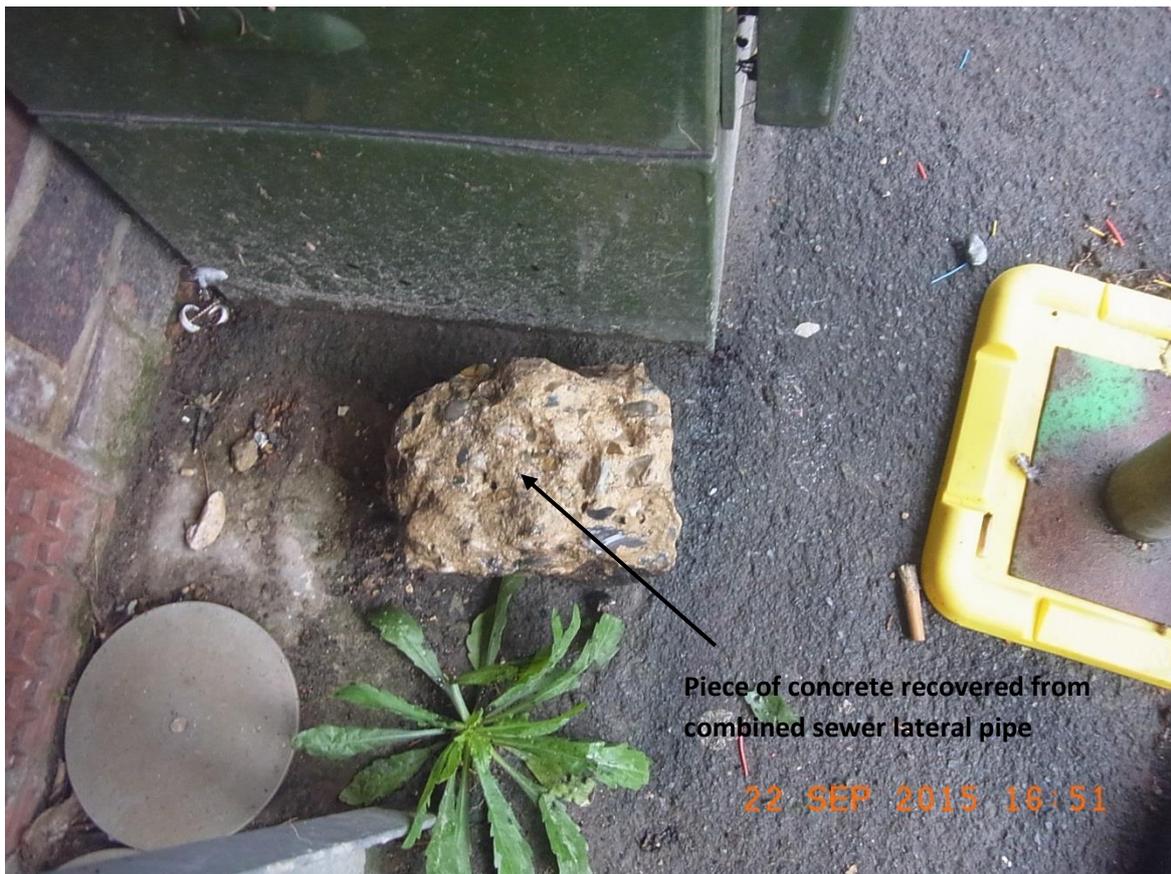
Subsequent investigations by Southern Water found a blockage caused by a piece of concrete in the public sewer leading from Cumberland Walk to a submersible pump at Warwick Park. This provides foul and surface water drainage for the block of properties between Cumberland Walk, Nevill Park and Warwick Park and surface water drainage for buildings and some of the highway drainage at this location. The piece of concrete can be seen in Photo 2.

Photo 2 Piece of concrete recovered from 150mm diameter combined sewer line (Source: Southern Water)

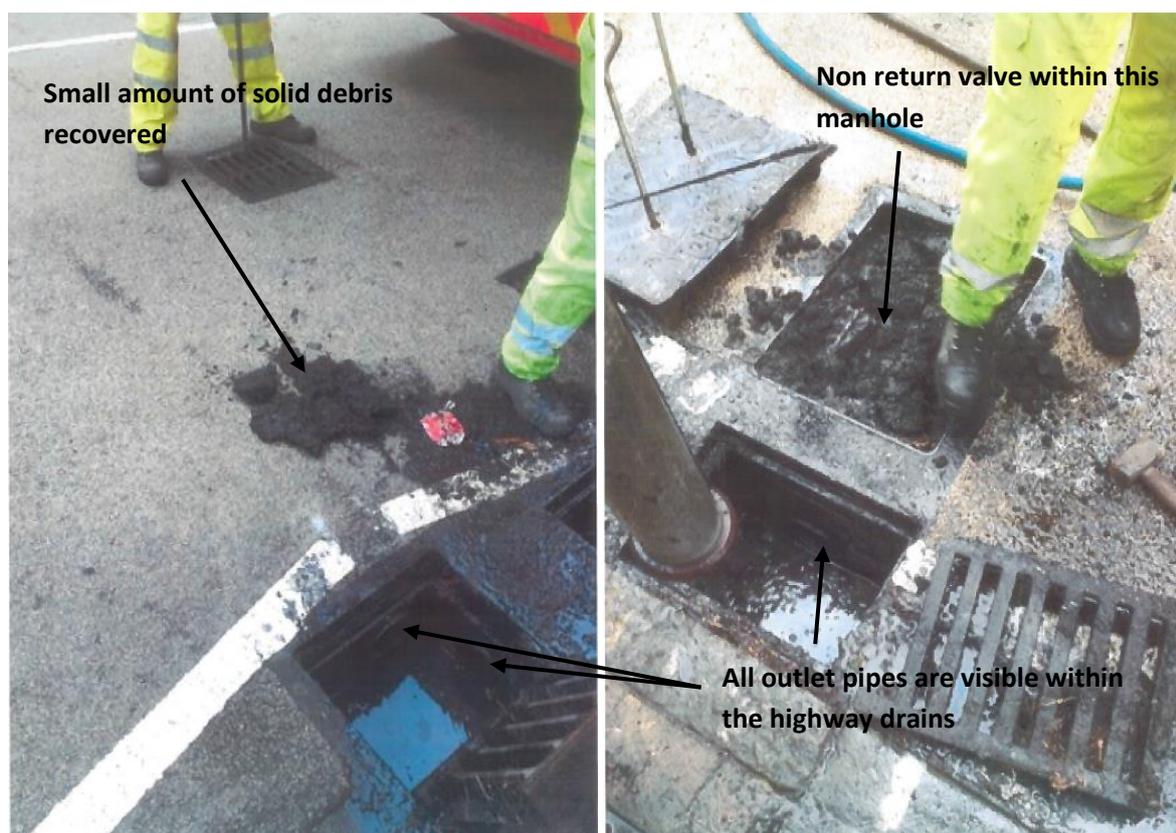
Photo 3a and 3b Photographs taken during drainage cleansing on 25th August (Source: Southern Water)

During the clean-up operations following the flood event, highway gullies on the western side of Nevill Street, adjacent to the Pantiles, were found to contain some tarmac in their sumps. However, these deposits were not significant and did not block the outlet pipes from these drains.

A manhole adjacent to the highway drains at Nevill Street in Photos 3a and 3b contains a build-up of silt, however this is only an access to a non-return valve and this debris is not causing a blockage on the drainage network. A subsequent CCTV survey undertaken by KCC shows the non-return valve to be in full working order.

Standard procedure for resurfacing works is to cover the gullies to prevent tarmac from entering them. If this procedure had not been followed the drains would have been fully and visibly blocked with tarmac and unable to be cleaned. These deposits may have come from a previous repair on these gullies. No tarmac was found in the other highway drains within the area that was resurfaced.

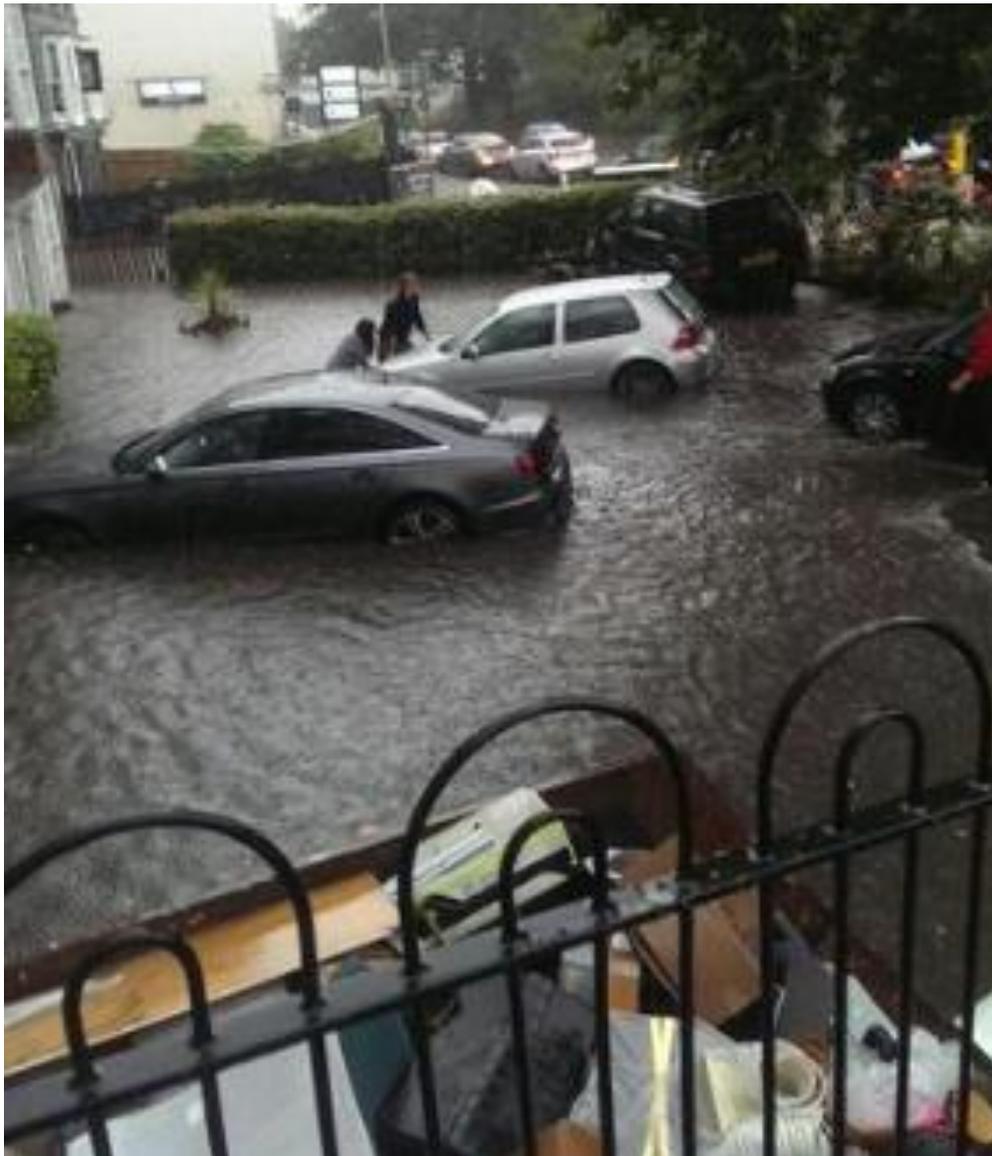
In Castle Street, which is located off London Road, one commercial property is reported to have flooded internally and the highway was flooded to a depth of approximately 0.3 to 0.4m over a distance of at least 50m in its lowest point.

Photo 4 Flooding of property off London Road near Castle Street (Source: Kent and Sussex Courier)

There is a localised topographical depression at Castle Street, where water can build up, which is likely to have led to flooding of properties on London Road from the rear. Other properties flooded on London Road from the front due to the water flowing down the road.

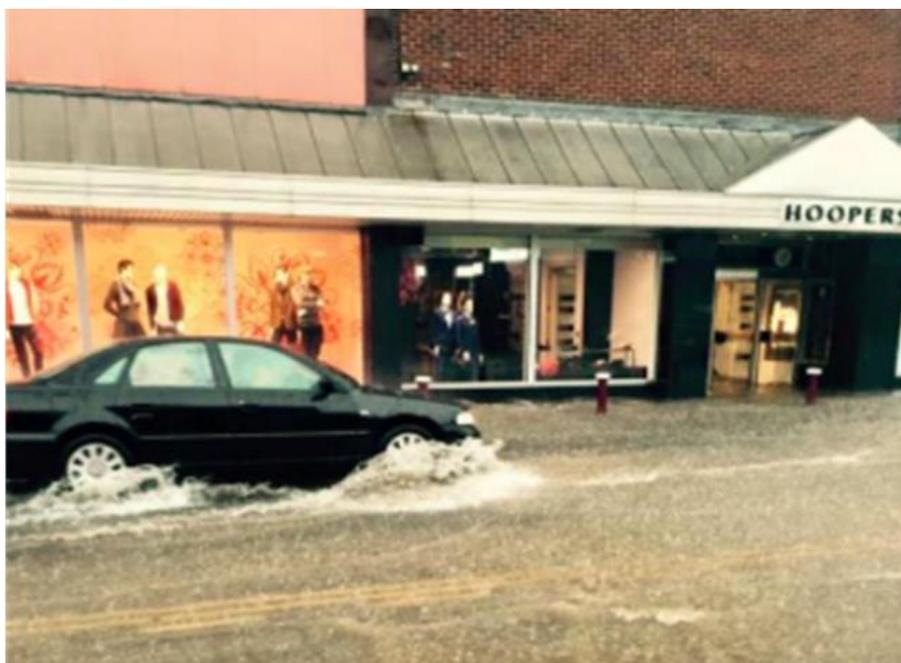
Flooding in this location is reported to have affected one commercial property in the ground floor and basement levels due to water flowing through doorways and into the basement. The highway suffered flooding due to water collecting in the lowest point up to 0.3m in depth shown in Photo 7.

Photo 5 Flooding of Mount Pleasant Road (Source: Kent Messenger)

The primary cause of the flooding was excessive rainfall which exceeded the capacity of the drainage in this area. This meant that surface water was unable to enter the sewer network fast enough and accumulated in the topographical low points, which reached sufficient depths to enter property.

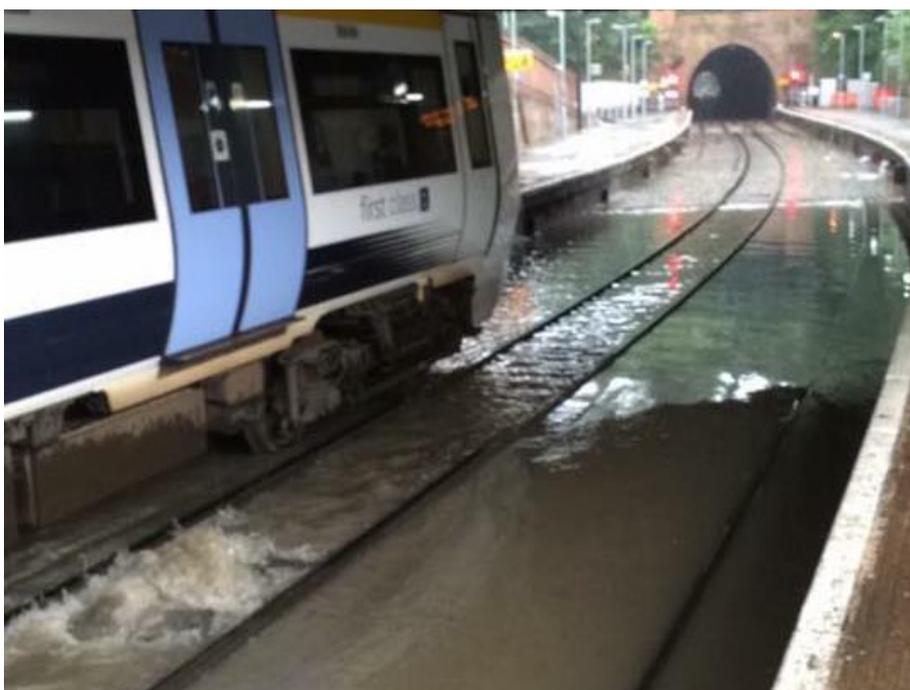
Tunbridge Wells Railway Station, located adjacent to Mount Pleasant Road, suffered flooding to the track bed of a depth of approximately 0.15m due to an overflowing manhole as shown in Photo 8. This caused a temporary closure of the Tonbridge to Hastings line.

Photo 6 Flooding of Tunbridge Wells Station (Source: Network Rail)

4. Network Rail should liaise with Southern Water regarding problems caused by the surcharging of a manhole in the track, which may include sealing of the manhole. Network Rail should ensure future incidences of flooding from the sewer are reported to Southern Water.
