March 2019

Kent County Council

Flood Investigation Report

Flooding affecting the Tunbridge Wells Area on
19 July 2017

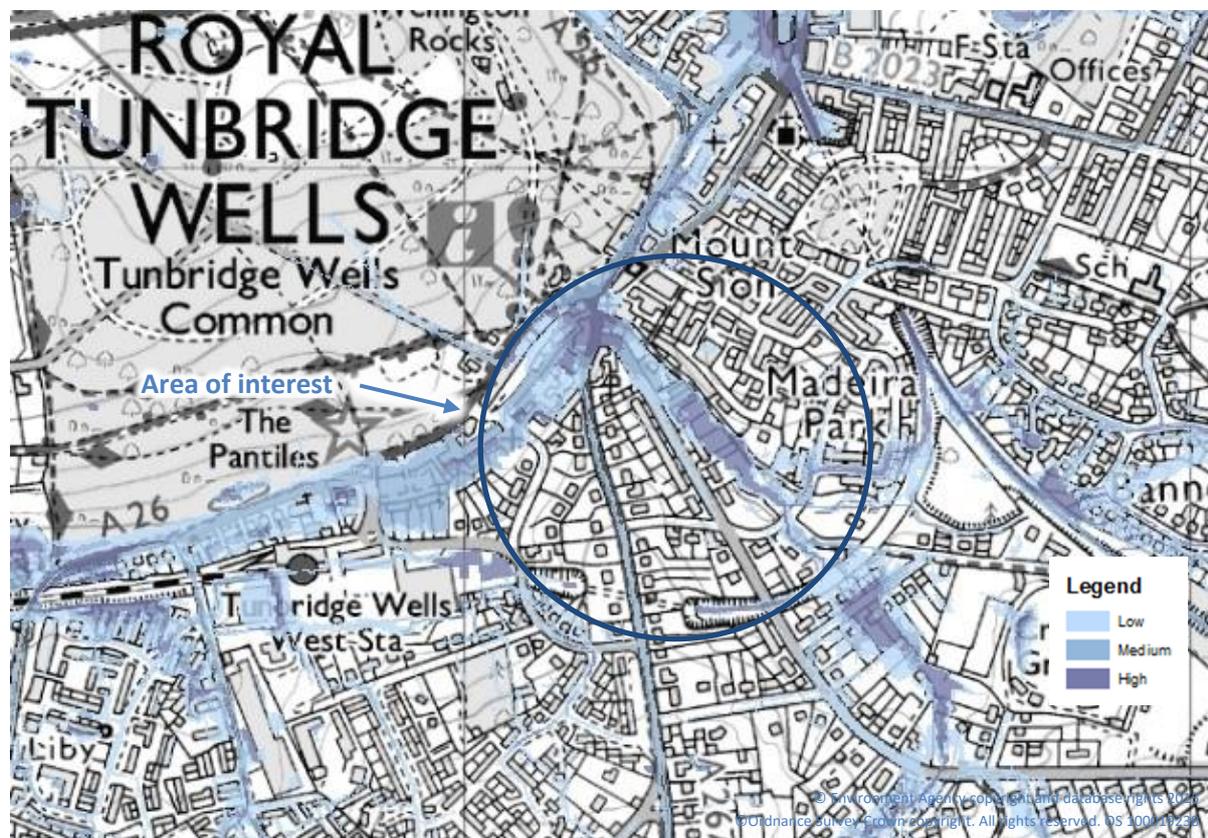
Figure 8 Surface water flood risk local to The Pantiles Area

The affected area includes locations indicated to be at high risk of surface water flooding. High risk is defined as a chance of flooding during a 1 in 30-year event. This map does not take into account the presence of watercourses, sewers or other drainage features that convey water efficiently and is only indicative of areas at risk of surface water flooding.

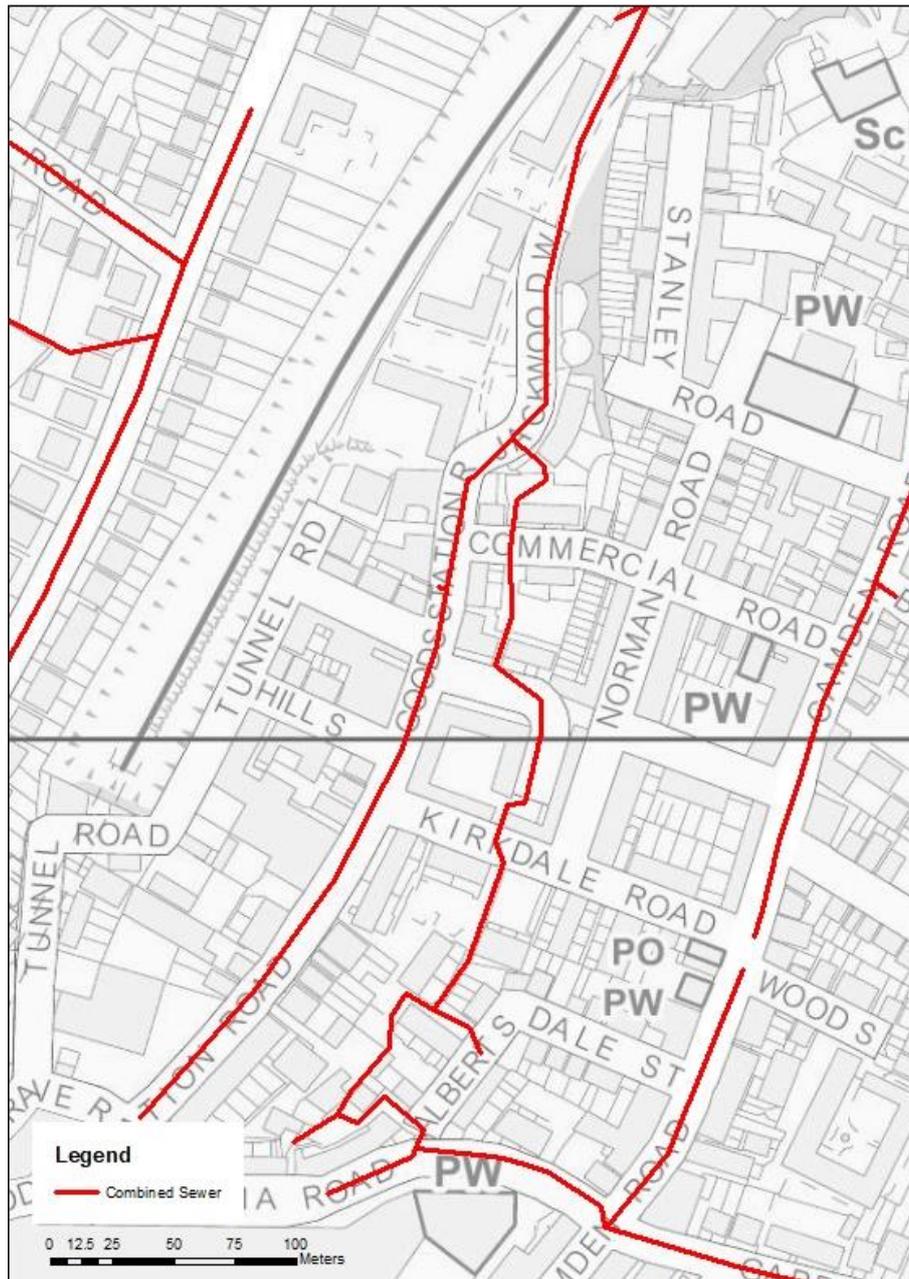
Figure 9 Sewer network upstream of Jackwood Way

The primary cause of the flooding around Royal Victoria Place was intensive rainfall which exceeded the capacity of the drainage and sewer systems in this area. The intensity of the rainfall meant that the sewer system is likely to have reached capacity leading to it being exceeded and overflowing.

The sewer system to the south of Jackwood Way is reported to have been under sufficient hydraulic overload to cause the manhole to surcharge. Water from the sewer flowed from manholes in Kirkdale Road and Commercial Road to Jackwood Way. The houses at Jackwood Way sit lower than the land to the south, the flood water entered the rear gardens where it ponded and reached sufficient depth to enter the properties from the rear.

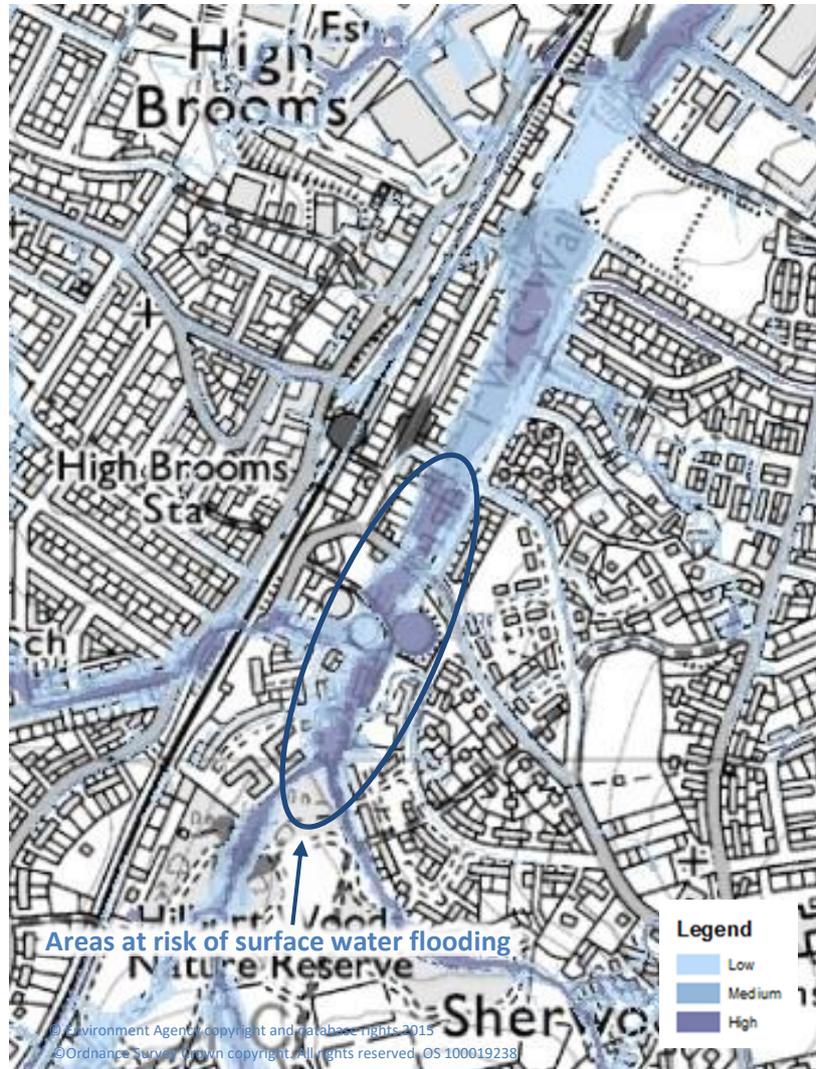
Figure 11 Surface Water Flood Map for High Brooms

This drawing includes what appear to be flood levels for 1 in 2 year, at 72.06 m, 1 in 30 year, at 72.3 m, and 1 in 100 year, at 72.4 m. These levels appear to be below the finished floor level of the Dougall Close properties, though only by a small margin.

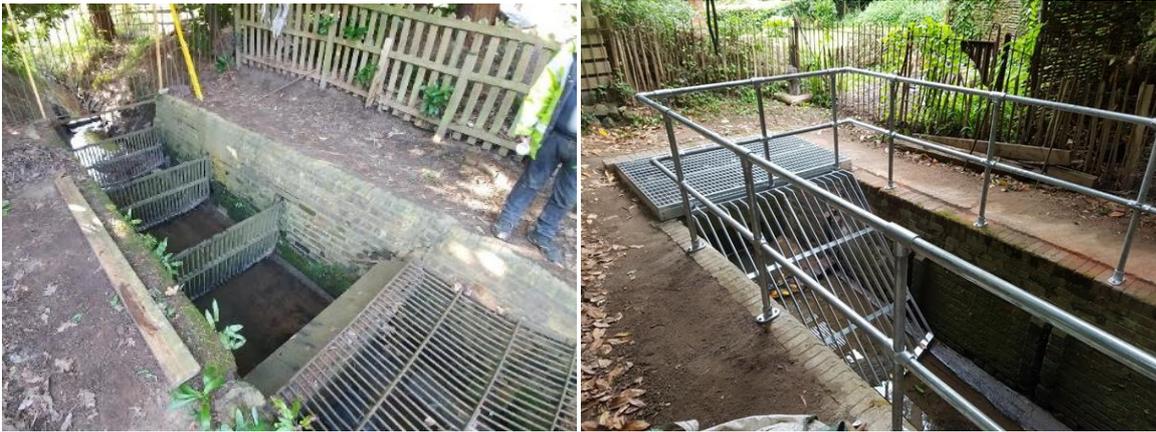
Image 1 and 2 River Grom trash screen before (above) and after (below)

KCC have replaced the trash screen on the entrance to the River Grom as shown in Image 1 and 2, the previous vertical screens have been replaced with a single raked trash screen. The new screen allows more effective and safer maintenance of the screen as it can be cleared of debris during higher flows and allows water to pass through easily.

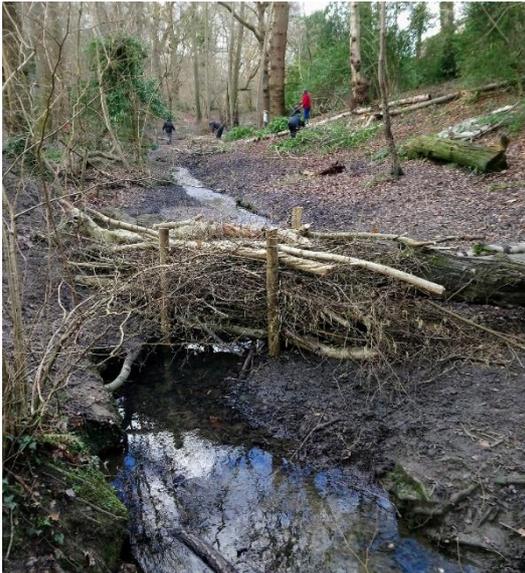
Image 3 Example of a beaver dam on the Southborough Stream

The construction of leaky dams along the watercourse, replicates naturally fallen timber which helps to dam peak flows and reduce the speed at which water reaches pinch points and areas of high flood risk. The dams are fixed securely to the bed and banks of the channel to remove the risk of debris detaching and causing additional flood risk. An example is shown in Image 3.
