# Flood Investigation Report

Location of Investigation: Five Oak Green

Date of incident: 9 February 2020

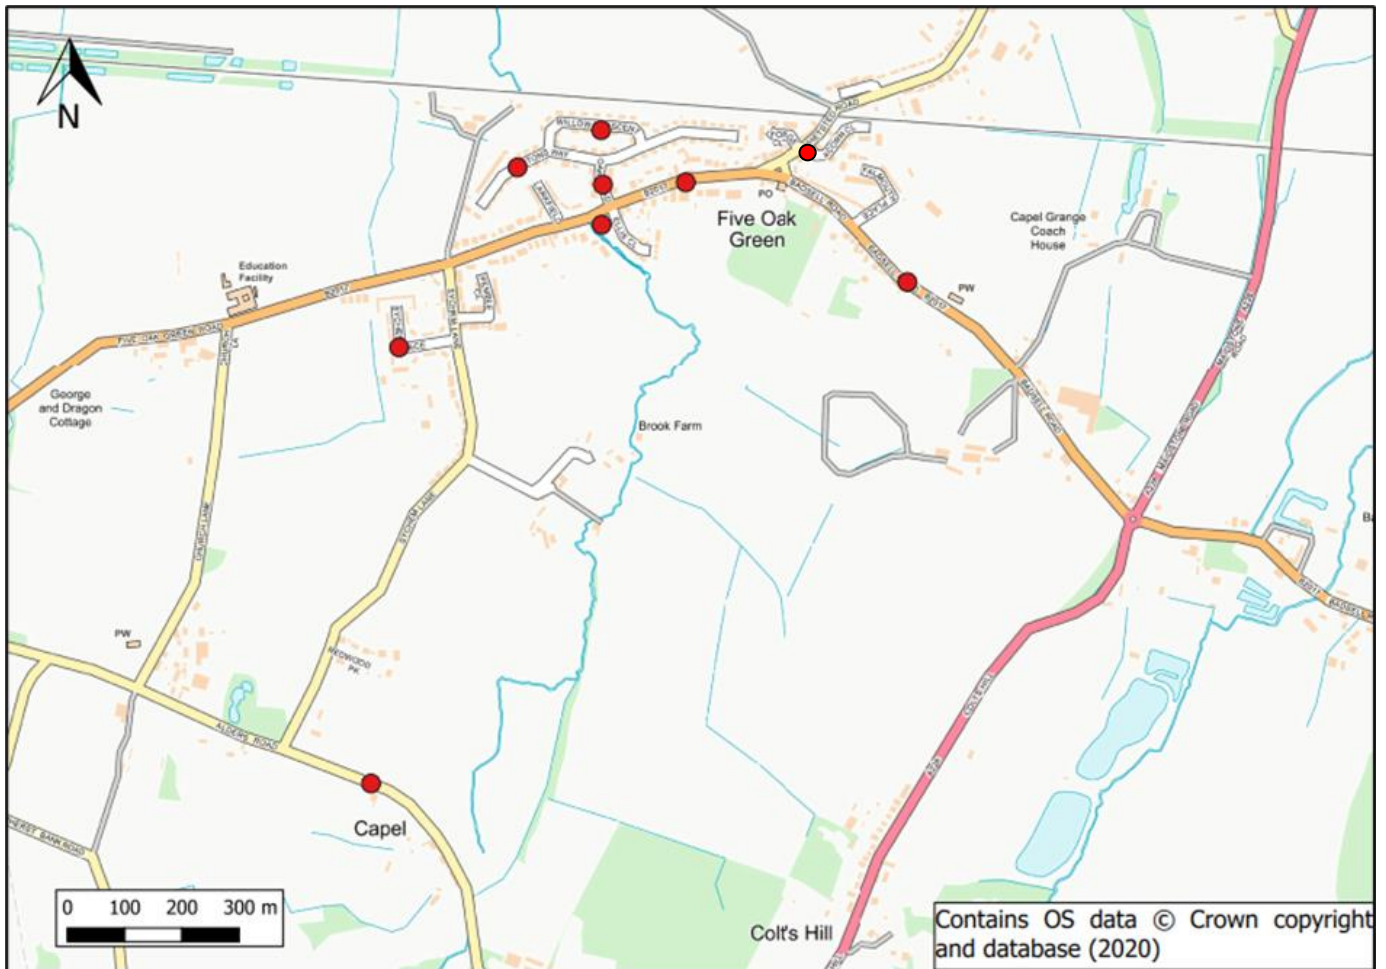
Approximately 40 properties are reported to have been flooded by a combination of overland flow, sewage and surface water with many of these properties experiencing internal flooding. The approximate locations of the reported flood incidents are shown in Figure 1 below (please note: only the roads where the properties are located have been mapped, and not the individual properties).

Figure 1 Location of reported flood incidents

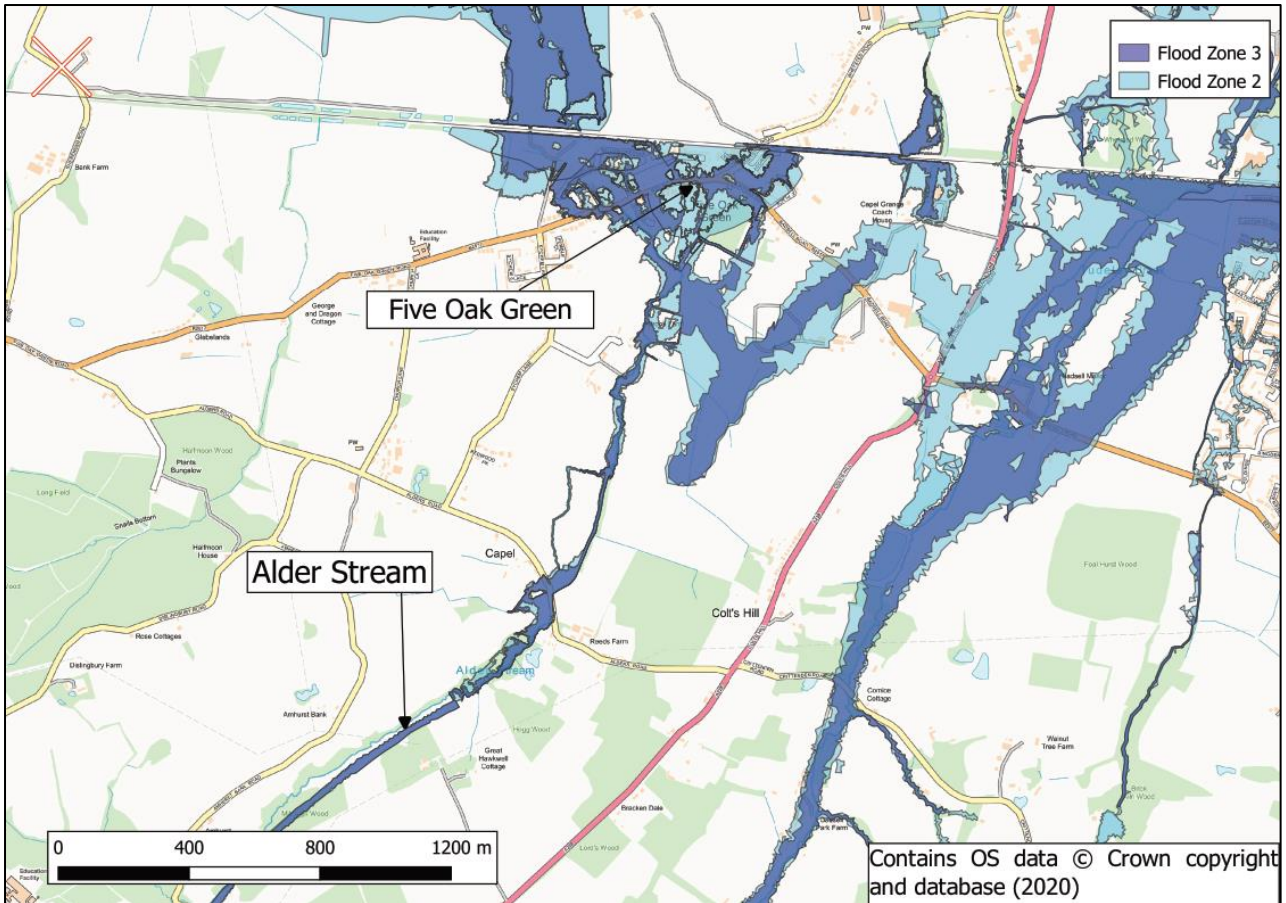
Figure 8 shows an extract from the Environment Agency's Flood Map for Planning (Rivers and Sea). The map indicates that Five Oak Green and the area along Alders Road adjacent to Alder Stream are located within the high-risk Flood Zone 3<sup>4</sup>. The fluvial flood risk is associated with the Alder Stream. Flows within the Alder Stream are well contained within the watercourse upstream of Capel.

Figure 8 Extract from the Environment Agency's Flood Map for Planning

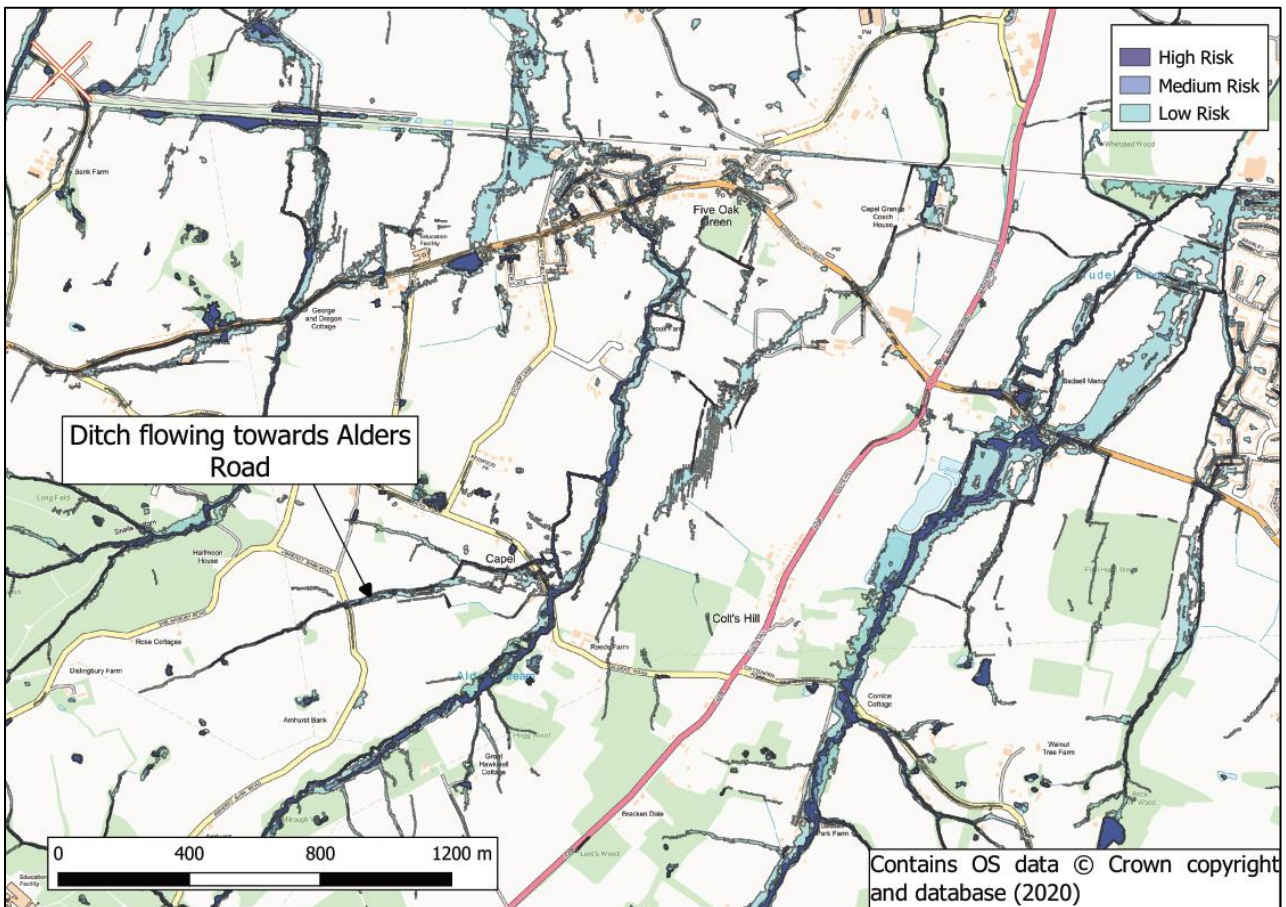
Figure 9 shows an extract from the Environment Agency's Flood Risk from Surface Water map. Flooding from surface water is typically associated with natural overland flow paths (including the Alder Stream) and local depressions in topography where surface water runoff can accumulate during or following heavy rainfall events. The Environment Agency's map indicates that the areas at a high risk of flooding from surface water<sup>5</sup> sources include areas that experienced flooding during Storm Ciara. There is also a surface water flow path which is associated with a ditch to the south-west of Alders Road which discharges into the Alder Stream. The areas identified as high risk on the Environment Agency's Long Term Flood Risk map are consistent with the locations of reported properties affected by the Storm Ciara flood event.

Figure 9 Extract from the Environment Agency's Flood Risk from Surface Water map

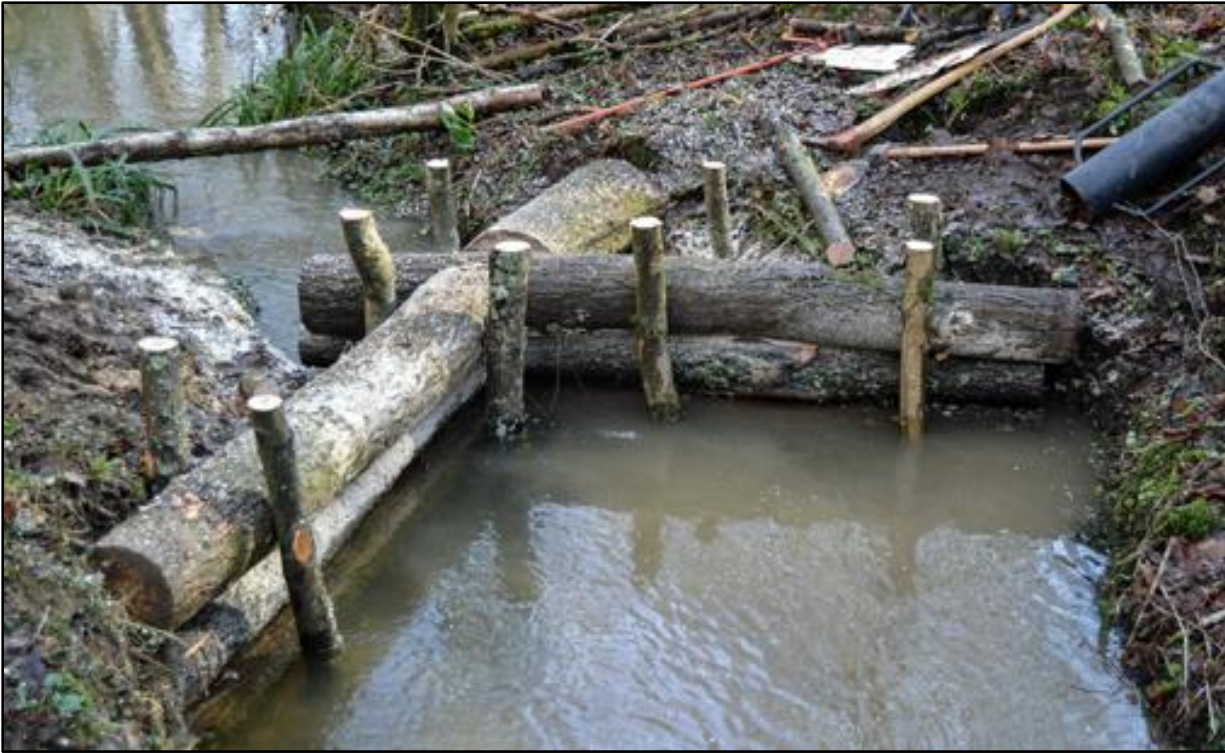
The aim of the scheme is to reduce and delay the peak river flows within the Alder Stream to reduce the likelihood of flows overtopping the banks and affecting properties. The leaky woody structures were found to be operating well during the flood event as reported by the South East Rivers Trust, although it is too early to understand if the NFM measures had an impact on the amount of flooding experienced at Five Oak Green<sup>6</sup> and they are currently only installed in a small area of the catchment, so are unlikely to provide a significant benefit at Five Oak Green. Figure 11 shows a photograph of one of the leaky woody structures located along the Alder Stream.

Figure 11 Leaky woody structures along the Alder Stream<sup>7</sup>

There are further opportunities that could be explored to see if additional NFM measures would be feasible along other stretches of watercourse within the Alder Stream catchment. Consultation and partnership working with the Environment Agency, the South East River Trust and local landowners will be undertaken to understand the potential opportunities and funding available to install more leaky woody structures or other NFM measures.

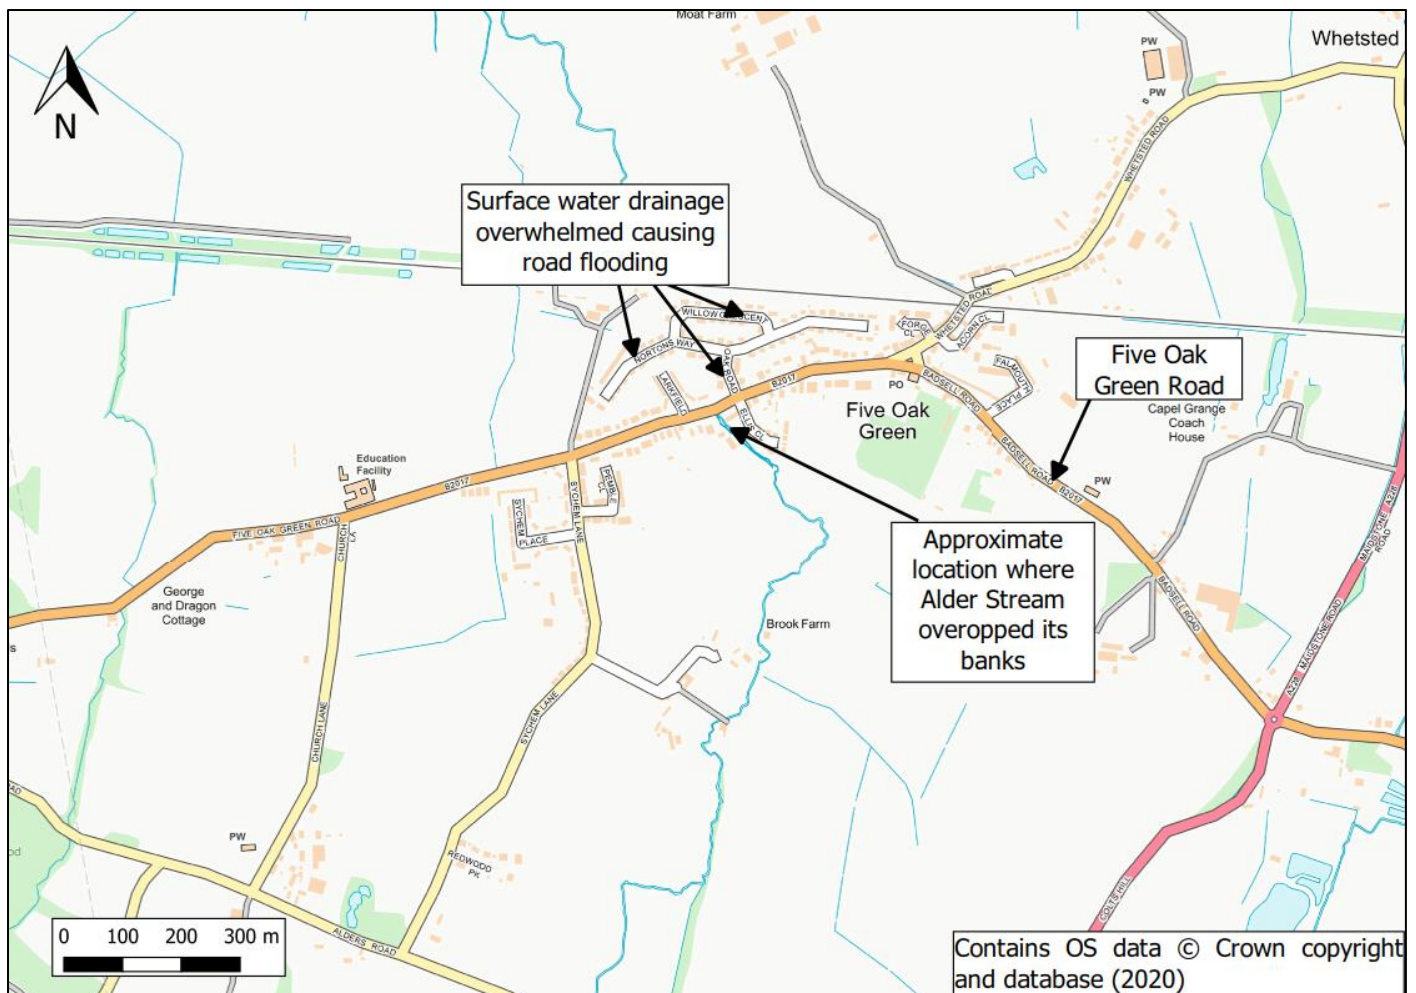
Alder Stream, which flows through the centre of Five Oak Green, is known to have overtopped the banks of the watercourse during the flood event at approximately 20:00, based on evidence provided by the Environment Agency. Alder Stream overtopped the banks upstream of the culvert underneath Five Oak Green Road. Figure 12 shows the approximate location of where the Alder Stream overtopped the banks. Correspondence with the Environment Agency indicates that the trash screen at the inlet of the culvert was free from debris and that peak flows within Alder Stream gradually subsided.

Figure 12 Flooding mechanism for properties located along Alders Road

As a result of the watercourse overtopping its banks the local surface water drainage system would not have been able to discharge into the river causing surcharging of drains and surface water flooding to the local roads.

The culvert beneath Five Oak Green may have contributed to the flooding experienced, however further assessment of the capacity of the culvert is required to understand if the culvert is likely to have surcharged during the flooding event. Consultation with the Environment Agency indicated that the culvert has greater capacity in comparison to the channel upstream of the structure. A previous study of the catchment included a hydraulic model completed in 2015. It is likely to be used to further understand the capacity of the culvert. Further consultation with the Environment Agency regarding the performance of the culvert and debris screen will be undertaken by the LLFA.

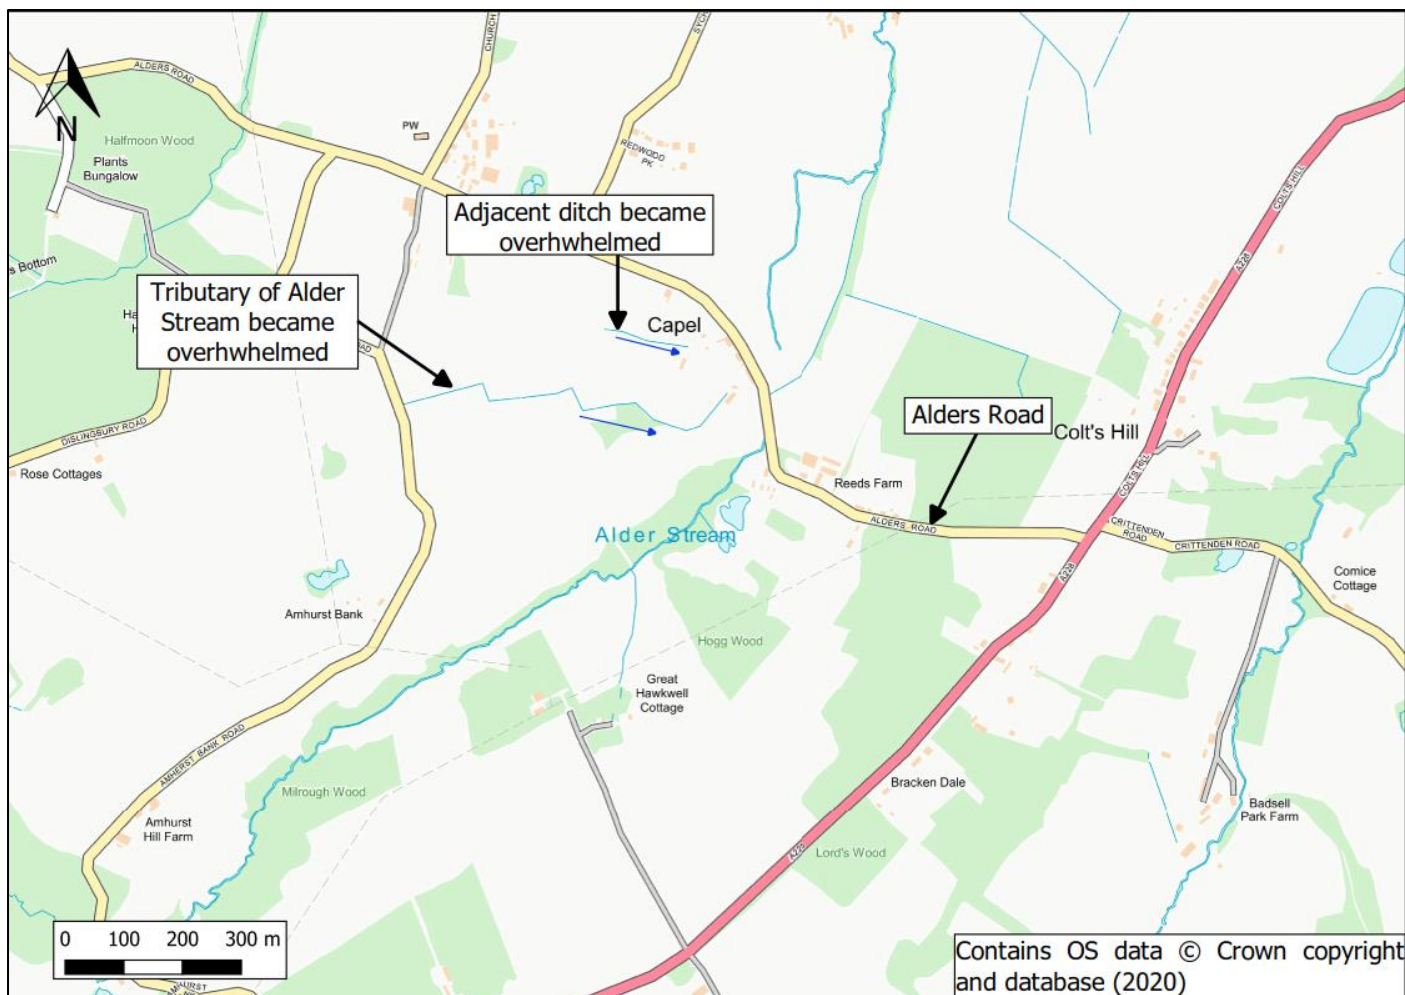
The properties located along Alders Road flooded from fluvial sources. Anecdotal evidence suggests that a tributary of the Alder Stream and adjacent ditch located to the south-west of Alders Road were the main causes of flooding to the affected properties located along Alders Road and not the Alder Stream itself. The location and direction of flow in the tributary of Alder Stream and the adjacent ditch is shown in Figure 13, below. This is further supported by site visits undertaken by the Environment Agency after the flood event. Correspondence from residents indicates that floodwaters entered the back of the properties with flood depths of approximately 20 to 30 cm internally.

Figure 13 Flooding mechanism for properties located along Alders Road
