Kent County Council

# Flood Investigation Report

Flooding affecting the Swale Area on 29 May 2018

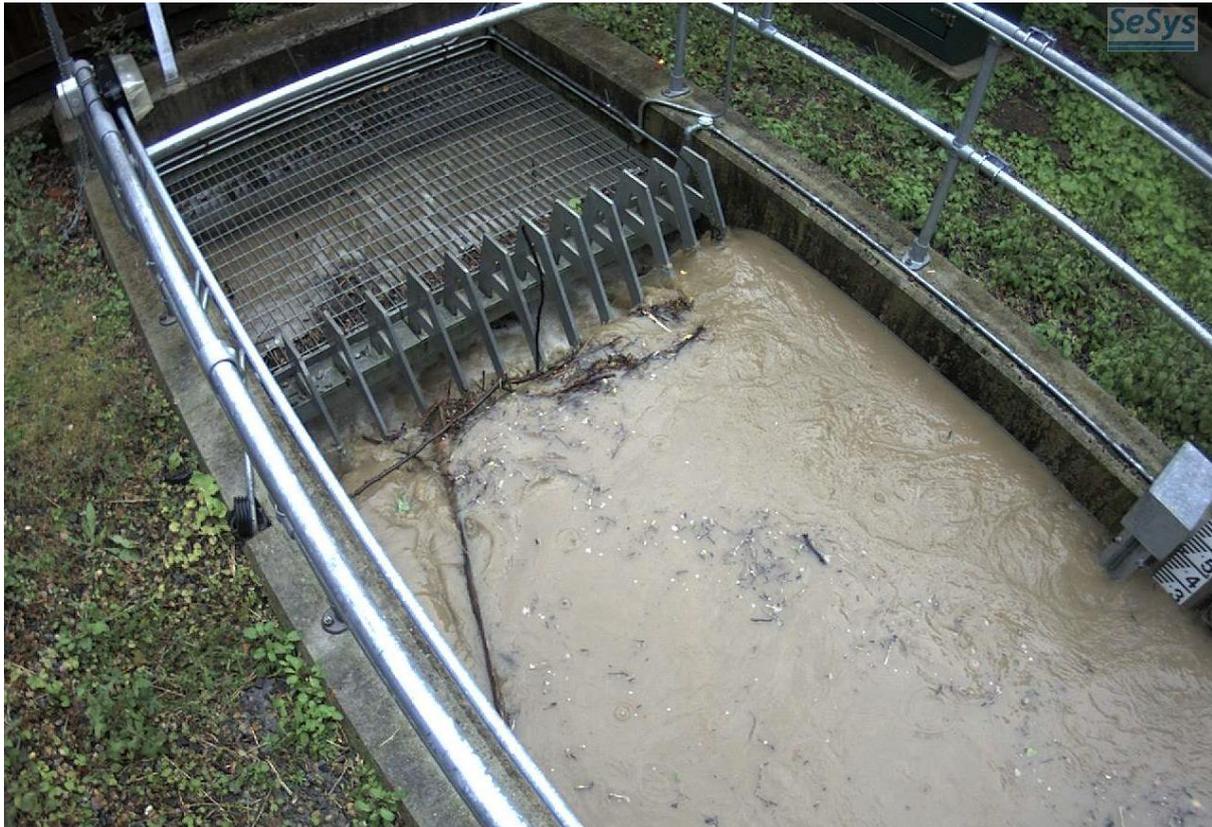
Following the call from Iwade Parish Council and another local resident the Environment Agency deployed teams to Iwade. They found travel on the roads was made difficult by flooding along the A2, with the public being diverted onto country lanes. However, all seven available Environment Agency operatives were able to reach Iwade to assist with the incident. Upon arrival water had already started to overwhelm the road culvert at Sheerstone and Springvale but an attempt was still made to clear the screens. It was found that there was little debris on the screens so the decision was made to deploy a 6" pump to overpump from one side of the Sheerstone culvert to the other. A image of the Sheerstone screen is shown in Image 1, taken at 13:45 BST.

Image 1 Sheerstone screen at 13:45 BST

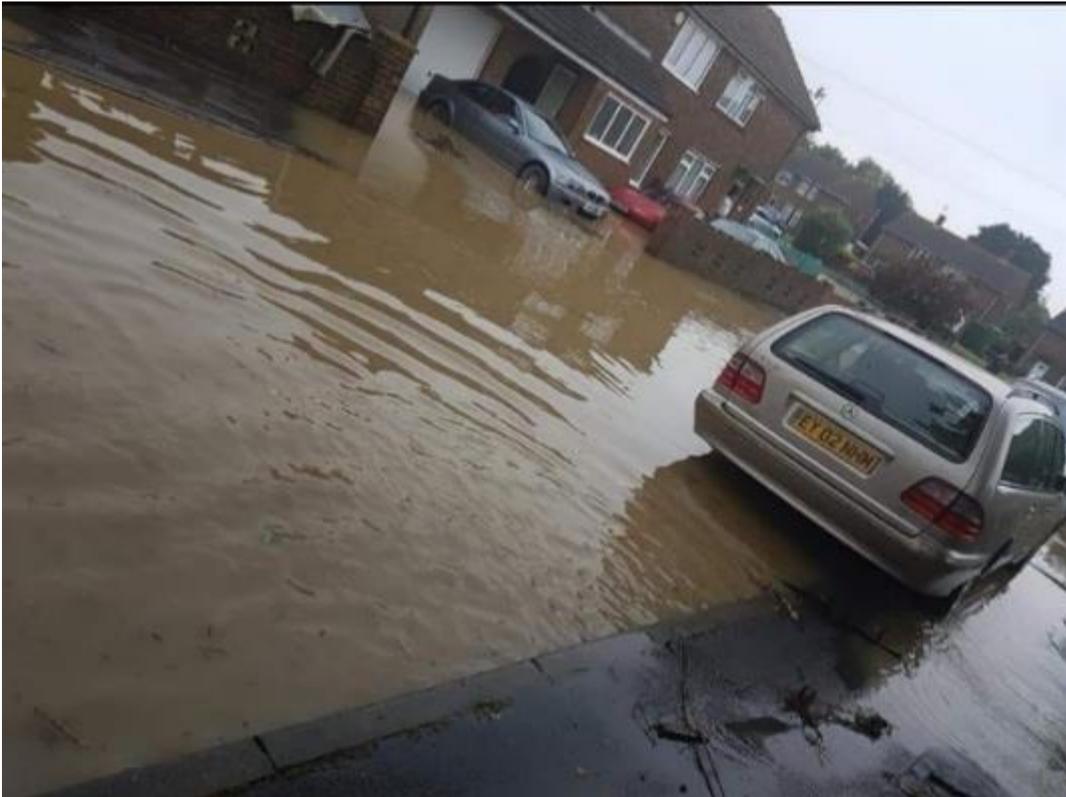
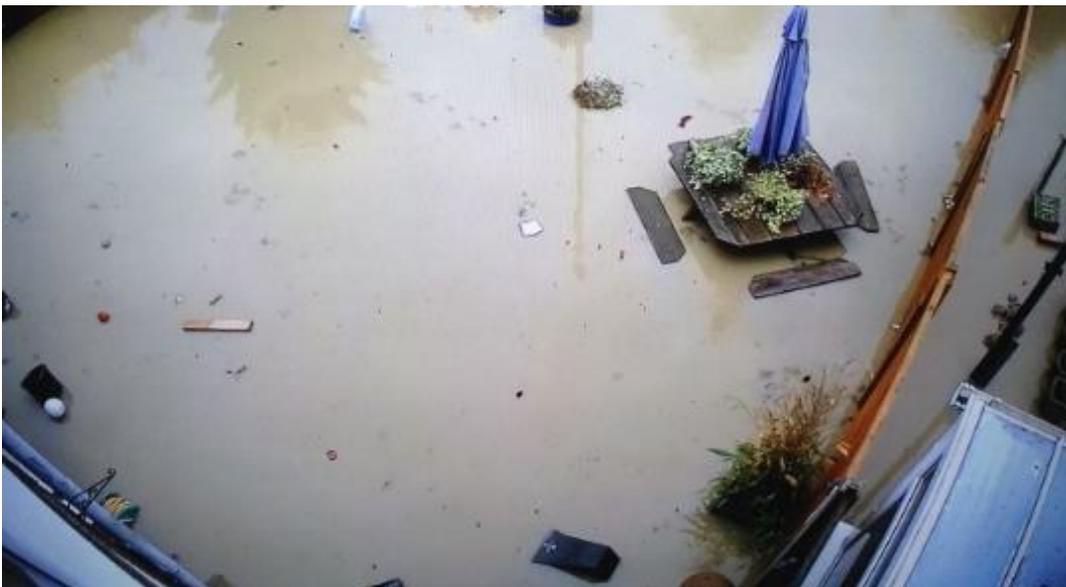
Images 2 and 3 show the flooding to the front and rear of property on Sheerstone Road.

**Images 2 and 3 Flooding to the front and rear of Sheerstone Road**

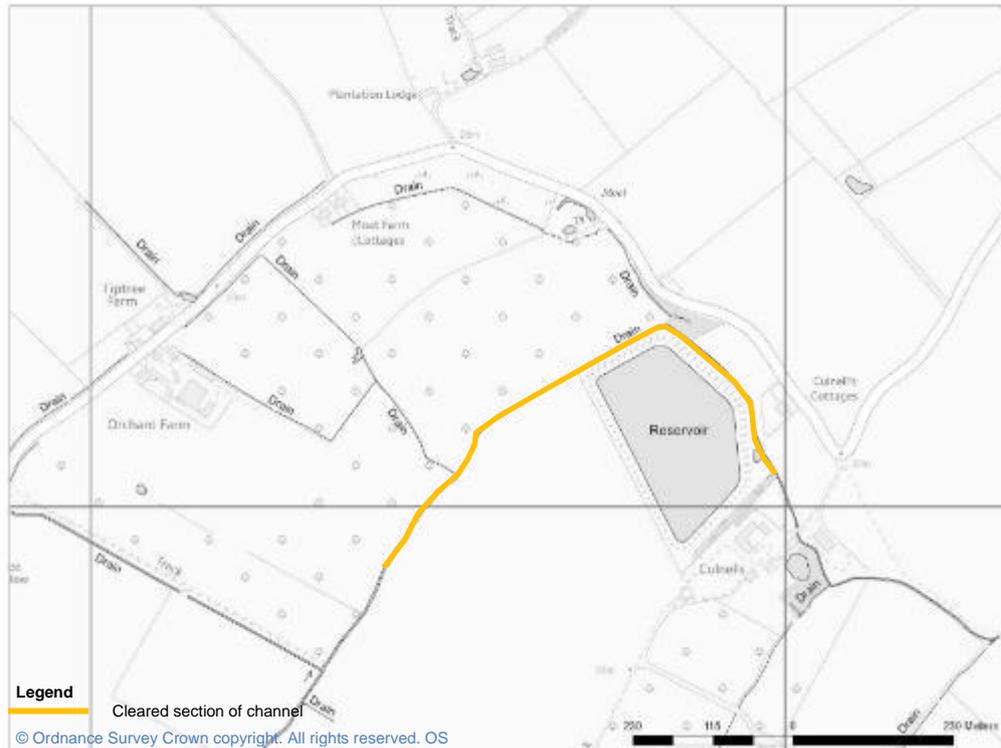
**Figure 8 Location of clearance work along Iwade Stream**

Downstream of the reservoir, approximately 735 metres from the quarry site is Culnells Farm, this complex consists of a number of small businesses, which reported that they experienced overland flooding from run-off from the fields and highway, however at this location there was no fluvial flooding, the flow in the Iwade Stream remained in bank at this location.

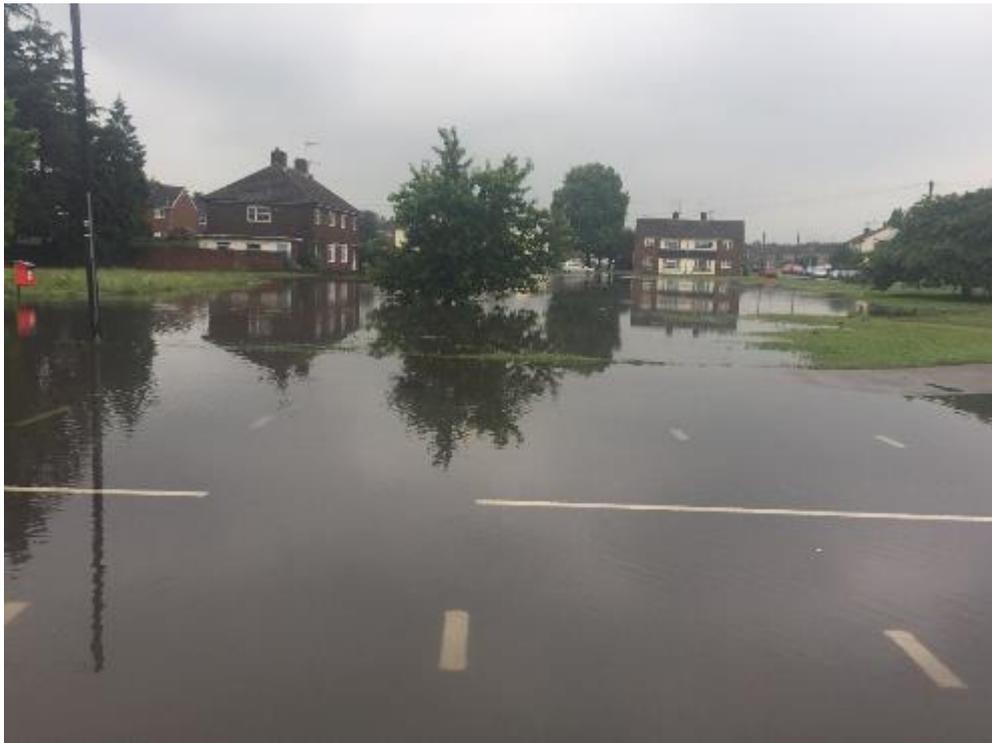
Image 3 shows the flooding on Canterbury Road.

**Image 3. Flooding at Snipeshill**

The main cause of the flooding was the intensive rainfall which exceeded the capacity of drainage systems in the area. The urban areas within Sittingbourne are drained by soakaways which quickly became filled by the intense rainfall that was experienced. Once the capacity of the drainage was exceeded, runoff collected in topographical low points.

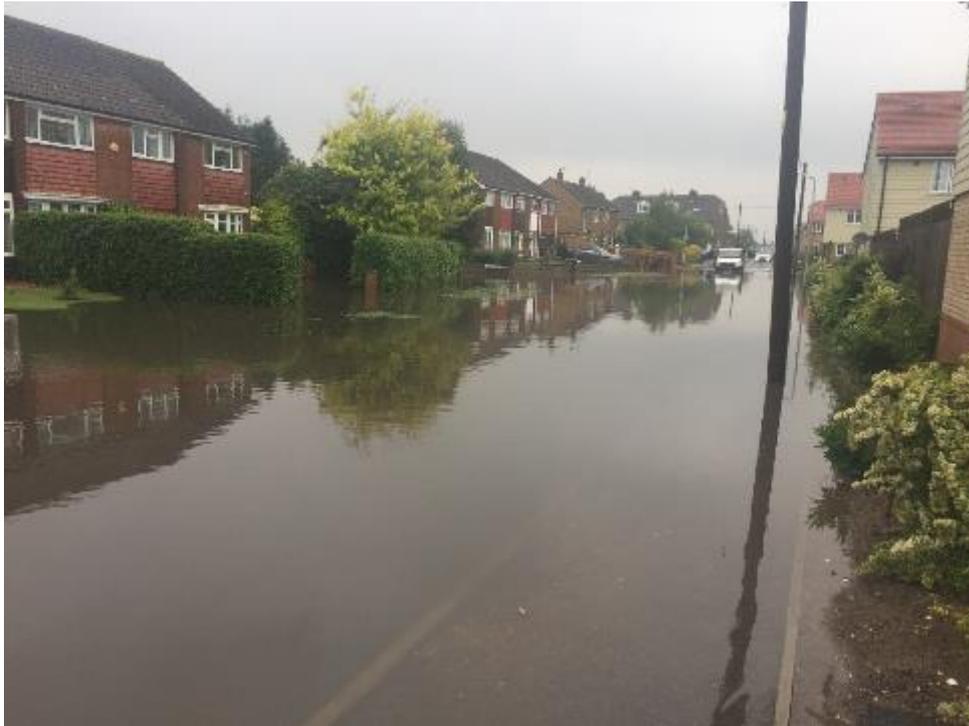
Bow waves contributed to the issue of internal property flooding as vehicles drove through the flood water on the highway. On the Lower Road in Teynham at least one vehicle became stranded as a result of attempting to drive through the flood water.

**Image 3. Flooding on the Lower Road, Teynham**

The highway drains in this area on the Lower Road drain via into a culvert that runs to the north under the railway line. This culvert is known to be partially blocked. This blockage may have contributed to the flooding in this location.

Network Rail are aware that the culvert under the railway line near the Lower Road is in need of repair.

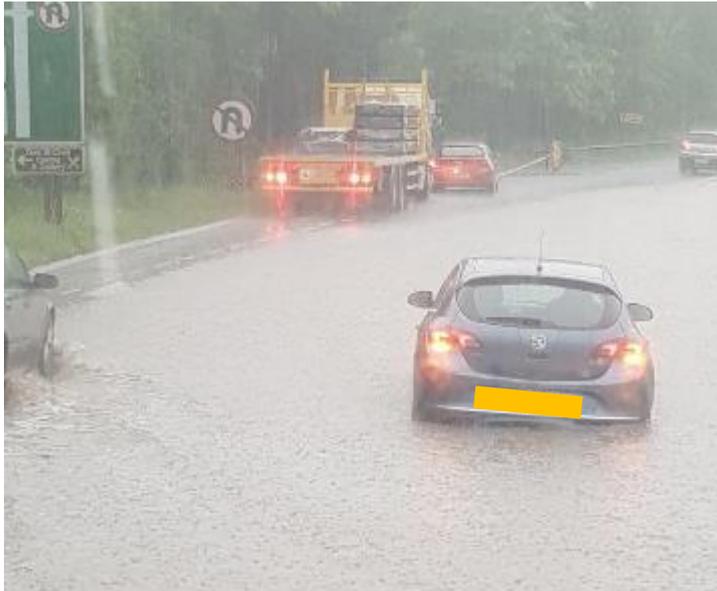
Flood water began flowing onto the highway at around 11:30 on 29 May 2018, most of this water is likely to have been the result of run-off from the adjacent land. By 12:00 surface water flooding near the Stockbury roundabout had begun to occur and by 15:30 the road was closed due to severe flooding, the road remained closed until the following day.

**Image 4. Flooding on the A28 (Source KentOnline)**
