# Culvert Replacement

Catts Place, Tonbridge

**Kent County Council's Flood and Water Management Team has successfully supported a local community to replace a damaged culvert that was causing significant repeated flooding to properties.**

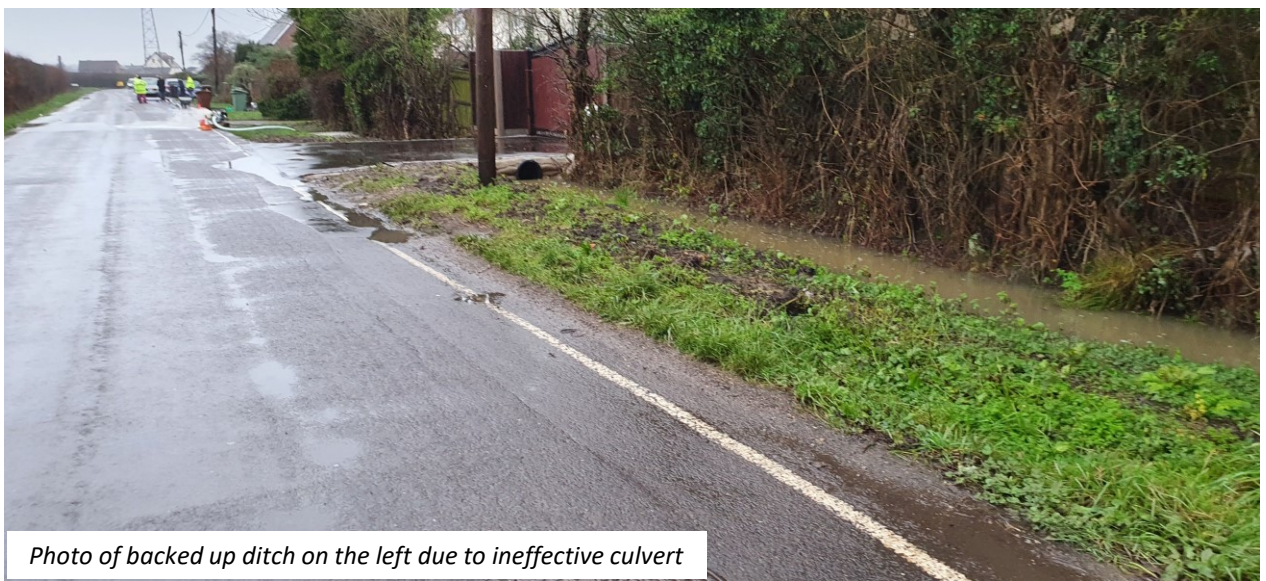
Investigations found the culvert was blocked with substantial tree roots and silt and had multiple defects. The best solution was to replace the culvert. However, the culvert was in multiple ownership, and it was difficult for the residents to organise fixing this problem.

**Between 2014 and 2021, Catts Place residents and highway in Paddock Wood, experienced 20 incidents of flooding.** The poor condition of the culvert caused the floods. It's length, at over 100 m, and lack of access points made it difficult to maintain using the standard equipment for pipe clearance. It was also in poor condition, with displaced joints that meant blockages were likely to reoccur even if they were removed.

*Photo of backed up ditch on the left due to ineffective culvert*

**Working closely with residents, the Flood and Water Management Team assessed options to replace the culvert, reduce flood risk and improve the maintainability of the system. The preferred** scheme replaced the long culvert with a culvert in three sections, with access at approximately every 30 m, which will allow access for maintenance and allow overpumping if further blockages do occur.

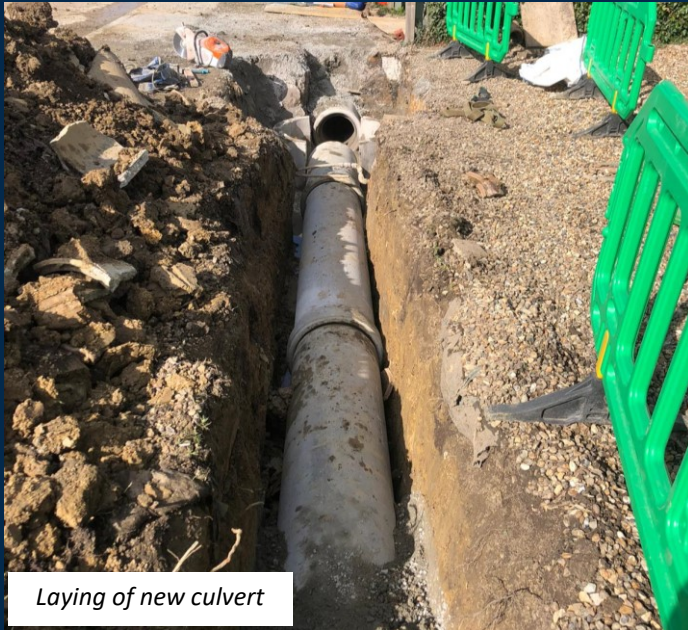
The culvert is located under driveways, garden walls, and vegetation at the front of the resident's gardens and between the services and utilities serving the properties. The new culvert was installed with the minimum of disruption.

*Laying of new culvert*

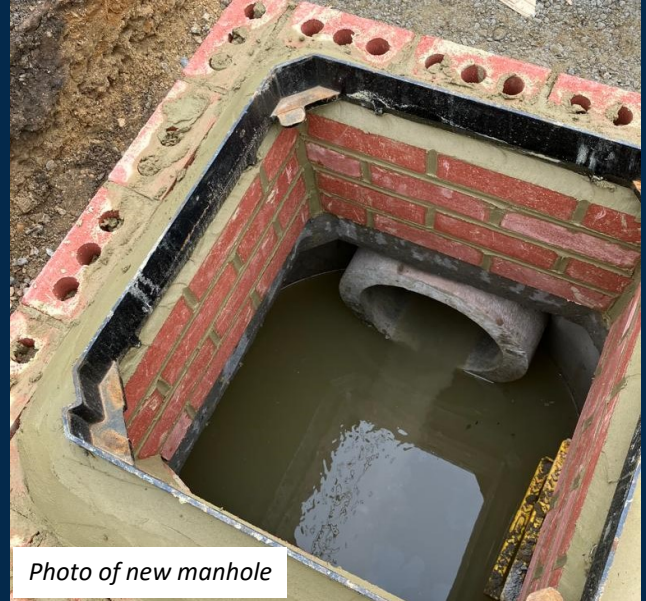
*Photo of new manhole*

**Three manhole chambers** were installed to add capacity and aid future maintenance and repair work by landowners. It also allows standard jetting equipment to be used as the length of culverted sections is reduced.
