Flood Investigation Report

Location of Investigation: Vigo Village and Culverstone

Date of incident: 10 June 2019

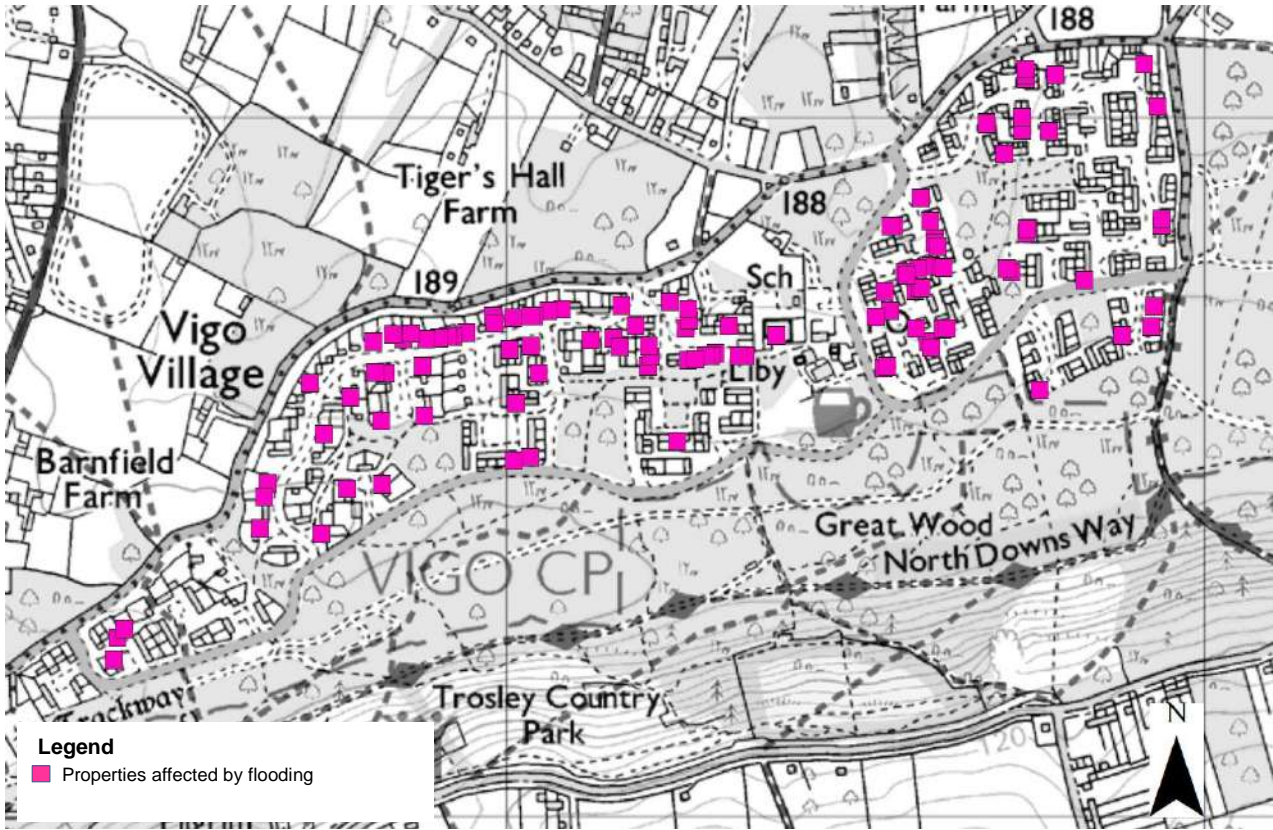
Figure 1 Location of properties in Vigo Village affected by flooding

Location of flooding in Vigo	Details of flooding	Source of Report
Admers Wood	4 properties confirmed to have flooded internally and 4 properties experienced external flooding. Overland flows from the surrounding greenspaces affected a number of properties and contributed to flooding on the highway.	KFRS, VVPC
The Coppice	2 properties reported internal flooded from foul sewer 2 properties reported external flooding near lowest point in the road.	KFRS, VVPC
Fern Down	9 properties confirmed internal flooding. Overland flow was reported to have come from Admers Woodland and Admers Wood Road. Properties reported flooding from the foul sewer.	KFRS, VVPC
Ash Keys	3 properties reported flooding external and two of those also reported internal flooding.	KFRS, VVPC
Beech Mast	6 properties reported external flooded at lowest points in the road.	KFRS, VVPC
Timber Bank	36 properties flooded, 19 affected which reported foul water flooding from the rear of the property. 17 experienced external flooding near the lowest point in the road.	KFRS, VVPC, KCC

Chestnut Lane	External flooding experienced at 3 properties	KFRS, VVPC
Churchside	1 property reported internal and external flooding from overland flow to the rear of the property	VVPC
Croftside	2 properties reported flooding – 1 report of internal flooding, water entered property from the land to the rear.	VVPC
Downswood	External flooding affected three properties, with 1 property also reporting internal flooding. Flood water was reported as coming from land to the rear of the property and foul water from the drain.	VVPC
Highview	17 properties experienced external flooding – 7 properties reported internal flooding.	VVPC
Hornbeams	External flooding affected one property	VVPC
Stonecroft	3 properties reported flooding. 1 reported external flooding, 1 property reported internal and external flooding and 1 property reported internal flooding.	VVPC
The Coachdrive	External flooding affected 3 properties	VVPC

The Gallops	External flooding affected 2 properties	VVPC
Vigo School	External and internal flooding	VVPC

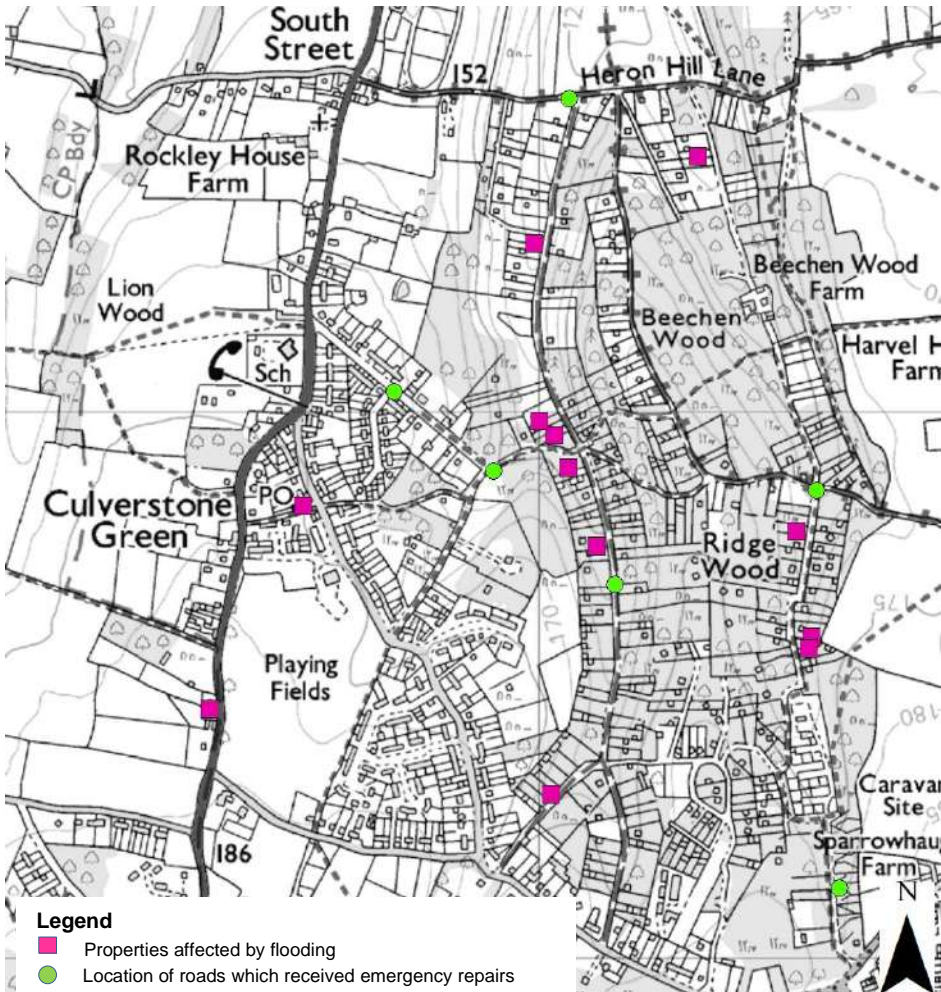
Figure 2 Location of properties and roads in Culverstone affected by flooding

Location of flooding in Culverstone	Details of flooding	Source of Report
Heron Hill Lane	1 property reported internal flooding to the cellar of the property	KFRS, MPC
Rhododendron Avenue	5 properties reported flooding 4 properties reported internal flooding and 1 property reported external flooding and flooding in the garage. External flooding affected the road surface	KFRS, MPC
Valley Lane	3 properties reported flooding, 1 property reported internal flooding to the basement and 2 reported external flooding with damage to a retaining wall and sewage tank External flooding affected the road surface	KCC Highways, MPC
Willow Walk	External flooding affected the road surface	KCC Highways, MPC
White Post Lane	1 property reported internal flooding which came through the concrete base of the property	KCC Highways, MPC
Meadow Lane	1 property reported flooding to the garage and external flooding	MPC
Wrotham Road	1 property reported internal flooding	MPC

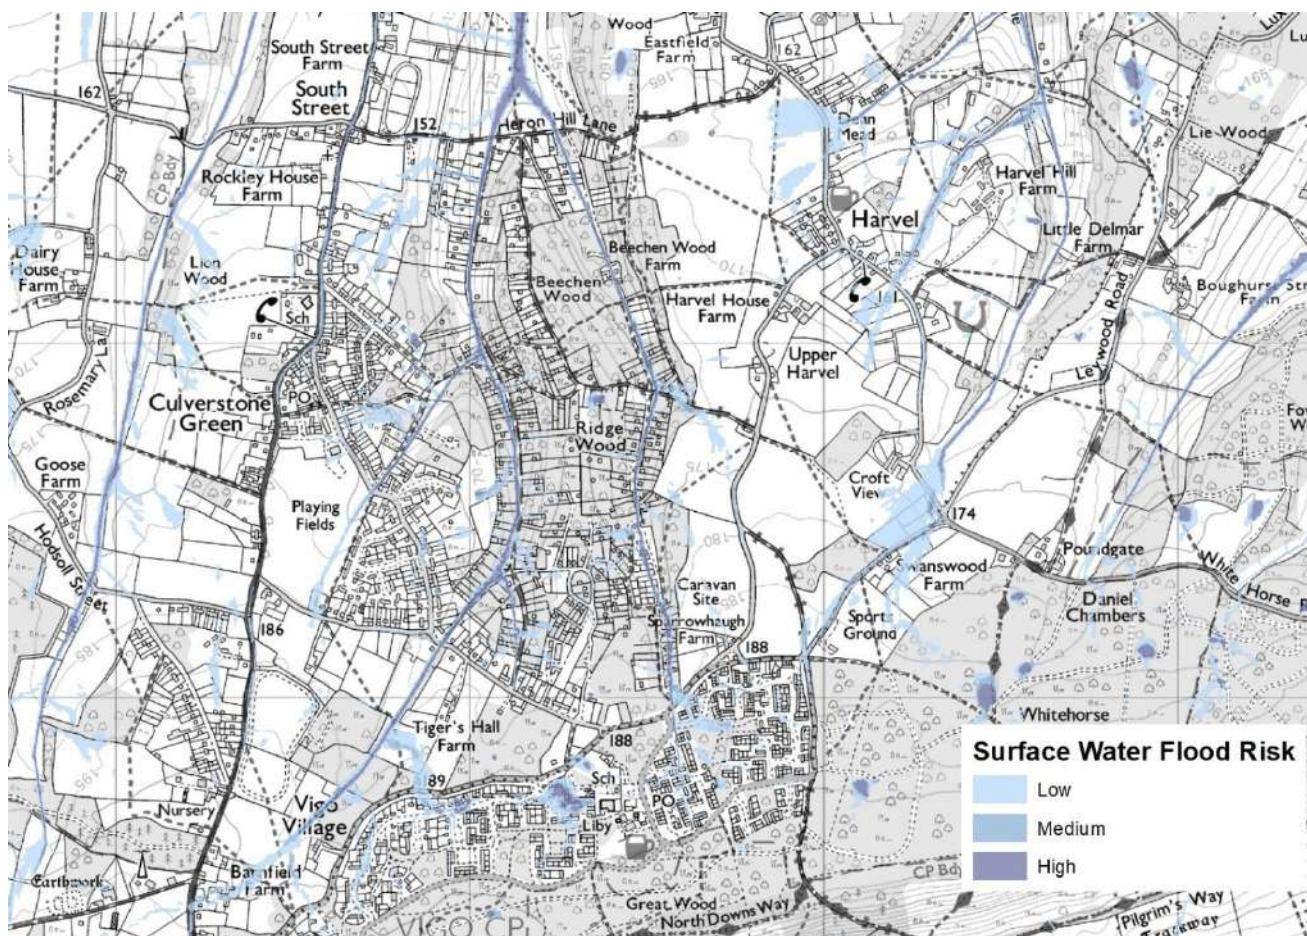
Figure 3 Environment Agency Surface Water Flood Risk Map

The national surface water flood map provided by the Environment Agency on the gov.uk long term flood risk information map indicates topographical low points and these valley features to be at a medium to high risk of surface water flooding. Medium and high risk means that these areas have a chance of flooding of between 1% and 3.3% or greater in any one year. An extract from the surface water flood map is shown in Figure 2. It should be noted that all information shown by this mapping, particularly the likelihood of surface water flooding, is a general indicator of an area's flood risk, it is not suitable for identifying whether an individual property will flood.
