Flood Investigation Report

Location of Investigation: Bethersden

Date of incident: 25 July 2021

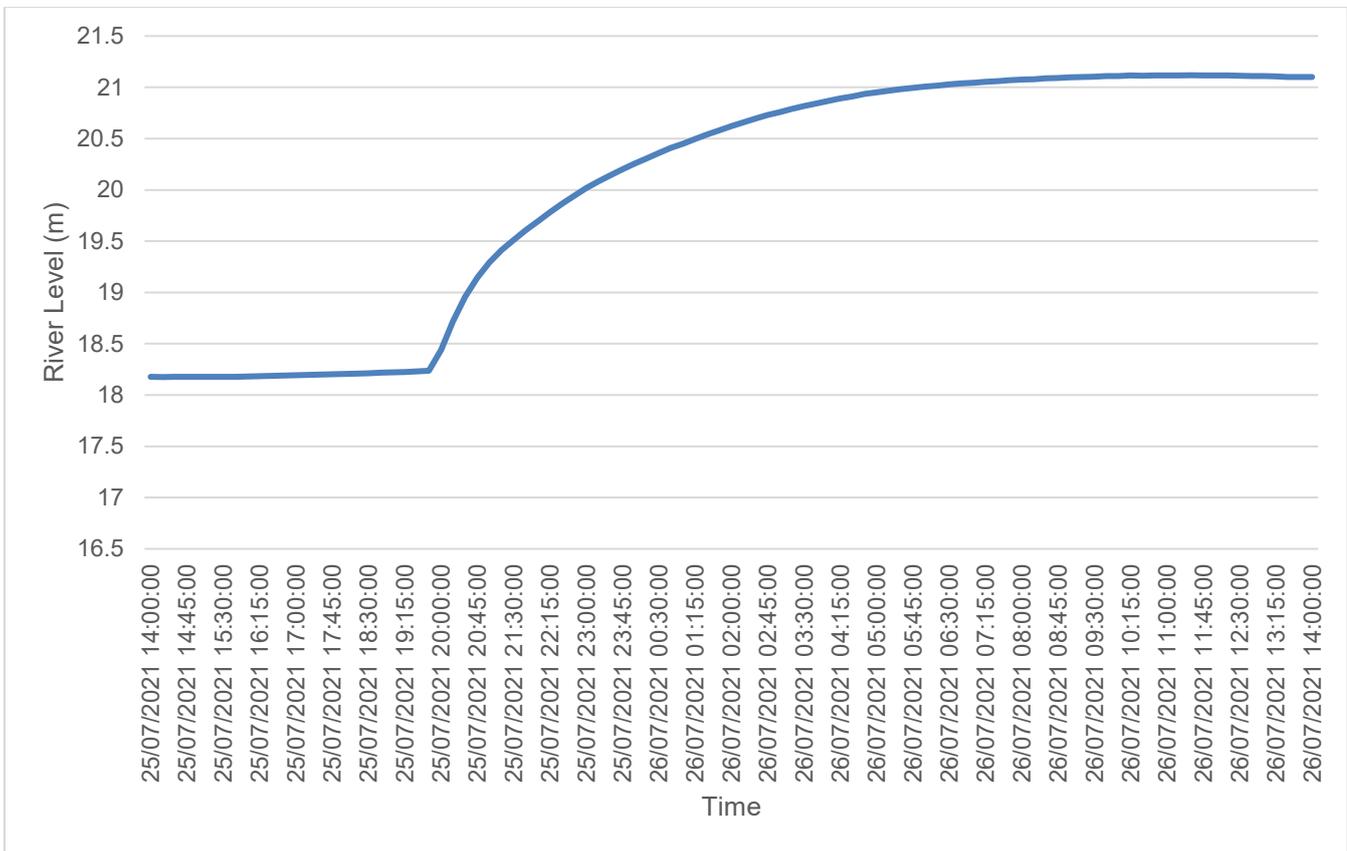
Figure 2 River level gauge data along the River Beult recorded during the flood event on 25th July 2021

There are no river gauges on the River Beult or its two tributaries located in close proximity to or within Bethersden. The nearest Environment Agency river gauge is located at Smarden on the River Beult approximately 5.3 km to the west of Bethersden. Although the River Beult is approximately twice the size of each of the two tributaries located within Bethersden, the Smarden gauge is located downstream of the site of interest. Annex 5 at the end of the report shows the location of the Smarden river level gauge in relation to the tributaries of the River Beult and Bethersden. Data obtained from the Environment Agency for the 25 July 2021 at the River Beult level gauge at Smarden is shown in Figure 2, clearly indicating a steep rise in river levels as a result of the heavy rainfall. The increase in river levels along the River Beult starts at approximately 20:00 on the 25 July at approximately 18.2 m, peaking at approximately 10:45 on the 26th July at 21.12 m.

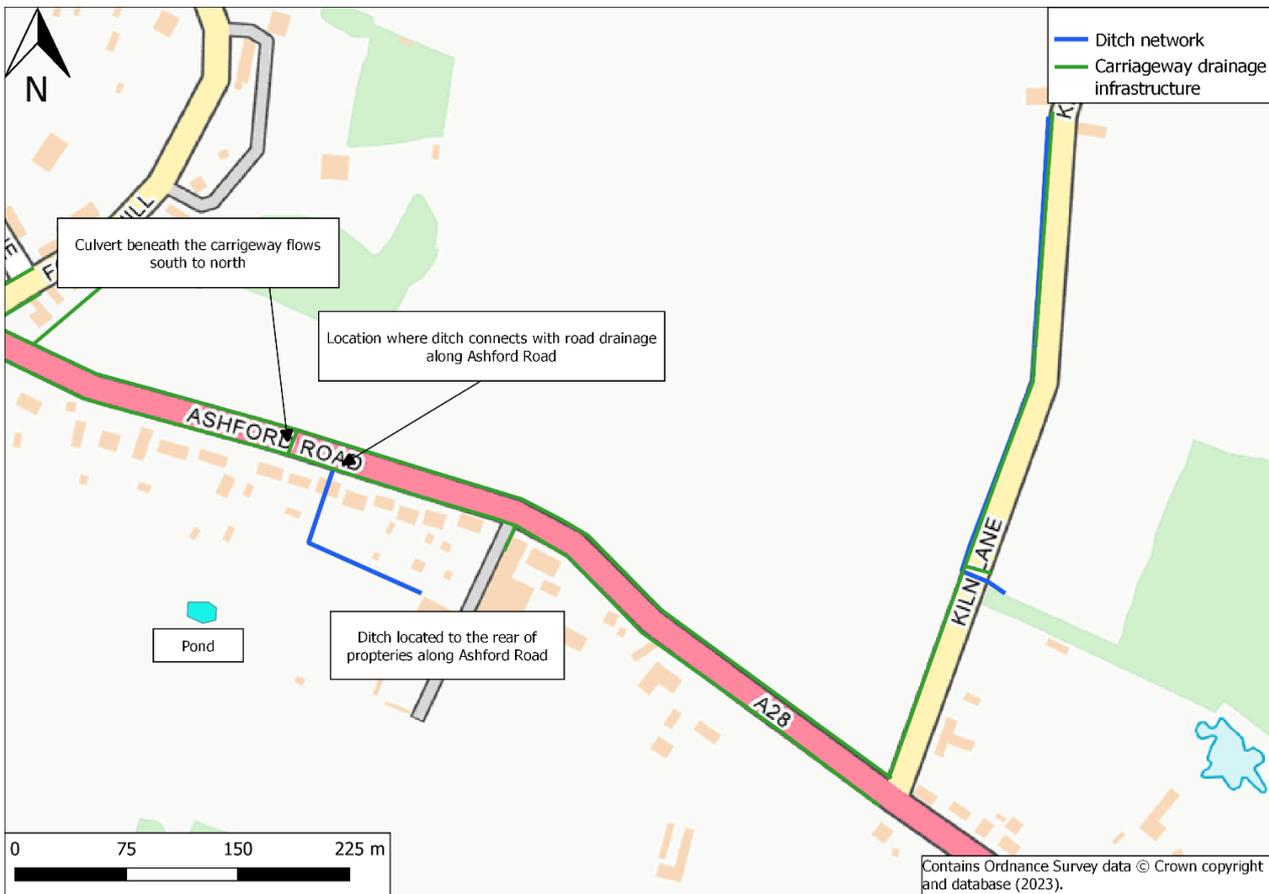
Figure 3 Flooding mechanism for properties located along Bailey Fields, Ashford Road

A land drainage ditch is located to the south of the properties at Bailey Fields on Ashford Road which flows in an east to west direction. The ditch is fed from a pond to the south which collects surface water runoff from the adjacent fields and has an overflow pipe which connects into the ditch. The ditch discharges to a drainage pipe which flows north and discharges into the road surface water drainage system. A CCTV survey undertaken in August 2020 as part of a planning application submission indicated that the pipes were damaged and silted resulting in a decrease in the capacity of the system.

During the flood event it was reported to Ashford Borough Council and the Environment Agency that there was evidence of debris located near to the drainage pipes to the south of Bailey Fields. Reports indicate that during the intense rainfall the ditch was unable to cope with the overland flows from the land to the south and overtopped leading to flooding of properties along Ashford Road. KFRS attended Ashford Road on the 25 July 2021 to pump out floodwater from multiple properties. Figure 3 below shows the location of the pond and drainage ditch in relation to Ashford Road. KCC attended the site in December 2021 and inspected the land drainage ditch which was found to be in a good condition.

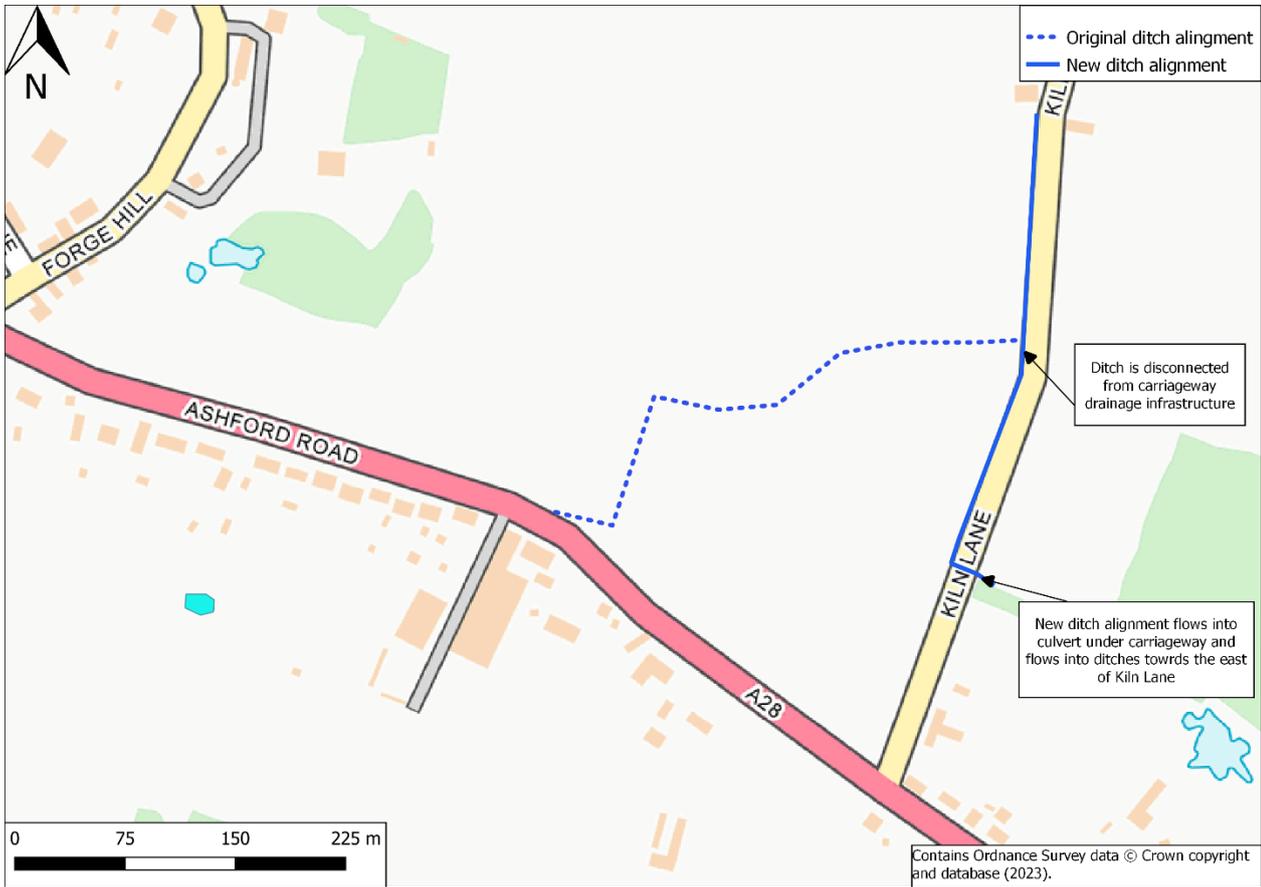
Figure 4 Comparison of original and new ditch alignments along Kiln Lane

An overland flow pathways across agricultural land to the north of the A28 connects to the drainage network and flow to the main river via culverts underneath Forge Hill. Land drainage for the field has been realigned and the ditch alongside Kiln Lane has been diverted away from Bethersden so that it flows south alongside Kiln Lane and crosses the carriageway through a culvert and continues into the fields to the east of Kiln Lane. Figure 4 below shows a comparison of the original and diverted alignments of the land drainage ditch.

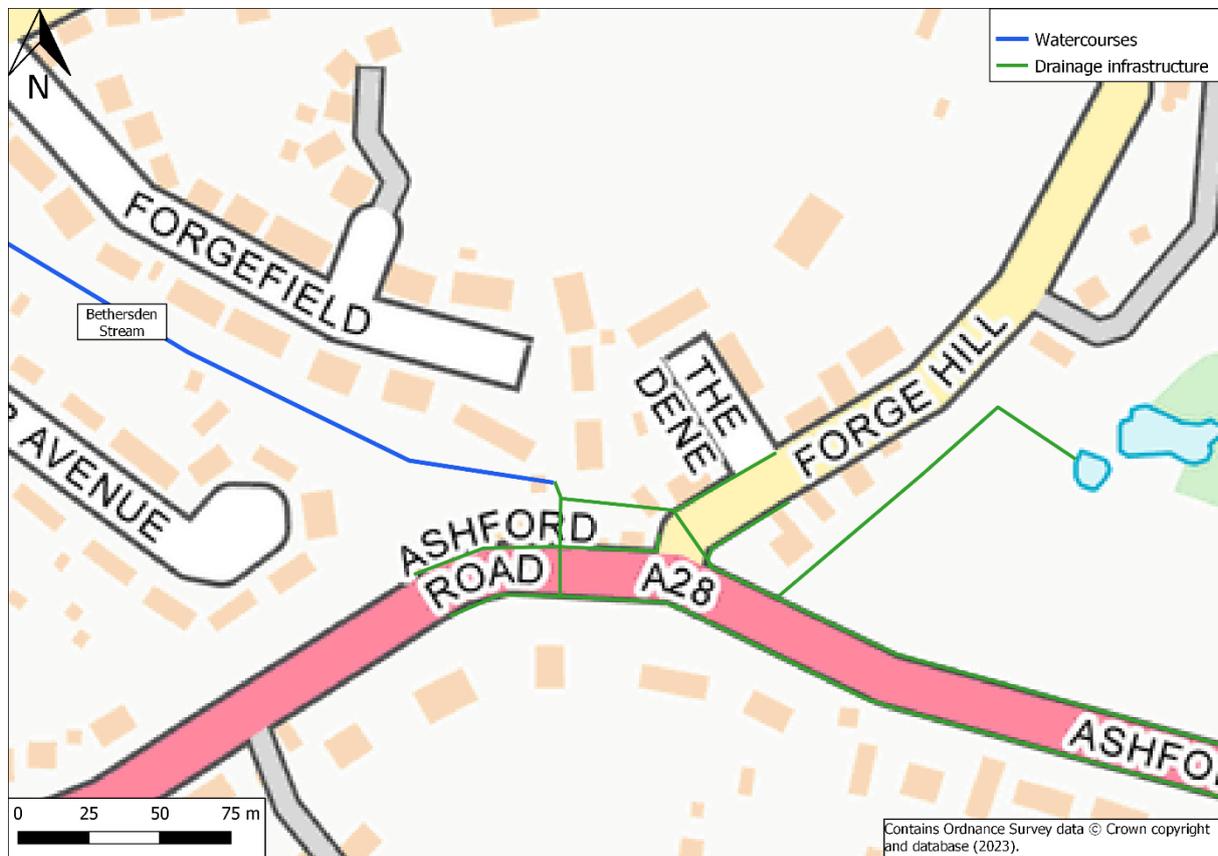
Figure 5 Overview of Forge Hill area

The Bethersden Stream flows through a 675 mm culvert beneath the junction of Forge Hill and Ashford Road A28. It then becomes open channel between the rear gardens of the properties on Forgefield and Chester Avenue. The Bethersden Stream is classified as a main river from Forge House. The junction of Forge Hill and the A28 is a low spot and surface water is known to pond at this location Figure 5 below provides an overview of the drainage infrastructure within Forge Hill and the surrounding area.

During the 25 July 2021 flood event it was reported during the flood response undertaken by the Environment Agency that the culvert beneath Forge Hill was being bypassed by the high flows within the river channel.

KFRS attended the flood event and pumped out floodwater from inside properties at Forge Hill into the Bethersden Stream. However, it was reported to the Environment Agency and councils that this may have contributed to flooding of additional properties downstream due to the additional water flowing into a channel which was already overwhelmed.

The width of the Bethersden Stream is reported to be restricted by a number of sheds and fences which overhang the boundary, these may have caused local restrictions within the watercourse channel. These local restrictions could have potentially impacted flow conveyance leading to water coming out of bank.

KCC Highways undertook a review of the surface water drainage infrastructure for Ashford Road including CCTV surveys to understand the condition and connectivity. The culvert and surrounding drainage system located at The Street and Forge Hill junction was cleaned and pipe repairs were undertaken in March 2022.

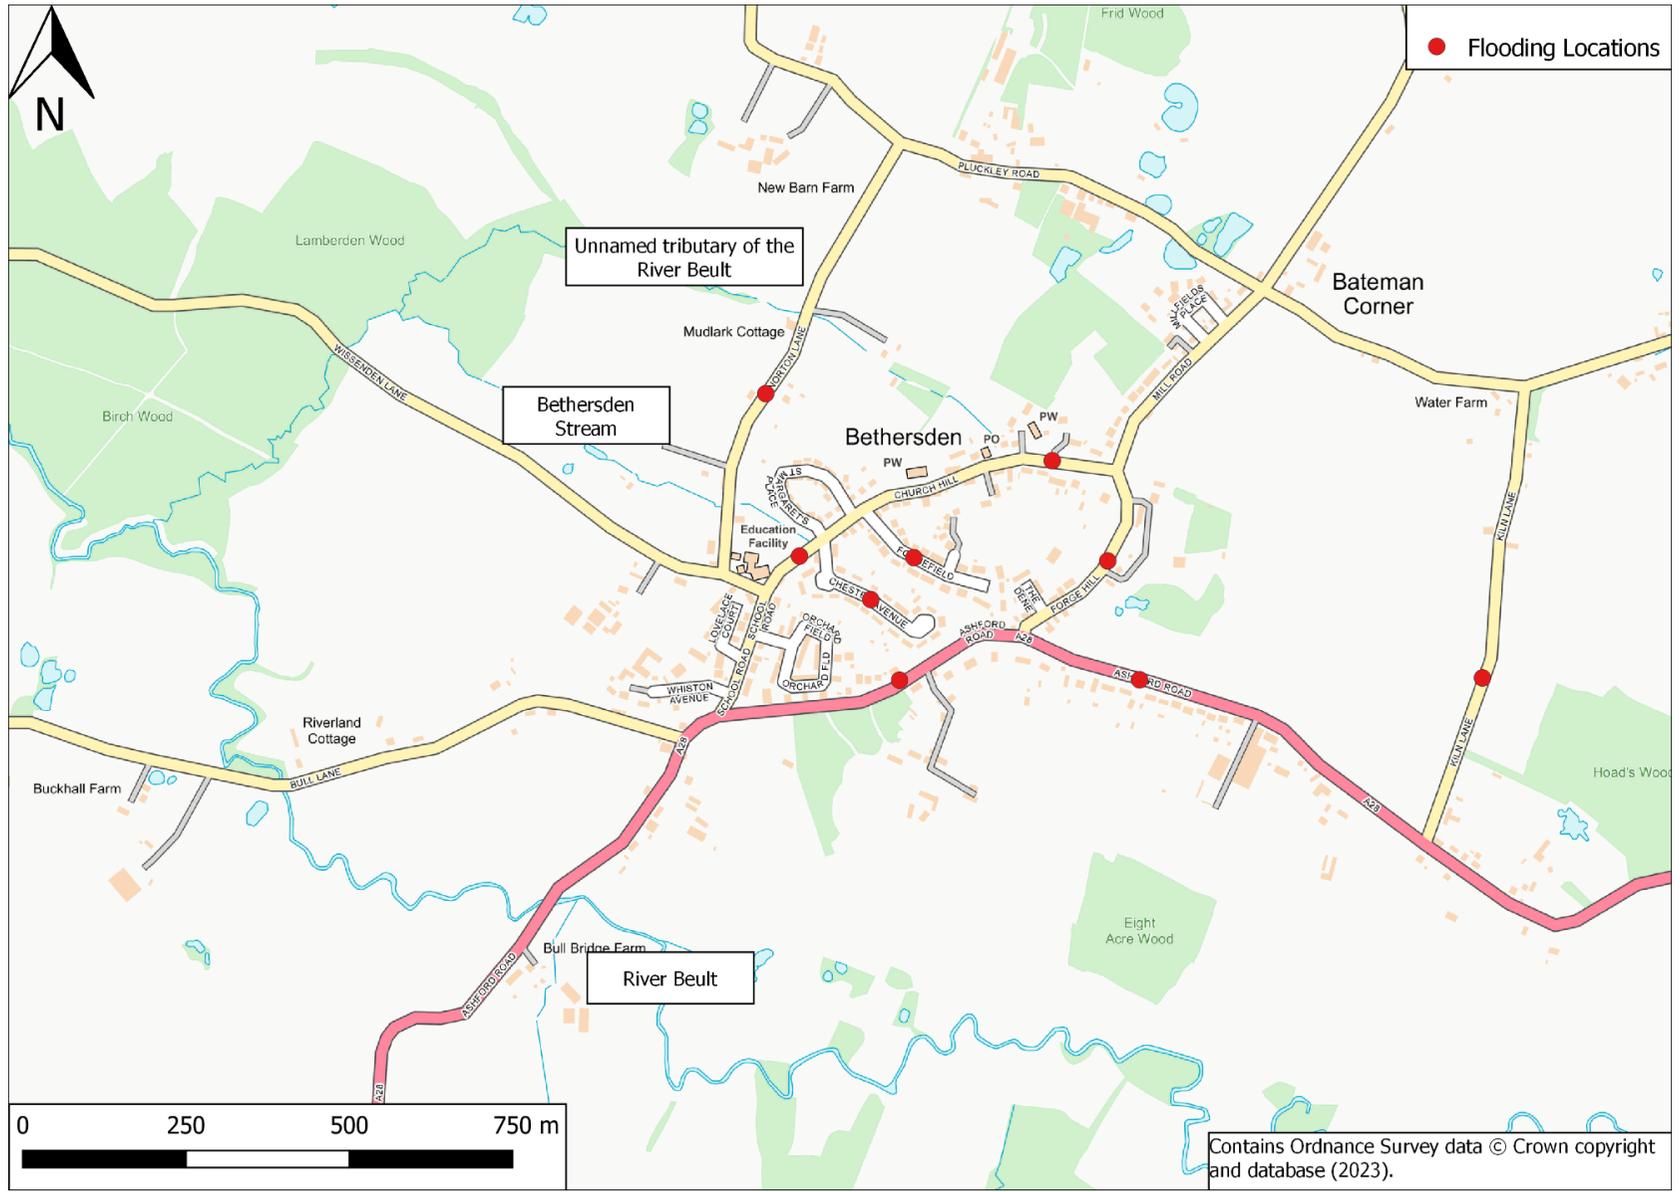
Annex 1 – Location of reported flood incidents across Bethersden

Approximately 33 properties throughout Bethersden are reported to have been flooded on the 25 July 2021, 22 properties reported flooding internally with an additional 11 properties flooding externally. The approximate locations of the reported flood incidents are shown in Annex 1 at the
