# **Flood Investigation Report**

Location of Investigation: West Kingsdown

#### Date of incident: 10 June 2019

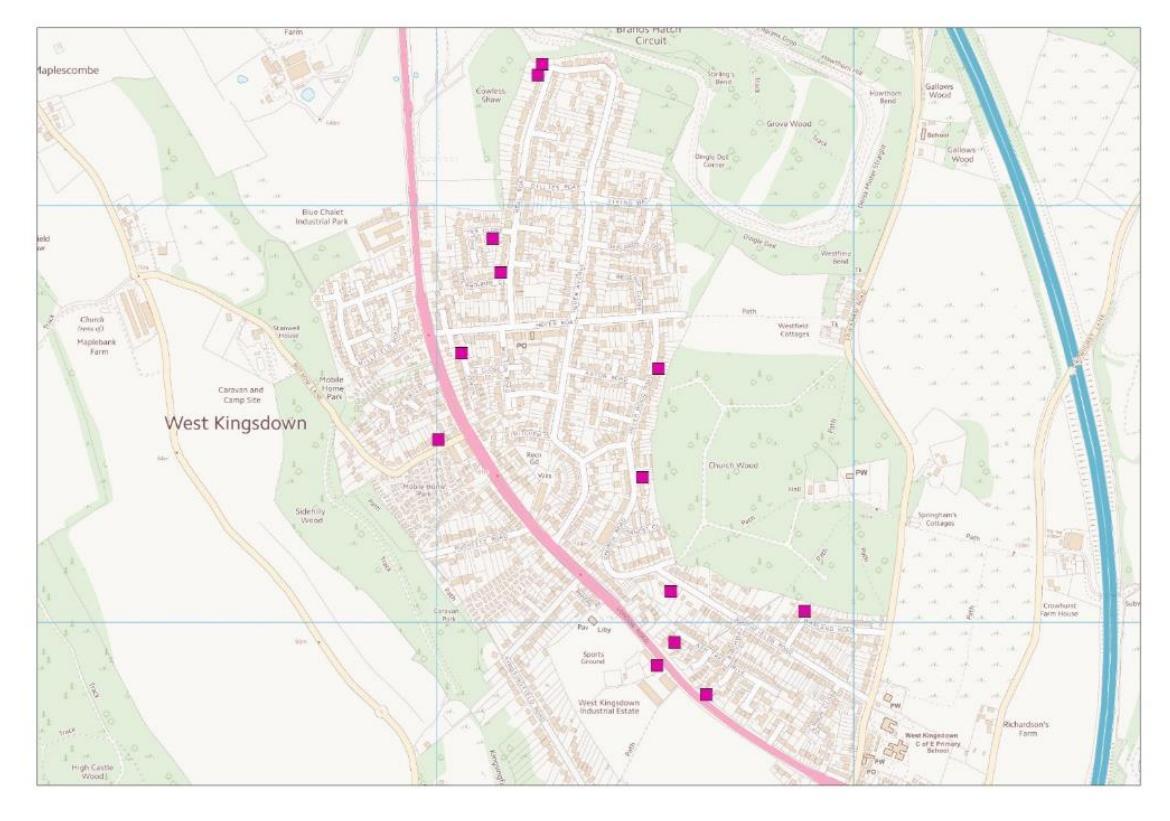
Figure 1 Location of Reported Flood Incidents in West Kingsdown on 10th June 2019

This report will focus on the West Kingsdown area where around a dozen properties are known to have been flooded by surface water, many of those were affected internally. The locations of the reported flood incidents are shown in Figure 1 and Table 1 provides a summary of the investigated flooding issues, known flood extent and previous reports of flooding.

| Location | Details of flooding | Source of<br>Information | Previous<br>Flooding<br>Reports <sup>2</sup> |
|---|--|---|--|
| A20 London<br>Road | 1 property flooded. Commercial property also internally flooded.<br>Flooding reported to be caused by overland flow from adjacent<br>farmland, causing significant amounts of muddy water to affect<br>the A20 and then flow towards Ash Tree Close. | KCC HTW | 17/01/2014,<br>08/10/2014,<br>31/05/2016 |
| Ash Tree Close<br>and Ash Tree<br>Drive | 5 properties internally flooding. Part of a conservatory wall<br>collapsed. Flood water came from the fields south of the A20<br>London Road, crossing into Ash Tree Close before flowing<br>further north towards Southfields Road. | KCC HTW | 17/01/2014,<br>13/10/2014 |
| Southfields<br>Road | 1 property confirmed to have flooding near the lowest point of<br>the road. Overland flows from the fields south of London Road<br>contributed to the flooding. | KCC HTW | 17/01/2014 |
| Neal Road | 2 properties affected internally with one resident evacuated by KFRS. Flooding reported to be waist high. 1 property in different location of road suffered external flooding. | KCC HTW<br>KFRS | None |

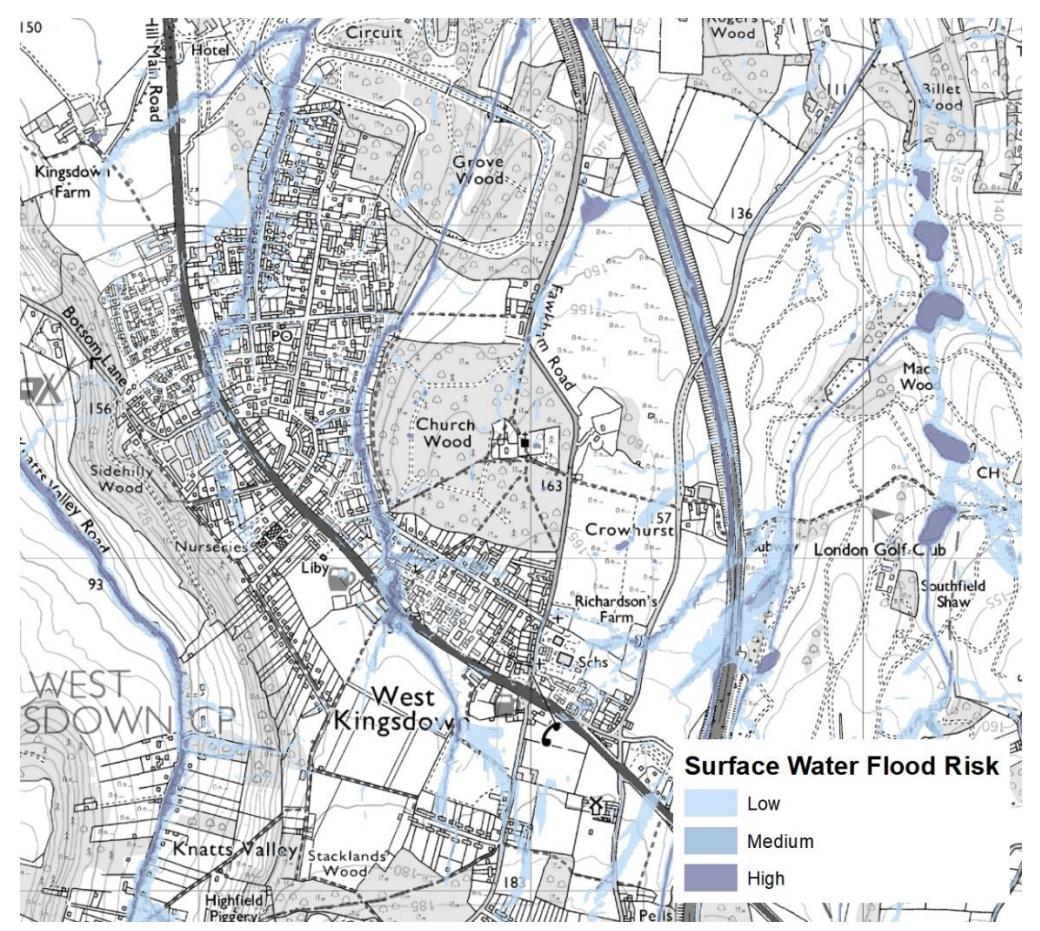
Figure 2 Environment Agency surface water flood map

The national surface water flooding provided by the Environment Agency on the gov.uk long term flood risk information map<sup>3</sup> indicates these areas to be at a medium to high risk of surface water flooding. Medium and high risk means that these areas have a chance of flooding of greater than 1% and 3.3% in any one year respectively.

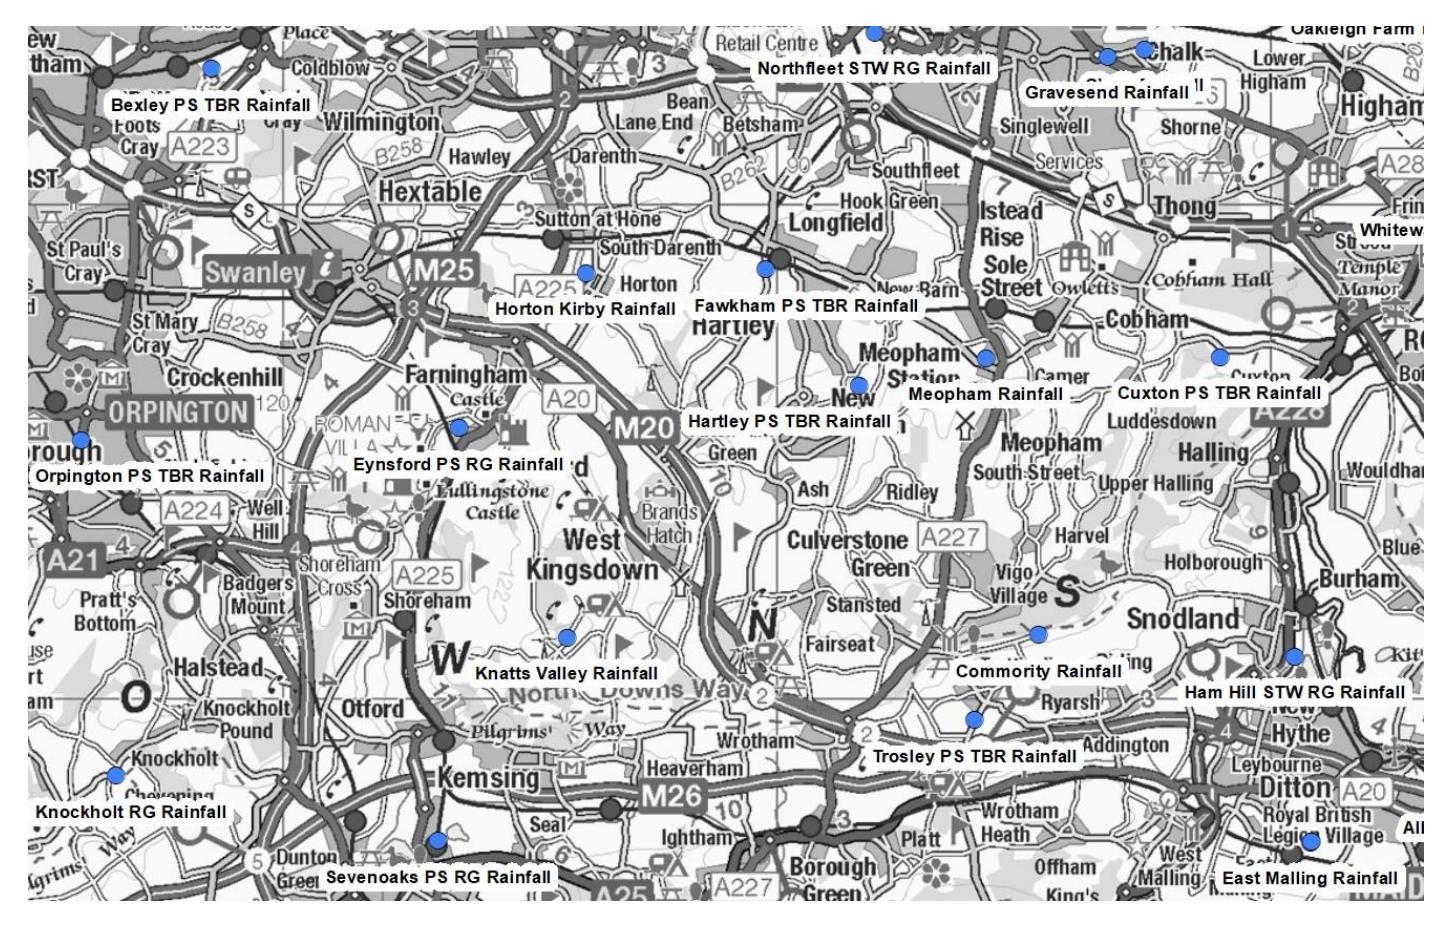
Figure 3 Location of rain gauge stations closest to the path of the storm.

Figure 3 shows the location of the rain gauges and Table 2 summarises the rainfall recorded at the Environment Agency rainfall gauge stations closest to the path of the storm on 10 June 2019.

The storm tracked broadly from the east to the west across the north downs, this is shown by the high levels of rainfall measured at Ham Hill, Commority, Eynsford and Orpington. Rain gauges to the north and south of this path, Hartely and Trosley respectively, show lower, but still relatively high levels of rainfall. The rain gauges at Fawkham and Sevenoaks which lie further to the north and south respectively show further lower rainfall levels.

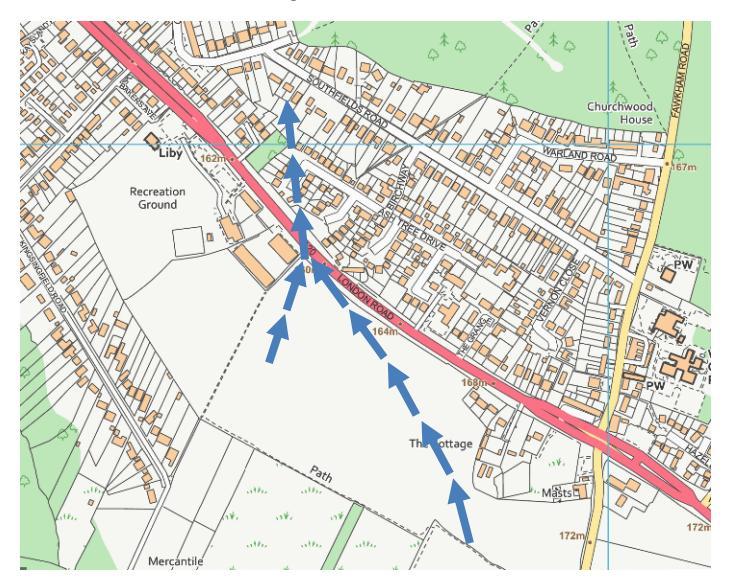
More widespread flooding occurred after 21:00 following an additional 45mm of rain. Significant overland flows from both greenfield and built areas were reported, particularly along the A20 London Road where muddy run-off flooded the road and continued to flow through Ash Tree Close and towards Southfields Road as shown in Figure 4. This caused extensive damage where the run-off travelled through properties.

Figure 2 Overland greenfield run-off flows towards A20 London Road and Ash Tree Close

Highway drainage is not generally designed to accommodate storms of this severity and it is unlikely that improvements to the highway drainage could prevent a similar flood from happening in West Kingsdown if this rainfall was experienced again. Options to mitigate this risk need to focus on preventing the build-up water at the low points, this includes from the rural catchment upstream and the deep water that collects behind the noise bund for Brands Hatch.

Kent Highways are considering a range of measures to manage flood risk to the highway. These measures include alternations to the existing surface water drainage to interlink the systems on the north and south sides of the road. Along with improvements to existing soakaways such as installation of new deep bored soakaway liners, together with additional pollution controls to ensure mud and debris from the field run-off does not adversely affect upon the soakaways in future. The existing soakaways will be tested as part of the works to help us to determine the residual risk of flooding in conjunction with the surface water modelling.
