Flood Investigation Report

Albert Road – Deal
Dover

A flood event occurred on 21st May 2014 at Albert Road, Deal. The flood event caused damage to 22 properties.

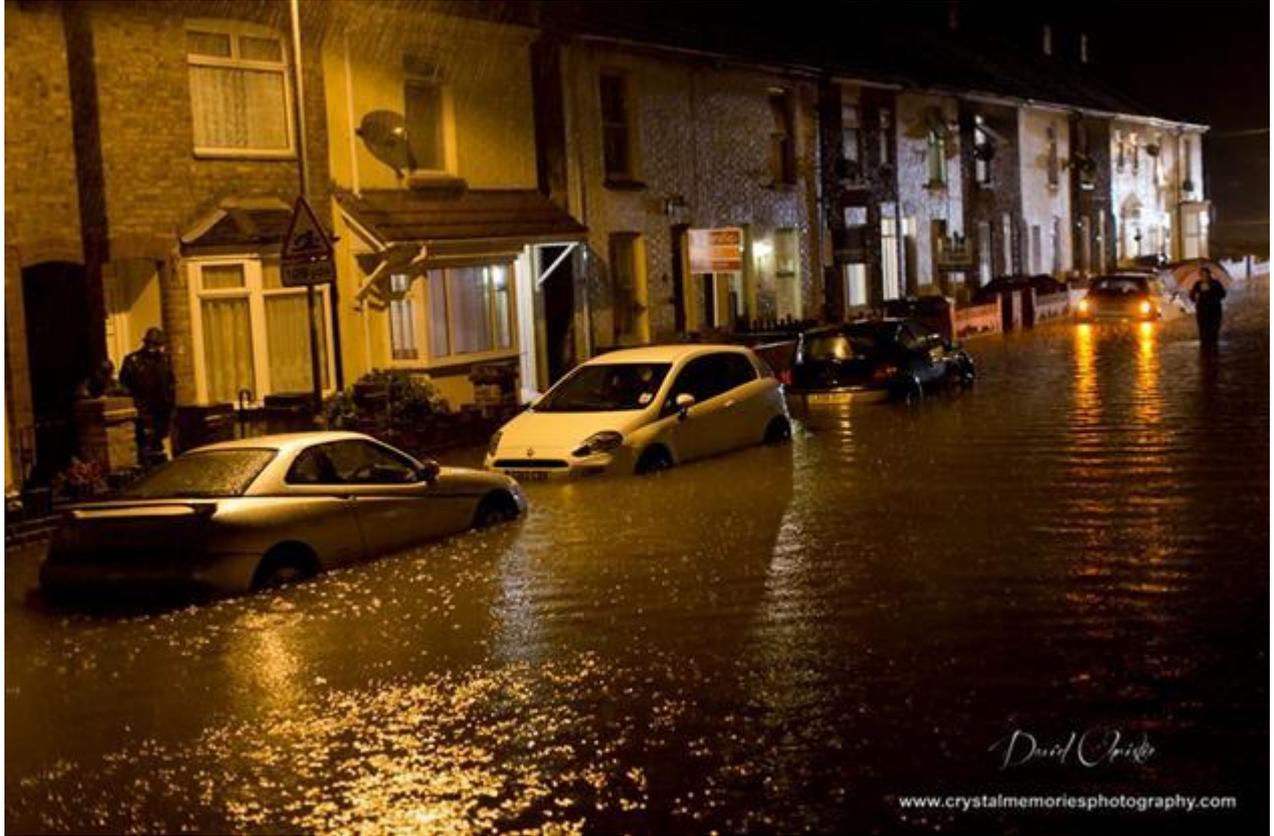
Figure 2 Flooding at Albert Road on 21 May 2014

On the 21st May 2014 it was reported to Kent County Council that Albert Road, Deal, shown in Figure 1 had flooded. Photo 1 shows the flooding that was experienced.

The flooding followed a period of heavy rainfall and resulted in damage to properties on Albert Road and flooding on the road, estimated to be approximately 30cm deep. 22 properties were flooded internally, and damage was reported to vehicles.

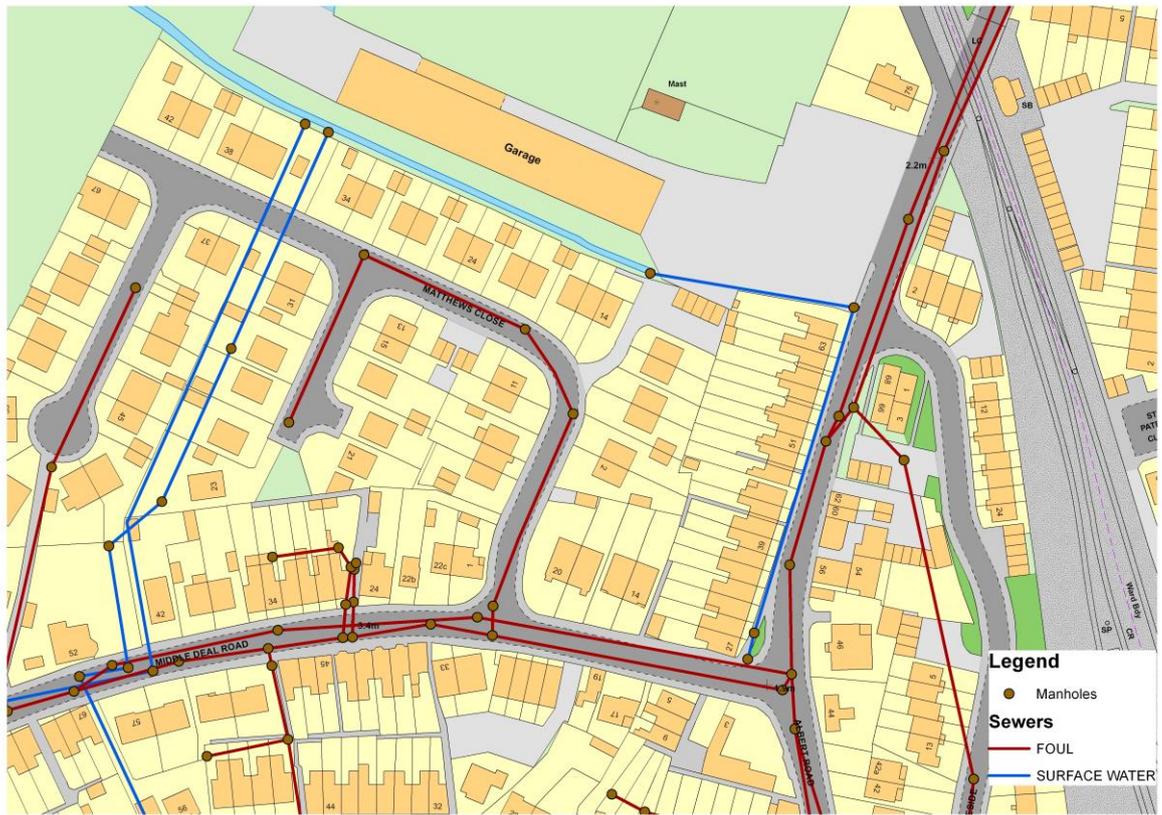
Figure 3 Albert Road sewers

These sewers can be seen on Figure 3. A foul sewer flows from the south under Albert Road from the junction of Middle Deal Road, this sewer is 825mm. This sewer splits in two along Albert Road and one of these is joined by another sewer from Bridgeside. The two foul sewers continue under the railway line to Golf Road, they are 1200 mm and 450 mm in diameter.

There is also a separate surface water sewer in Albert Road that collects the surface water runoff from a rainstorm event via the gullies in Albert Road and discharges to the ditch at the back of Matthews Close. The surface water sewer is 450 mm in diameter.

An unexpected electrical fault at the Golf Road pumping station resulted in the foul sewers backing up with the rainwater that was entering them and surcharging. Albert Road is the low point on the ground along these sewers and the excess water discharged there.

Once the water discharged onto the road there it was unable to escape quickly enough. The surface water sewer, which was already carrying the surface water from Albert Road, does not have the capacity to carry the water surcharging from the foul sewers, due to the difference in their sizes (nor is the surface water sewer intended to provide back-up in this eventuality).

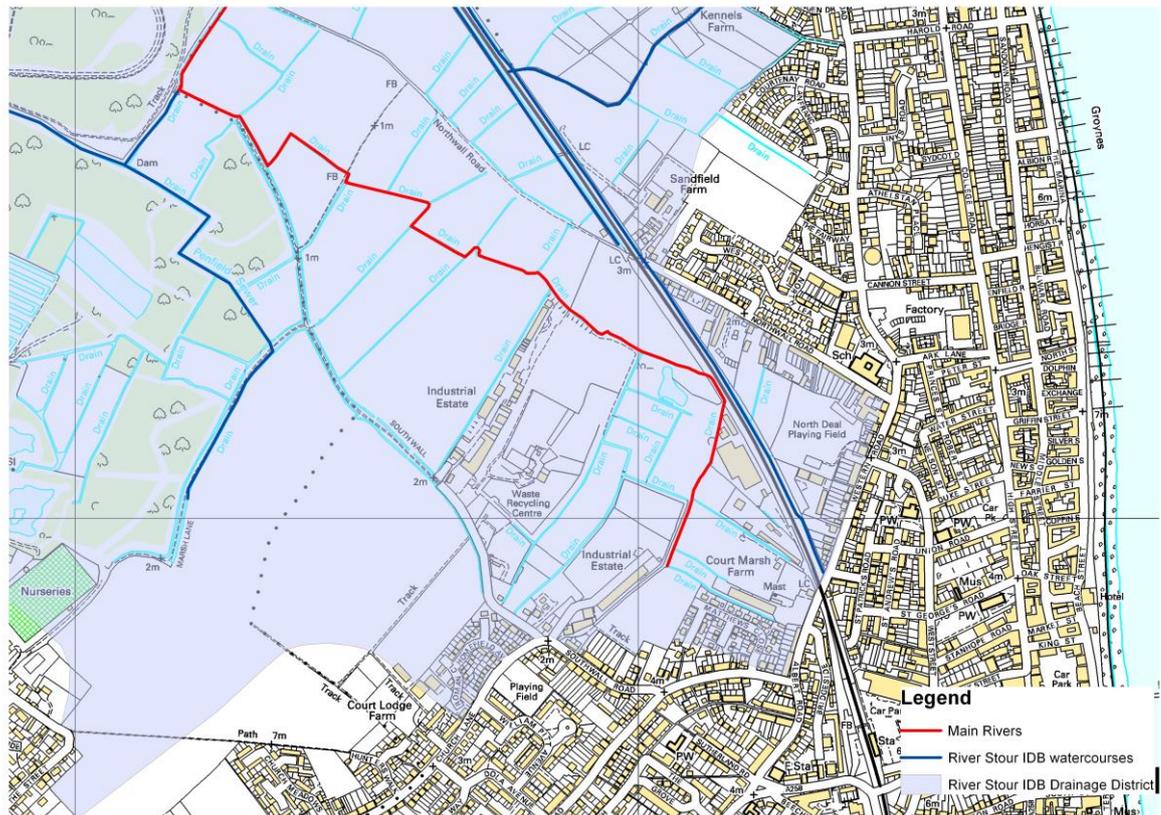
Figure 4 River and drains near Deal

There is an area of marshes to the north west of this part of Deal. This area has a number of ditches, drains and rivers to manage water levels. Some of these watercourses are main rivers, which are managed by the Environment Agency. The other watercourses are known as ordinary watercourses, these are the responsibility of the neighbouring landowners. The River Stour Internal Drainage Board oversees watercourses within its district, some of these ordinary watercourses it adopts and provides maintenance for. Figure 4 shows the main rivers, the area of the River Stour IDB and the watercourses they provide maintenance for.

The ditch at the back of Matthews Close is an ordinary watercourse and part of this system. There has recently been work undertaken by the River Stour Countryside Management Partnership to improve this ditch.

The ditch is open at the Albert Road end and then flows into a culvert. There is an opening for the surface water sewers in Matthews Close to discharge into the ditch and then it is culverted again to the Penfield Sewer, a main river.

The proposed works are to provide an open ditch that runs parallel to the culvert. This will provide increased capacity in the ditch and an improved local environment. At the time of the flood the works had commenced but not been completed. These works did not prevent the culvert from functioning and inspection of the culvert has shown that it was working properly.
