# A249 KEY STREET JUNCTION IMPROVEMENTS DORMOUSE SURVEY REPORT

# A249 KEY STREET JUNCTION IMPROVEMENTS

## DORMOUSE SURVEY REPORT

Client/Project owner	Kent County Council
Project	A249 Key Street Junction Improvements
Study	Dormouse Survey Report
Type of document	Report
Date	18/10/2023
Reference number	GB01T22H76-REP-ENV0007
Number of pages	20

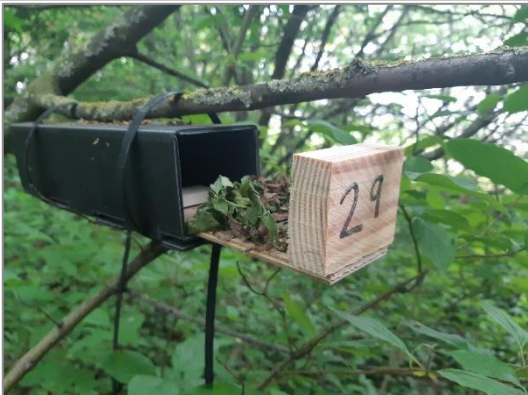
- 4.1.1 During the first visit, on 9<sup>th</sup> May 2023, nest tube 29 contained several green leaves however beyond this no other signs of dormouse were noted. On the 6<sup>th</sup> June 2023, during the second visit, tube 29 appeared to have more green leaves present (see Appendix 2, Photograph ID 1). However, over the remaining surveys the green leaves did not change or form a nest and no other evidence indicative of dormouse was noted. It is deemed likely that this was the beginnings of a wood mouse (*Apodemus sylvaticus*) nest.

PHOTOGRAPH ID	DESCRIPTION	PHOTOGRAPH	
1	<p><b>06/06/2023</b>            Visit 2            Nest tube 29            Evidence of several green leaves</p>

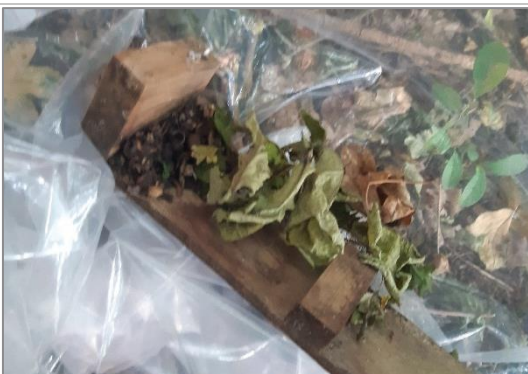
- 4.1.2 On the third visit on 4<sup>th</sup> July 2023 green leaves forming a wood mouse nest were recorded within nest tube 44 (see Appendix 2, photograph ID 2). A cache of cherry pips was recorded directly adjacent on the left. Caching is a behaviour typically associated with wood mice and is considered a diagnostic field sign.

2	<p><b>04/07/2023</b>            Visit 3            Nest tube 44            Evidence of wood mouse nest</p>

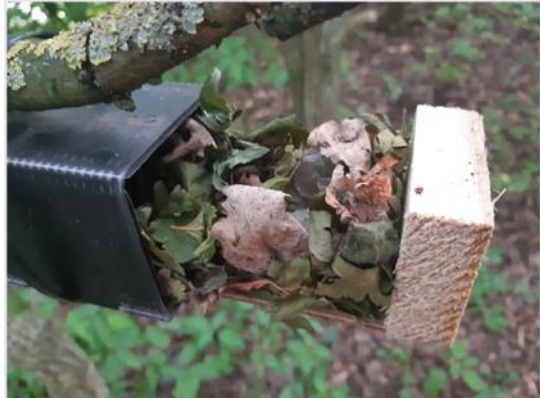
- 4.1.3 On the 8<sup>th</sup> August 2023 during the fourth visit, a green leaf mammal nest was recorded within tube 13 (see Appendix 2, Photograph ID 3). The nest contained a distinct chamber with plenty of green leaves and as such was considered a probable dormouse nest. This nest was not present during subsequent visits. It is likely the nest was not maintained beyond a single night and was blown out of the tube by inclement weather. No further signs of dormice were recorded within this tube during the last site visit.

<p><b>3</b></p>	<p><b>08/08/2023</b>          Visit 4          Nest tube 13          Tube 13 had a clear green leaf mammal nest in. As it had a distinct chamber and lots of green material, it has to go down as a probable dormouse nest. No other signs or dormice seen otherwise onsite.          Replaced the plastic sleeve on a damaged tube (probably bird damage) and a couple of cable ties.</p>
