Flood Investigation Report

Flooding affecting the areas of

Borough Green Road and Busty Lane, Ightham

On the 25th June 2016

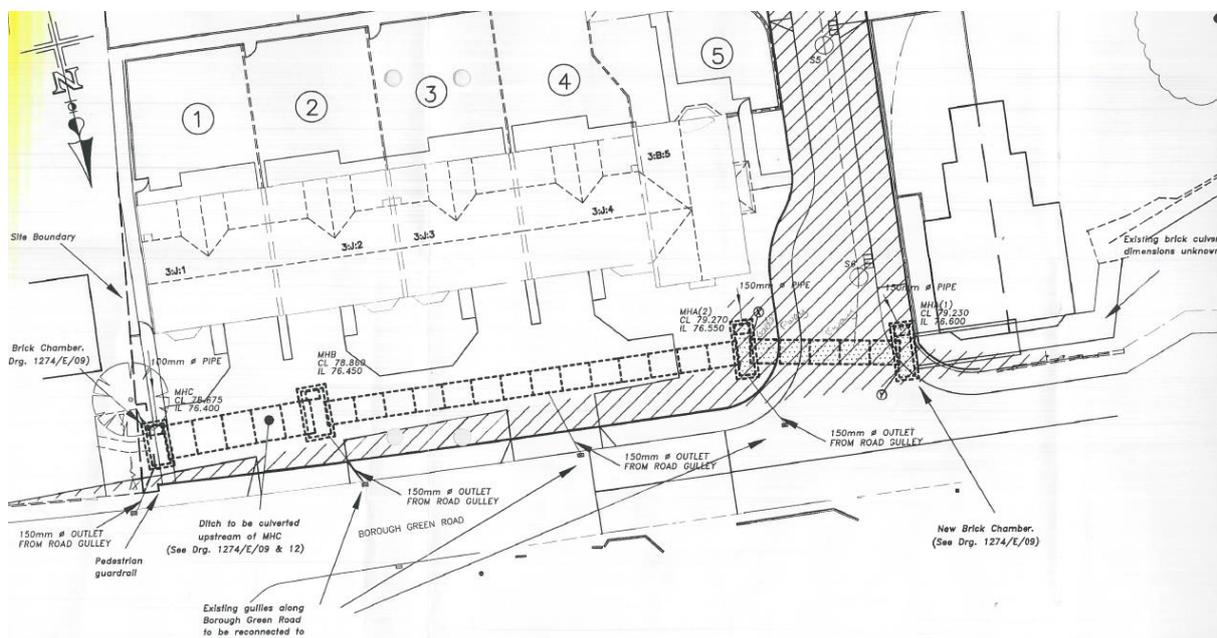
Figure 8 Site Plan for Durling's Orchard Development with culvert details.

There is also a structure of steel, brick and concrete culvert noted adjoining the culvert carrying the main site entrance over the stream. It is not clear whether this clear span structure or constructed akin to an 'Armco' culvert.

It appears it was originally planned for there to be a short section of open ditch remaining; however the final design extends the culvert to meet with the existing at old School Cottages. It is considered that the reason for this was due to the limited benefit of a short section of open ditch remaining. The layout of this culvert is shown in Figure 7.

The culvert was proposed for adoption by KCC Structures Management; however this process was never formally completed by the developer. The structure therefore remains under the riparian responsibility of each landowner for the sections of culvert within their land.
