May 2016

Kent County Council

Flood Investigation Report

Flooding affecting the Tunbridge Wells Area on
24th August 2015

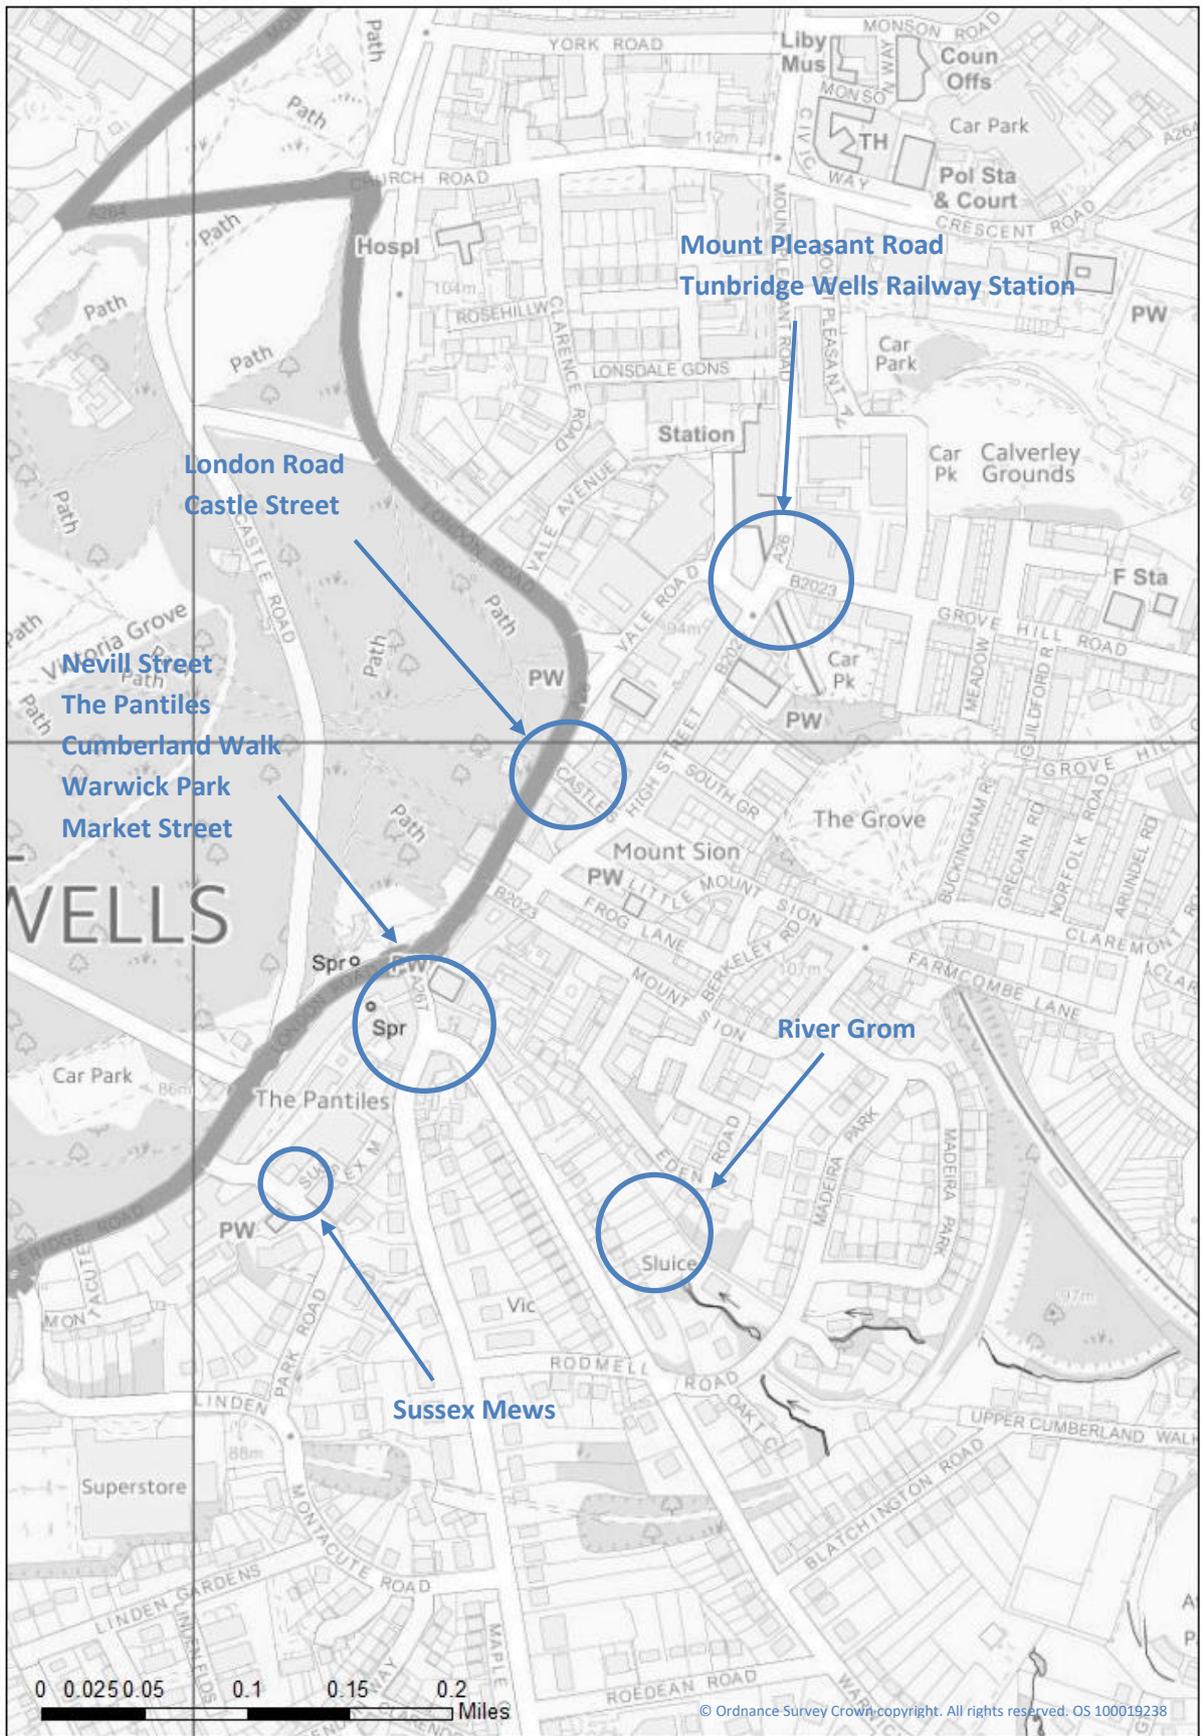
Figure 1 Locations of Flooding under Investigation.

Castle Street	1 commercial property internally flooded and highway flooded and impassable by pedestrians.	KFRS KCC
Mount Pleasant Road and Railway Station		
Mount Pleasant Road	Internal flooding to 1 commercial property and highway flooded.	KFRS
Tunbridge Wells Railway Station	Railway track flooded from overflowing drainage causing closure of Tonbridge to Hastings line until flooding subsided.	TWBC Network Rail

The locations of these roads can be seen in Figure 1. It should be noted that this list of affected locations is not exhaustive and many other localised incidences of flooding were reported at this time. Local news reports also indicate additional locations suffered flooding which were not reported to risk management authorities.

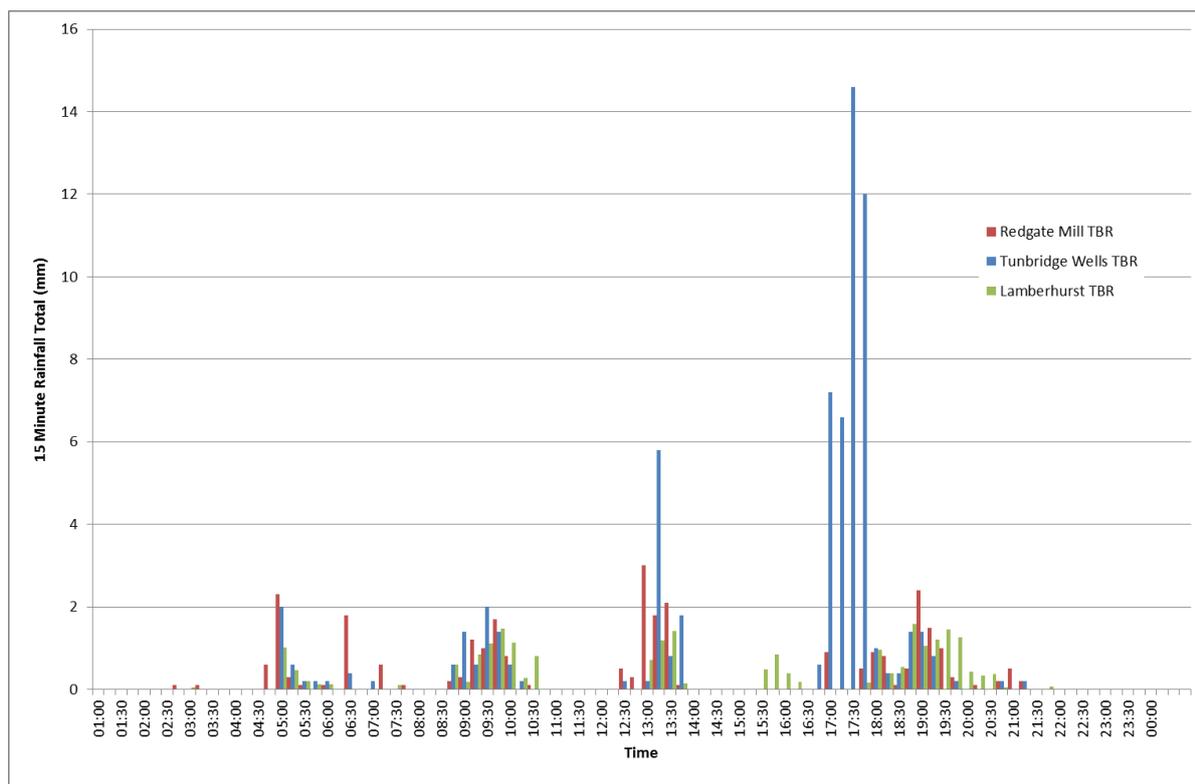
Figure 3 Rainfall Data for 24th August 2015 at 15 minute intervals, adjusted to BST.

The most significant rain was recorded between 17:00 and 18:00 BST at the Tunbridge Wells rain gauge, which recorded 40.4mm of rainfall within this hour period. This coincides with the first reports of flooding, which were received at 17:34. This event has a return period estimated as 1 in 51 year AEP using the Flood Estimation Handbook (FEH)¹. A total of 66.4mm was recorded for the whole day, 47mm of which fell between 15:45 and 20:30, which includes the above event.

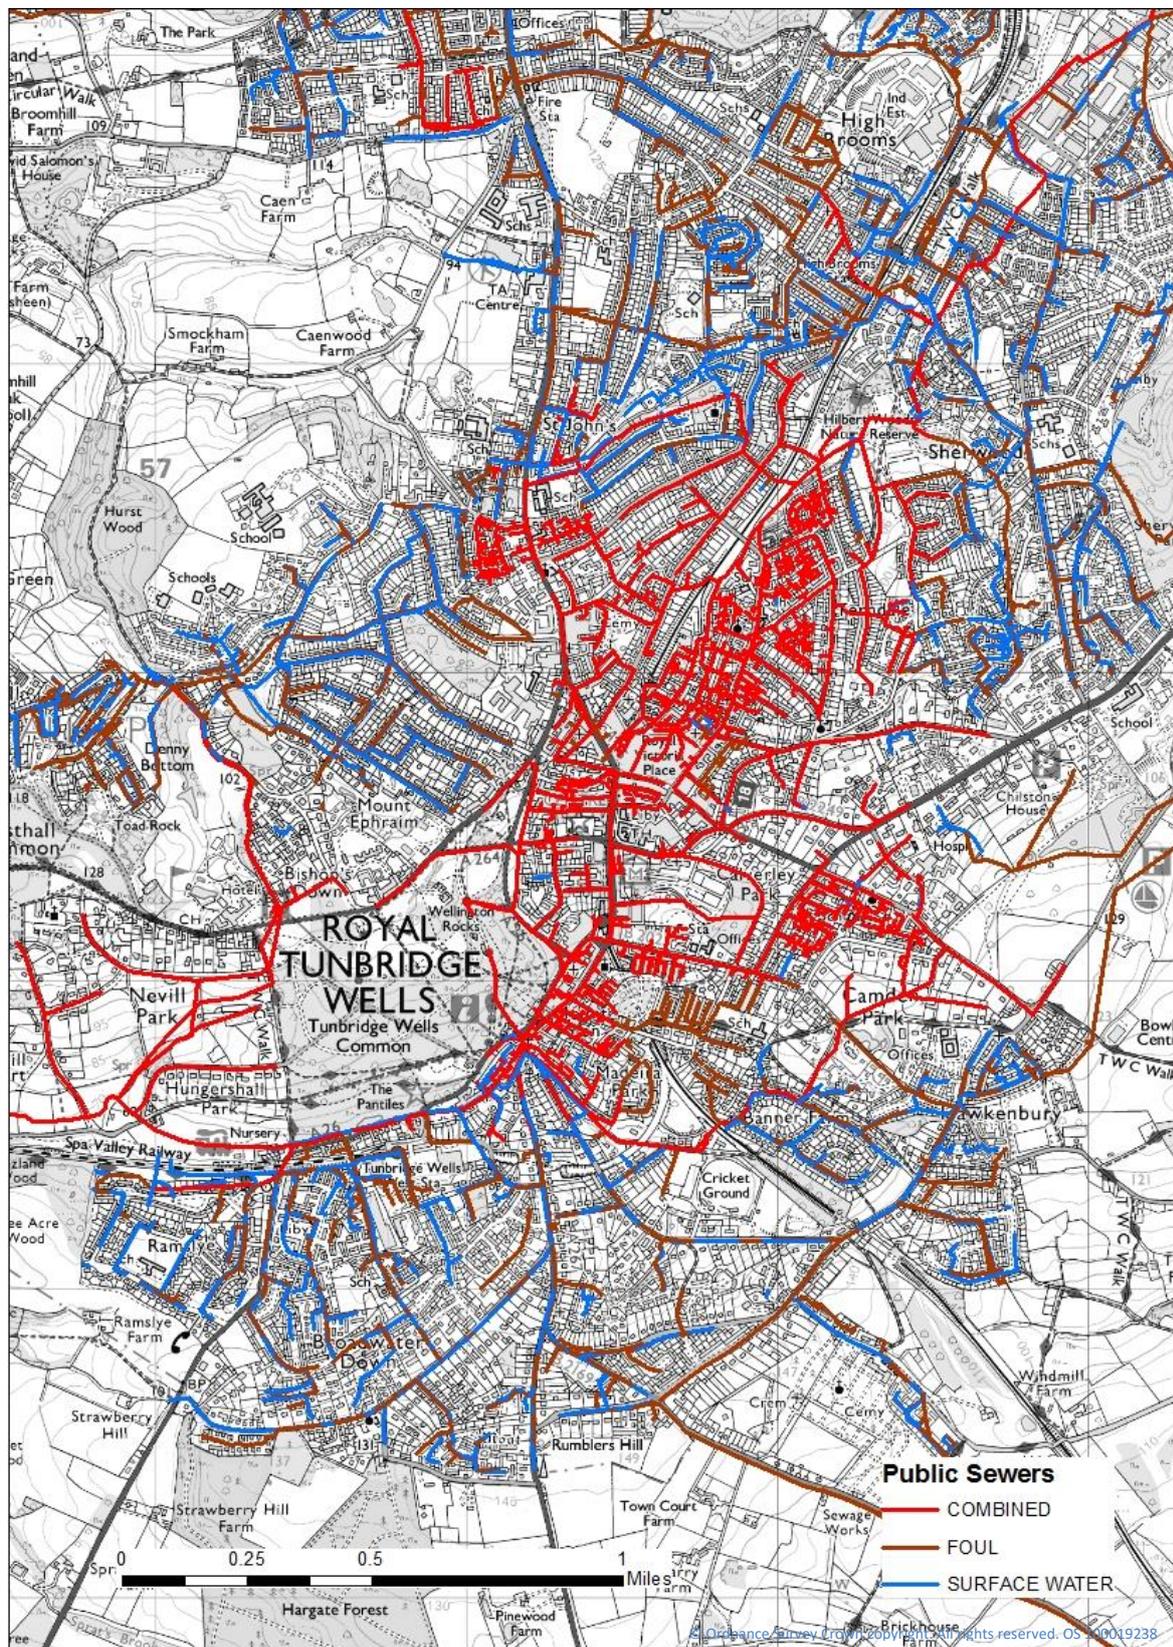
Figure 4 Public sewers in Tunbridge Wells

A plan of the public sewers in Tunbridge Wells can be seen in Figure 4. The concentration of combined sewers (red in the map) indicates the older areas of the town; with the separate system (blue for surface water and brown for foul) the more recently developed areas.

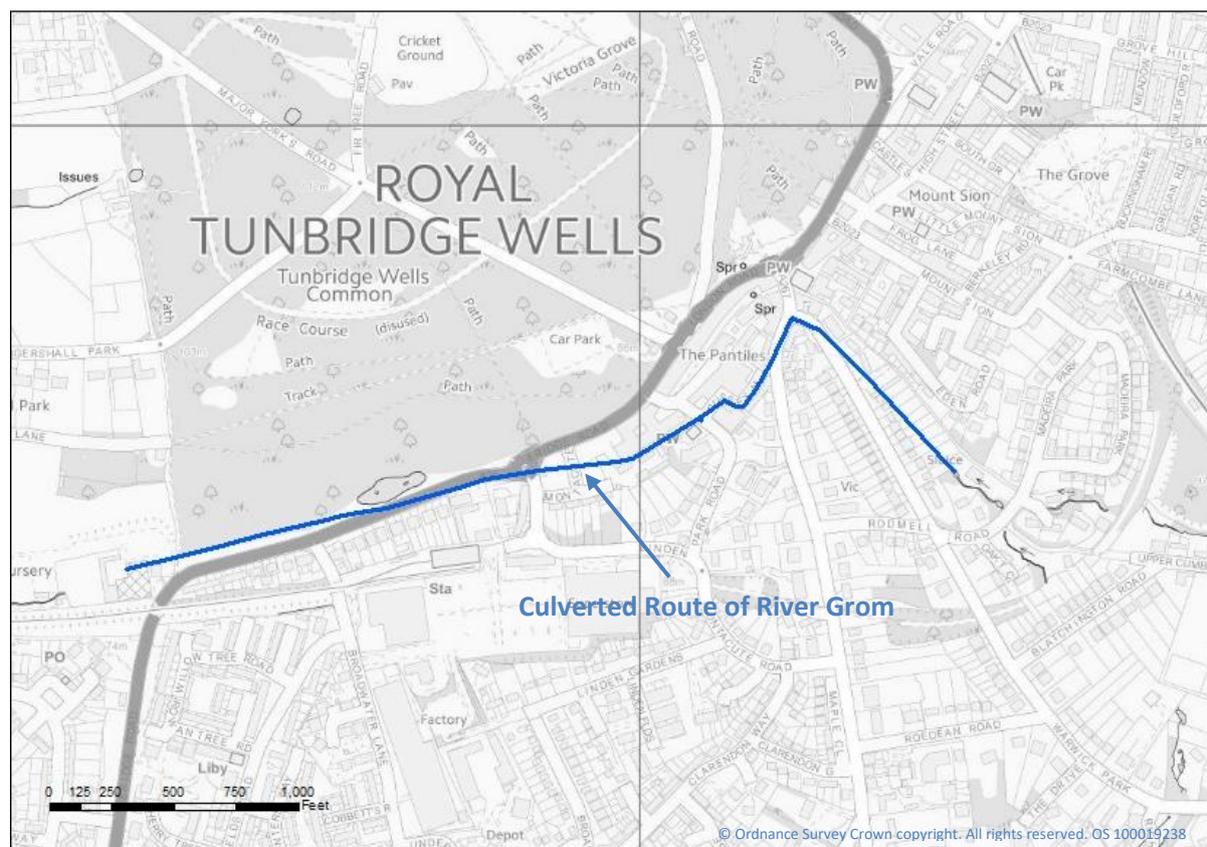
Figure 5 Approximate location of the River Grom culvert in Tunbridge Wells

The exact source and route of the tributaries of the River Grom is now unclear as there has been so much development in this area, but the River Grom flows into the in a private garden in the residential area northeast of Warwick Park. From there it flows in a north-westerly direction towards the junction of Warwick Park and Nevill Street, where it turns to the west and flows west and becomes an open watercourse again to the west of the Eridge Road railway bridge. The approximate course of the River Grom culvert can be seen in Figure 5.

It is likely to have been culverted first during the late Victorian era. The River Grom directly drains the area around the Nevill Cricket Ground, including an area to the north of the railway line. There is a Combined Sewer Overflow (CSO) from the public combined sewer in the culverted section of the River Grom that allows the combined sewer in the Pantiles area Tunbridge Wells to discharge into it if its capacity is exceeded. This is a consented discharge. There are also some surface water sewers that discharge into the River Grom culvert that drain the areas to the south of the river.

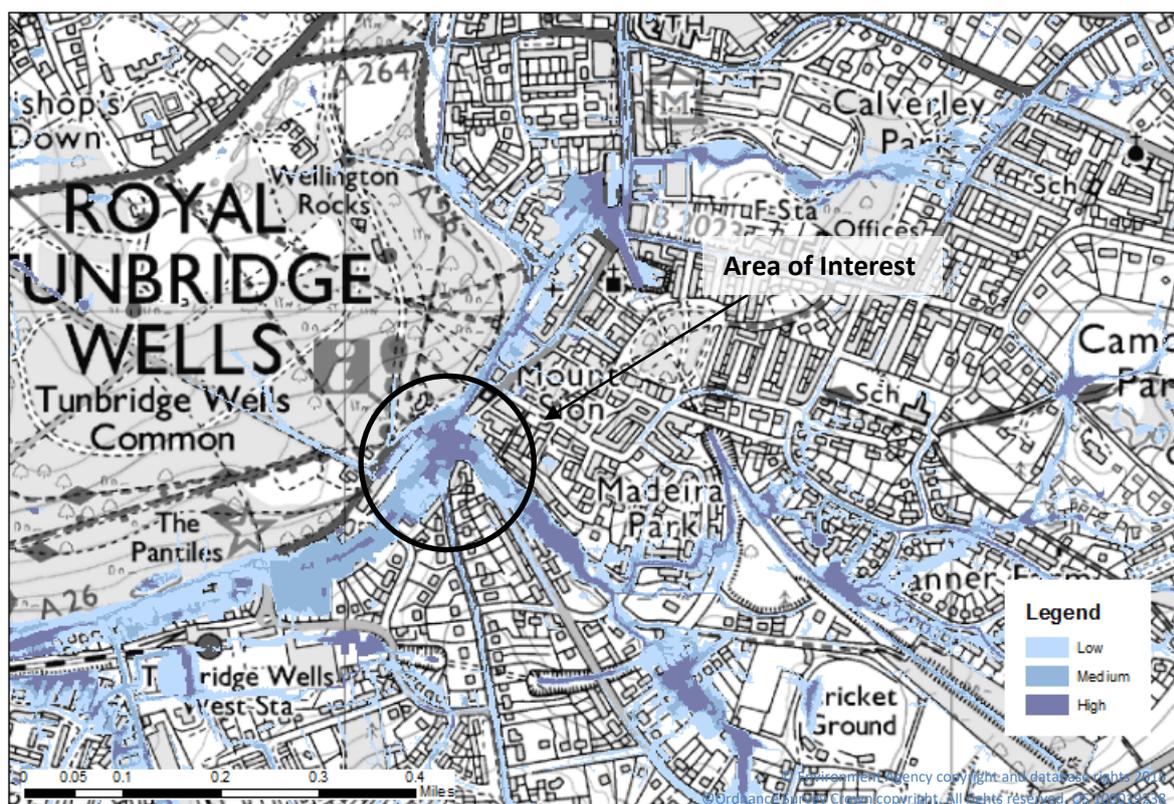
Figure 6 Surface water flood risk for the Pantiles Area.

The updated Flood Map for Surface Water (uFMfSW) shown in Figure 6 is published on the Environment Agency website and provides information on areas considered risk of flooding due to surface water.

The affected area includes locations indicated to be at high risk of surface water flooding. High risk is defined a chance of flooding during a 1 in 30 year event. This map does not take into account the presence of watercourses, sewers or other drainage features that convey water efficiently and is only indicative of areas at risk of surface water flooding.

The map indicates the risk in this area is due to the number of flow routes converging in this area with limited ability for the water to flow away over the ground.

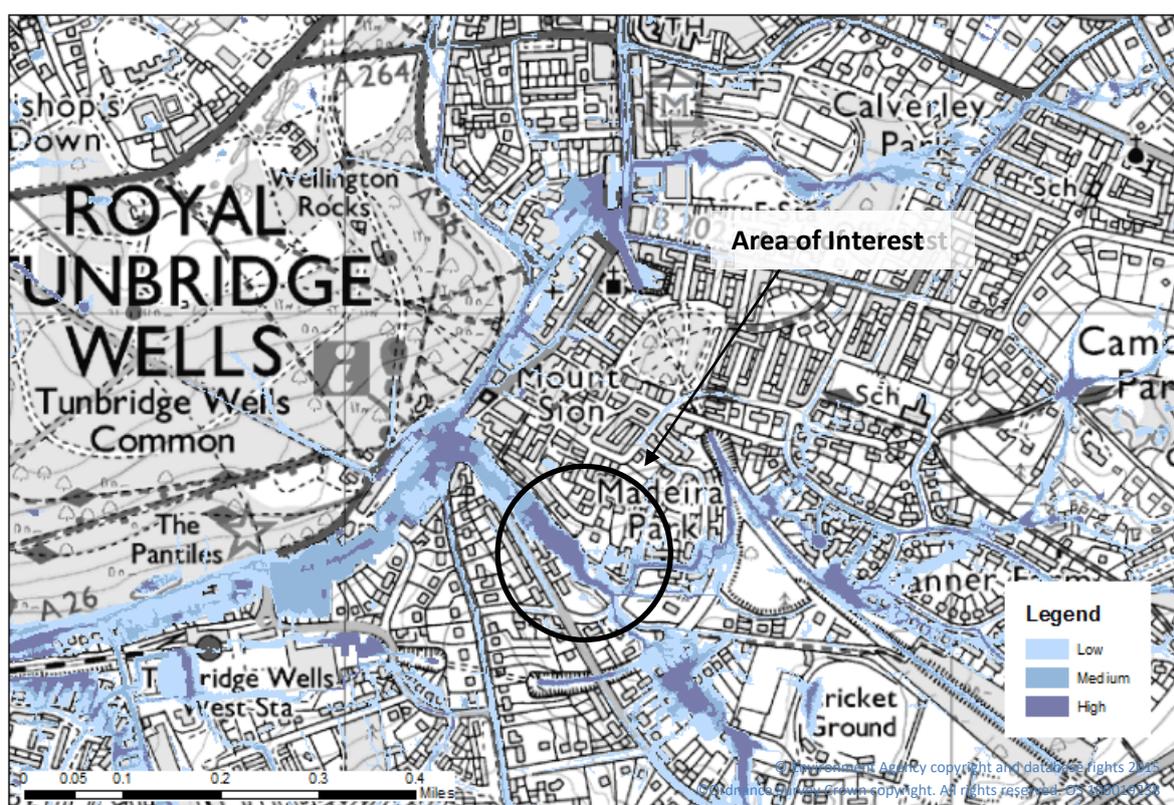
Figure 7 Surface water flood risk at Warwick Park

The entrance to the River Grom culvert lies in a private garden. The flow at this point has come from a mixture of open watercourses, culverted sections of watercourse and drainage from the developments in the area to the north, south and southeast of the Nevill Cricket Ground. Due to the river the topography in the area naturally drain water towards the culvert. This is reflected in the flood risk indicated by the Updated Flood Map for Surface Water, shown in Figure 7.

Due to the urban nature and the relatively low permeability of the ground in this area, the watercourses respond rapidly to rainfall. On 24 August the heavy rainfall caused high flows which overwhelmed the culvert and channel capacity. The culvert has a trash screen that prevents debris from entering the culvert where it can cause a blockage that is hard to remove. Due to the age of the trash screen and its design, it is dangerous to maintain in high flows.

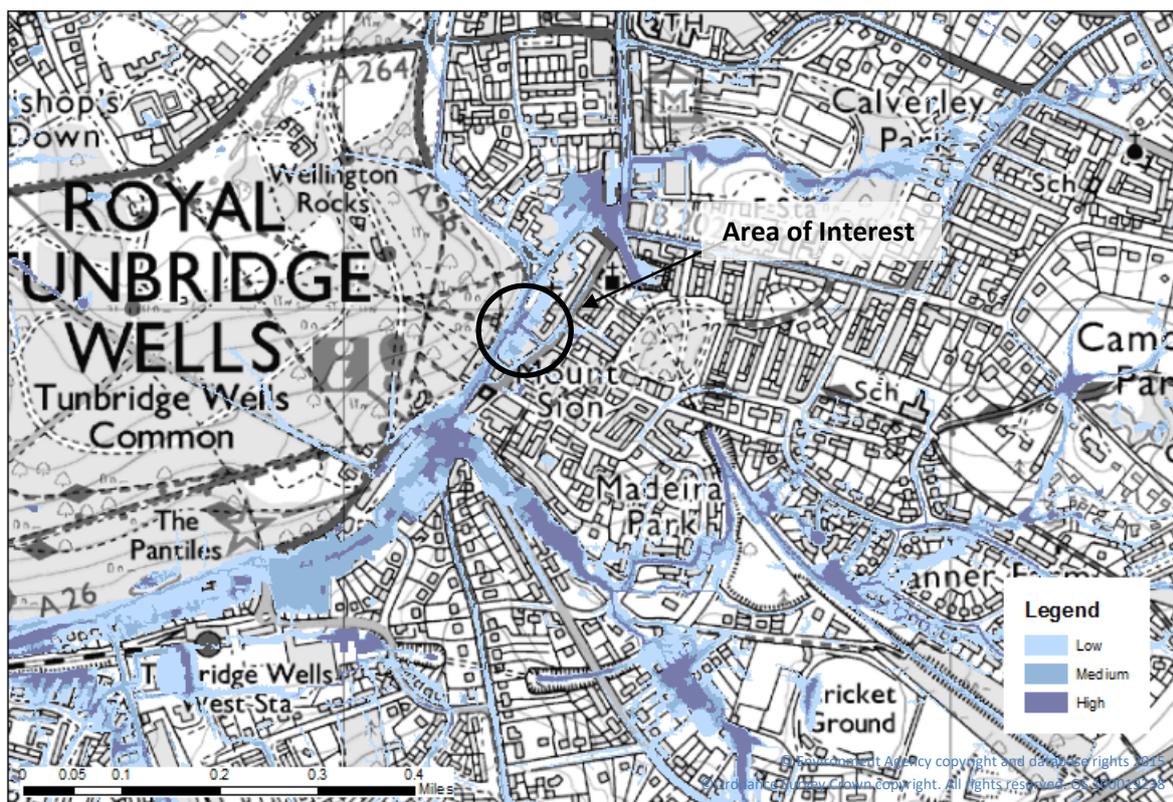
Figure 8 Surface water flood risk at London Road and Castle Street

There is a localised topographical depression at Castle Street, where water can build up, which is likely to have led to flooding of properties on London Road from the rear. Other properties flooded on London Road from the front due to the water flowing down the road.

The affected area includes locations indicated to be at high risk of surface water flooding. High risk is defined a chance of flooding in a 1 in 30 year event. This map does not take into account the presence of watercourses, sewers or other drainage features that convey water efficiently and is only indicative of areas at risk of surface water flooding.

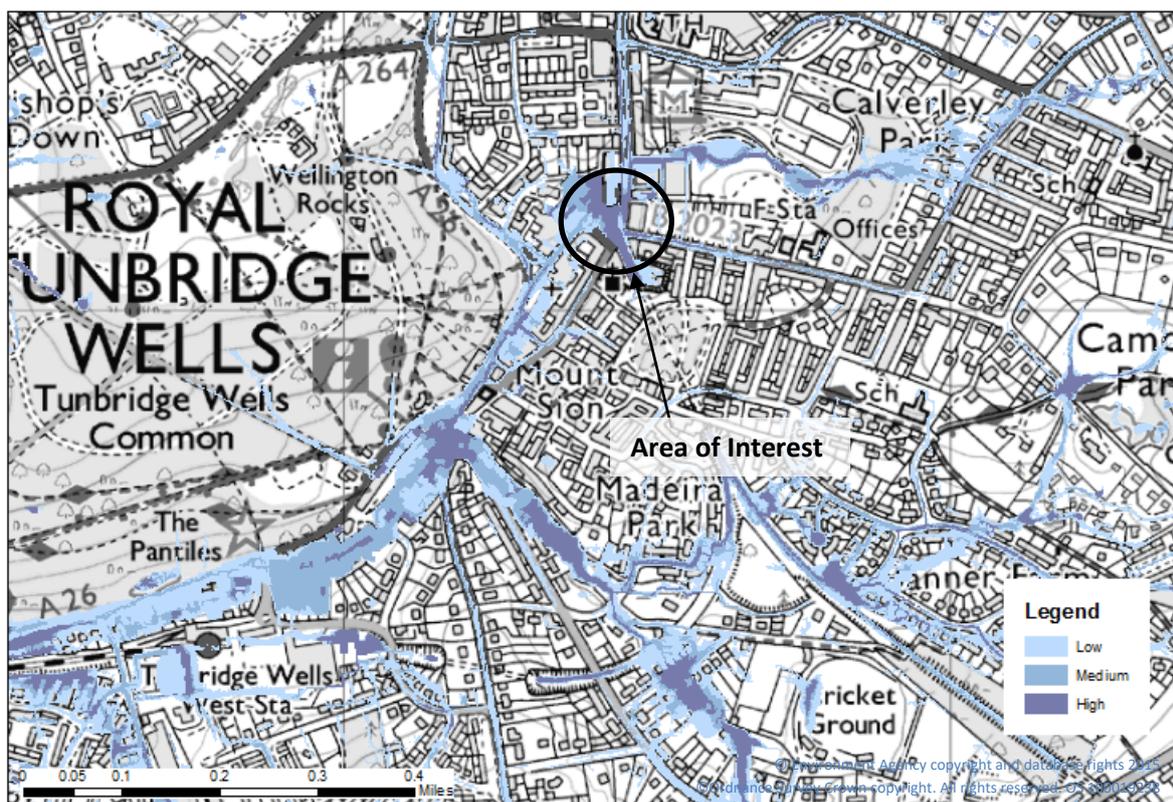
Figure 9 Surface water flood risk local to Tunbridge Wells Railway Station

At Mount Pleasant Road, a low point is present near the southern end of the road at approximately 94mAOD. The adjacent railway station lies in a deep cutting and passes beneath the highway at the southern end of Mount Pleasant Road.

The affected area includes locations indicated to be at high risk of surface water flooding. High risk is defined a chance of flooding in a 1 in 30 year event. This map does not take into account the presence of watercourses, sewers or other drainage features that convey water efficiently and is only indicative of areas at risk of surface water flooding.
