# Flood Investigation Report

Location of Investigation: Five Oak Green

Date of incident: 9 February 2020

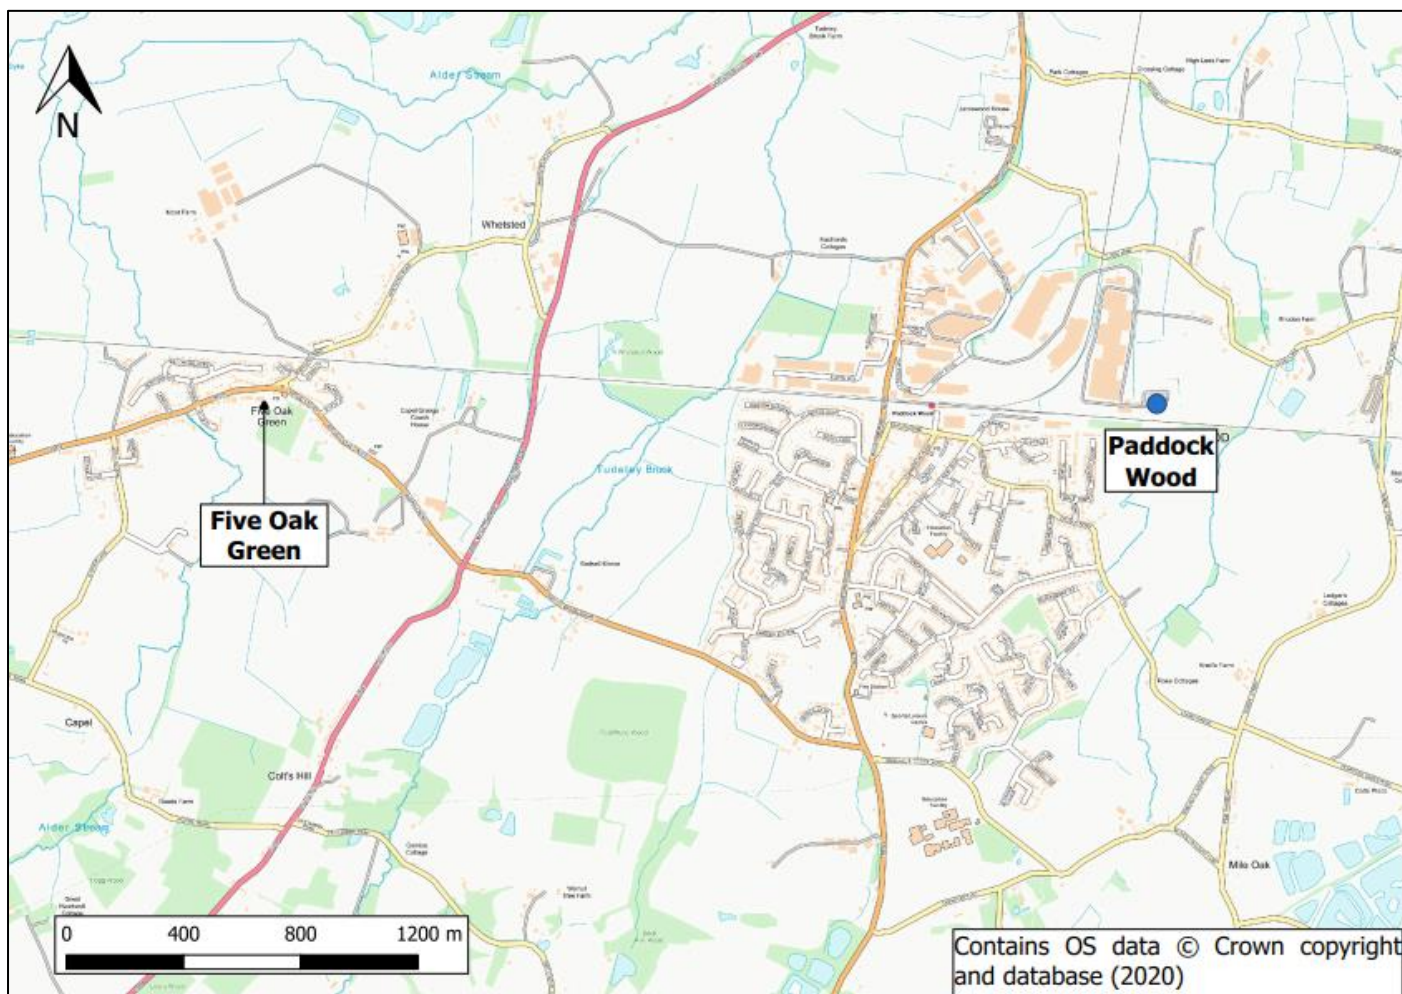
Figure 2 Location of Paddock Wood rain gauge

Figure 2 shows the location of the Paddock Wood rain gauge in relation to Five Oak Green. The rain gauge is located approximately 3 km to the east of the village. The Event Rarity Calculator assessed the Storm Ciara flood event as a 1 in 30-year event at Paddock Wood.

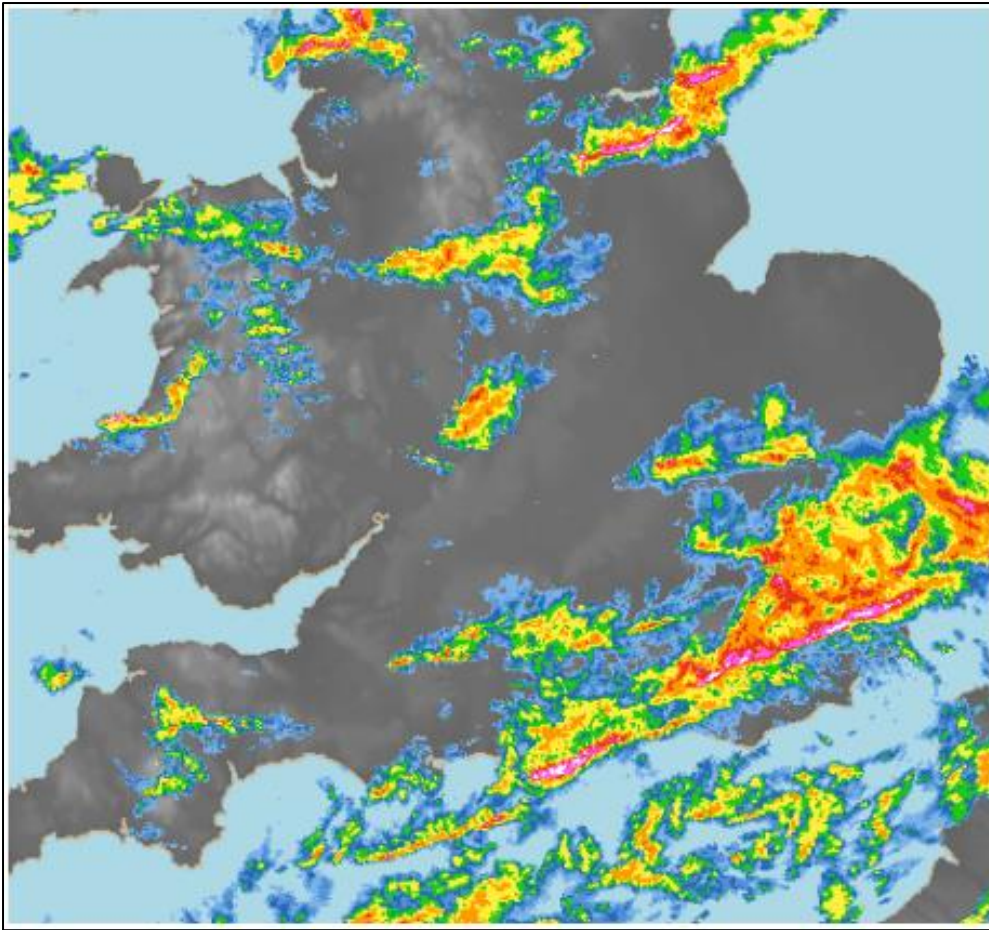
Figure 3 Met Office's rainfall radar during Storm Ciara

The Met Office<sup>3</sup> have also produced a short report on Storm Ciara providing information regarding rainfall and other weather conditions across the country and provides information regarding the South East. Figure 3 shows the rainfall radar captured during the evening of 9<sup>th</sup> February at 18:00 which is approximately when the heaviest rainfall occurred. The rainfall radar clearly shows bands of intense rainfall (white colours on the radar map) across the approximate area of Five Oak Green. According to the Met Office report rates of rainfall exceeding 32 mm per hour were recorded in some areas within the South East of the country. As a result, this provides some level of certainty regarding the rainfall gauge at Paddock Wood and the rainfall recorded.

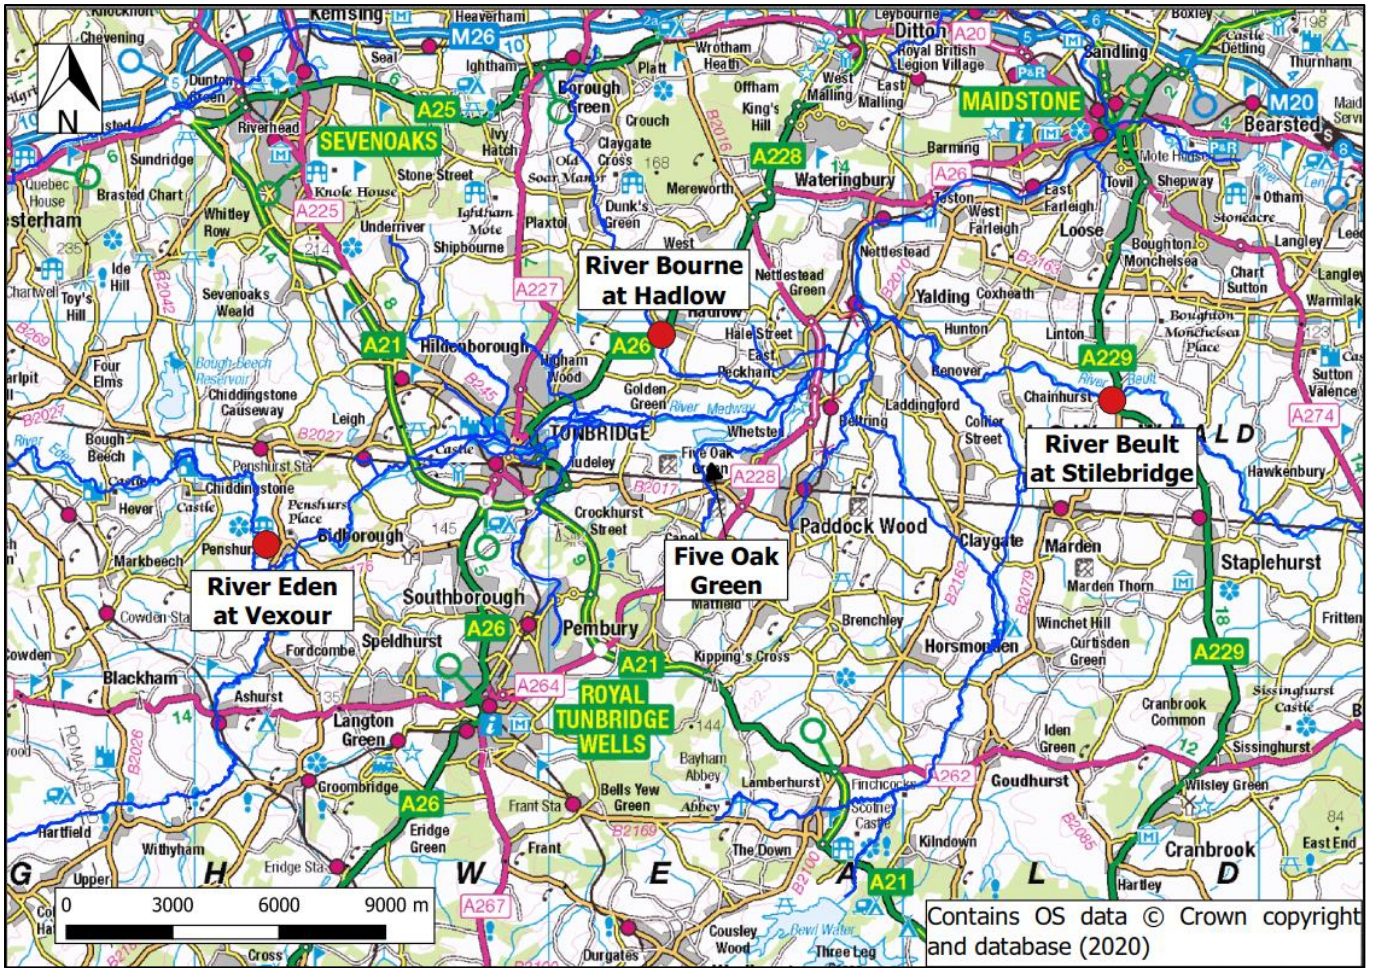
Figure 4 Location of flow gauges

There are no river gauges on the Alder Stream that record flow or water levels. The Environment Agency has flow gauges on tributaries of the River Medway, which the Alder Stream discharges into nearby. The nearest gauges are located on the River Bourne at Hadlow, the River Eden at Vexour and the River Beult at Stilebridge. Figure 4 shows the location of the three flow gauges in relation to Five Oak Green and the Alder Stream.

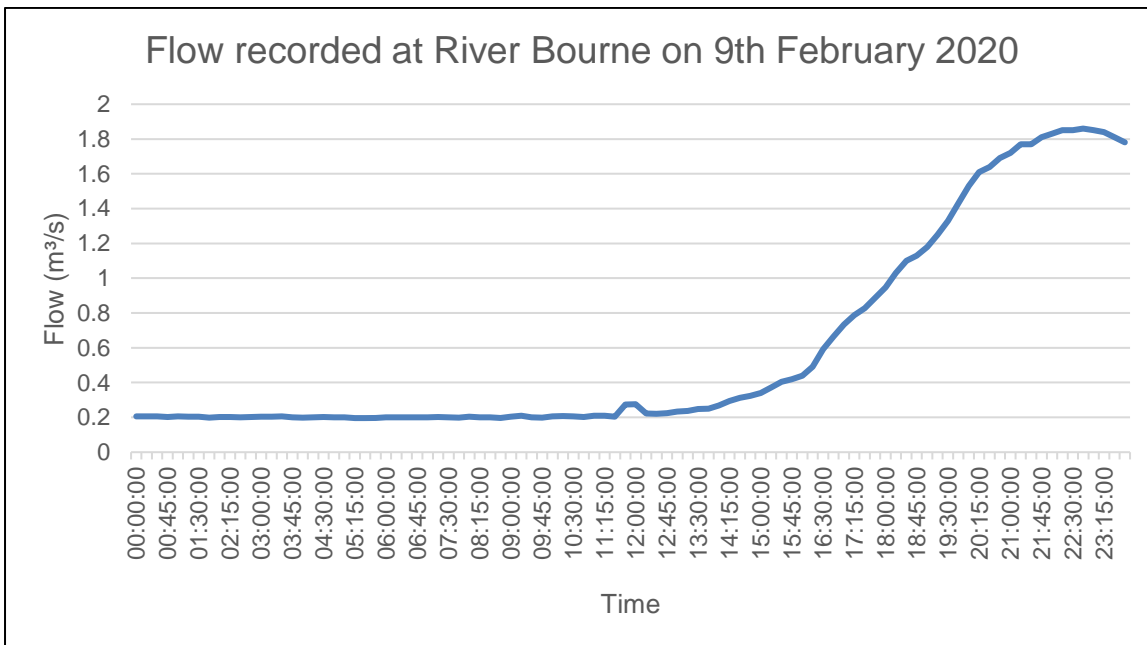
Figure 5 Flow gauge data along the River Bourne recorded during Storm Ciara

The River Bourne gauge at Hadlow is the closest gauge located approximately 4.5 km to the north-west of Five Oak Green. The River Bourne is the smallest of the three Environment Agency gauged rivers and as such is the closest in size to the Alder Stream at Five Oak Green. Data obtained from the Environment Agency for the 9<sup>th</sup> February 2020 at the River Bourne flow gauge is shown in Figure 5, clearly indicating a steep rise in river flows as a result of the heavy rainfall. The increase in flow along the River Bourne is approximately 2 m<sup>2</sup>/s, equating to around 10 times the nominal river flow. The other flow gauges in the surrounding area indicate a much larger increase in flow, this is due to the much larger size of the watercourses. The data from the gauges located along the River Eden and the River Beult are shown in Figures 6 and 7.

The data from the flow gauges indicate the same steep rise in river flows resulting from the heavy rainfall and show a peak of flow on the River Bourne at between 22:00 and 22:30. Consultation with the Environment Agency and reports from local residents indicate that the peak of flow along the Alder Stream was earlier than 22:00 at approximately between 18:30 and 19:30.

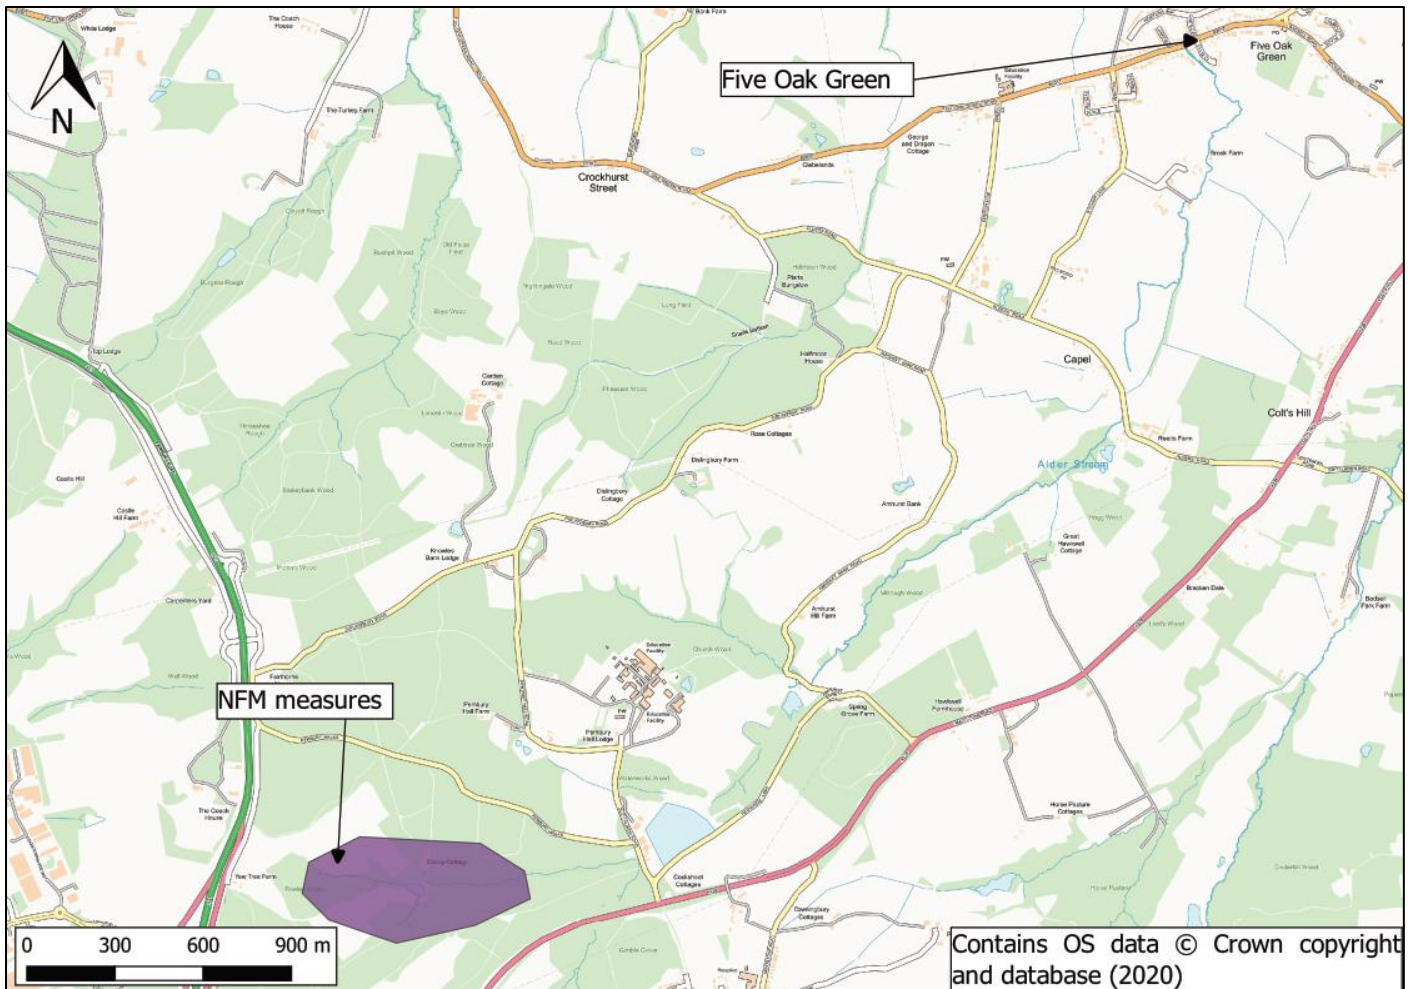
Figure 10 Location of NFM features in the Alder Stream catchment

In order to reduce flood risk to Five Oak Green associated with the Alder Stream, Natural Flood Management (NFM) measures have been implemented through a project led by the South East River Trust. In January 2020, a number of leaky woody structures were placed within a tributary of the Alder Stream approximately 4.3 km to the south-west of Five Oak Green. Figure 10 shows the location of the NFM measures.

The aim of the scheme is to reduce and delay the peak river flows within the Alder Stream to reduce the likelihood of flows overtopping the banks and affecting properties. The leaky woody structures were found to be operating well during the flood event as reported by the South East Rivers Trust, although it is too early to understand if the NFM measures had an impact on the amount of flooding experienced at Five Oak Green<sup>6</sup> and they are currently only installed in a small area of the catchment, so are unlikely to provide a significant benefit at Five Oak Green. Figure 11 shows a photograph of one of the leaky woody structures located along the Alder Stream.

There are further opportunities that could be explored to see if additional NFM measures would be feasible along other stretches of watercourse within the Alder Stream catchment. Consultation and partnership working with the Environment Agency, the South East River Trust and local landowners will be undertaken to understand the potential opportunities and funding available to install more leaky woody structures or other NFM measures.
