Kent County Council

# Flood Investigation Report

Flooding affecting the Swale Area on 29 May 2018

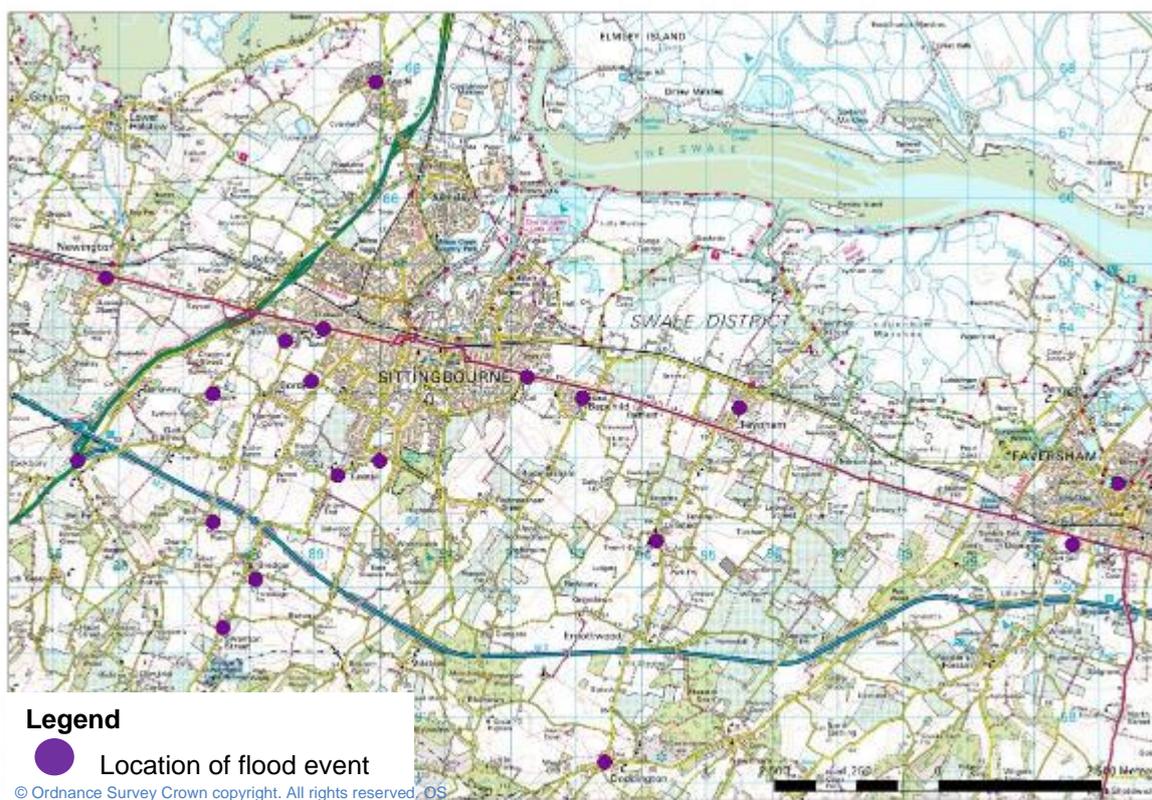
**Figure 1** Location of flood events

The locations of these flood events can be seen in Figure 1. It should be noted that this list of affected locations is not exhaustive, and many other localised incidences of road flooding were also reported at this time.

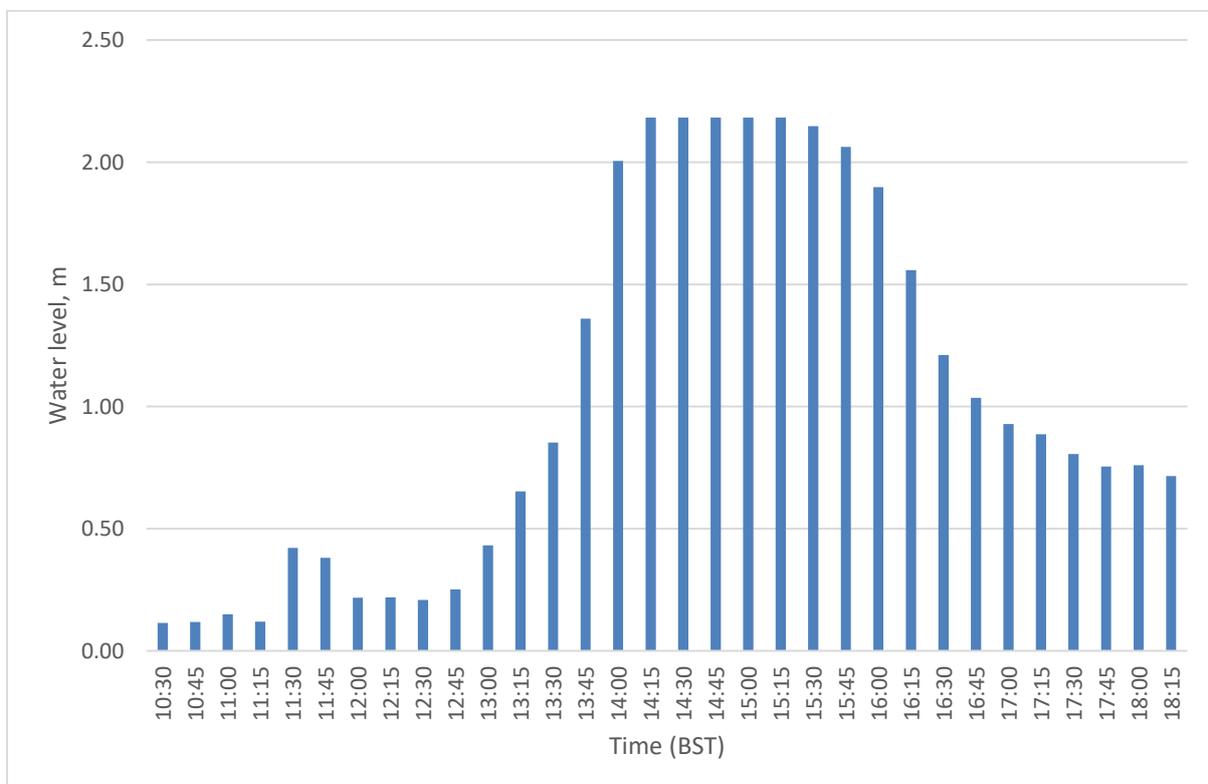
Figure 4 Iwade Stream level gauge

Fluvial flooding occurred within two hours of the storm starting, with water levels at the Iwade weedscreen recorded as rising by approximately 2 metres from 12:30. By 12:50 the Environment Agency level gauge recorded that the river at Sheerstone Road, on the main river section of the Iwade Stream, had reached a depth of 1.6 m causing the river to flow out of bank and through adjacent gardens and onto the road. The high water levels within the Iwade Stream continued until 15:30, reaching a peak of 2.18 m at 14:15. The water levels recorded by the level gauge are shown in Figure 6.

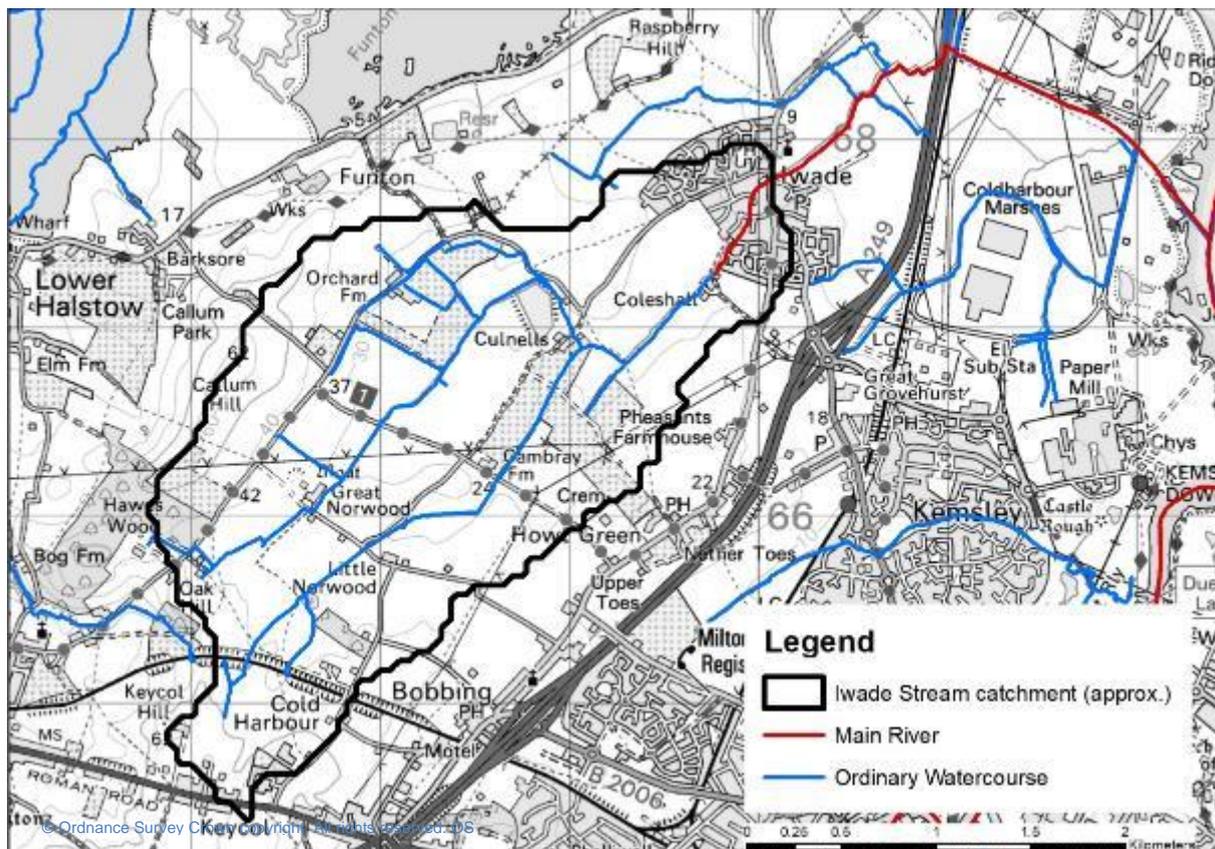
Figure 5 Iwade Stream catchment (showing catchment area at Ferry Road) (Source: Flood Estimation Handbook Web Service)

Adjacent to Chalkhill Close the stream passes through an Environment Agency weed screen and gantry which form part of the footbridge. The stream travels along the rear of properties on Sheerstone and passes under Sheerstone Road through a 0.9m concrete culvert, the culvert is fronted by an Environment Agency simple trash screen, the stream at this point is monitored by a level gauge and CCTV system. On exiting the culvert, the stream travels 91m before entering another culvert fronted by an Environment Agency weedscreen, the culvert passes under the public right of way which runs between Sheerstone and Springvale Road. The channel becomes open water course again passing through a privately-owned road culvert at The Waterways. The stream then enters a brick arch culvert underneath Ferry Road before returning to an open channel flowing into the Ridham Fleet on the Marshes, ultimately discharging into The Swale. A map of the Iwade Stream catchment is shown in Figure 4, including an approximate boundary of the catchment at Ferry Road.

The Iwade Stream is a small watercourse and may contain little water, particularly during drier periods. However the large catchment area and relatively small channel size means that it can respond quickly to heavy rainfall and has a history of flooding. In 2002 the Environment Agency classified the channel as main river through Iwade in response to flood risk concerns.

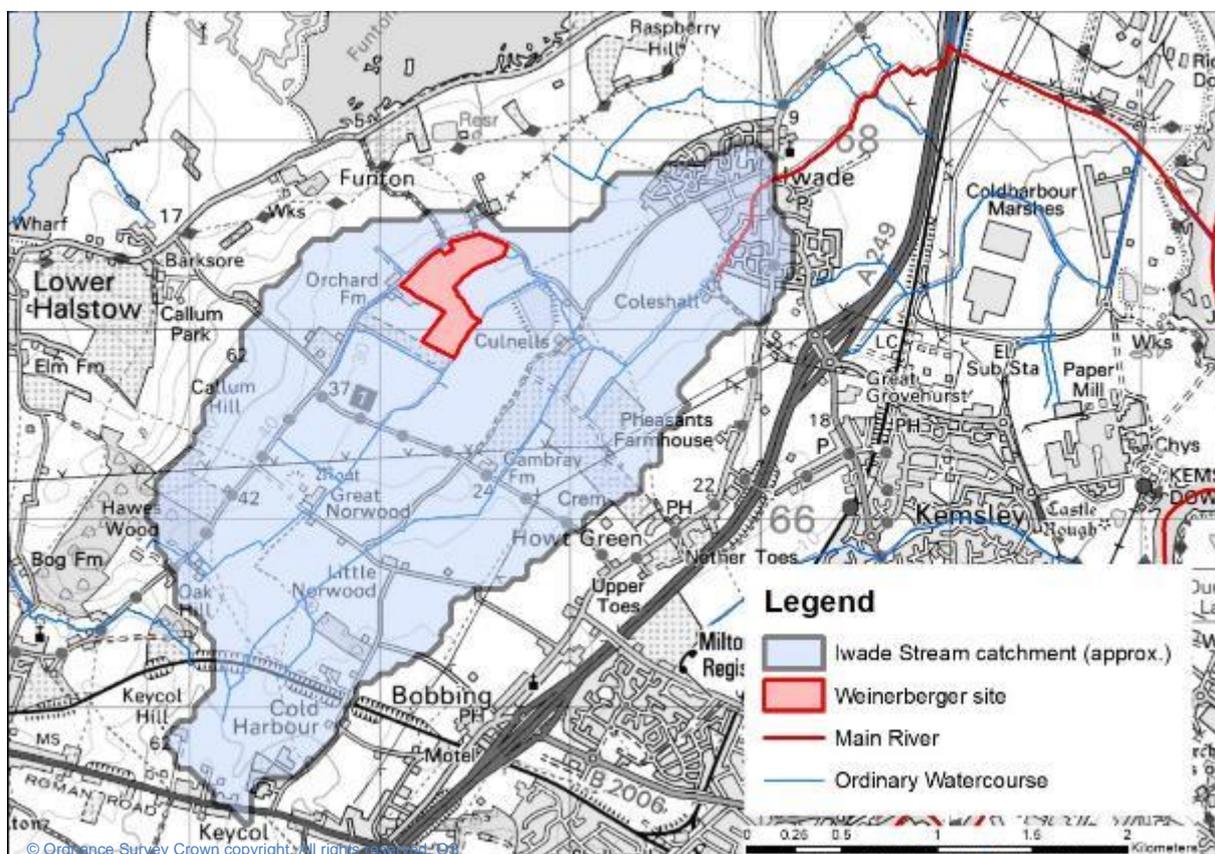
Figure 7 Map of the Iwade Stream catchment showing extent of Wienerberger site (Source: Flood Estimation Handbook Web Service)

Following the flooding from the Iwade Stream, the Parish Council and local residents reported concerns that the Orchard Farm brick earth quarry operated by Wienerberger had been the cause of the flooding. Figure 7 shows the Iwade catchment upstream from the Sheerstone culvert and the extent of the Wienerberger Quarry site (note the extent of the boundary in Figure 7 is the planning red line boundary, not the extent of the works on the site).

The Wienerberger quarry is located to the west of Iwade near Orchard Farm. It is extracting brick earth from the 14.6 ha site. The operation is leaving brickearth on the surface, that is, the full depth of the brickearth is not being extracted from the quarry.

The cause of the flooding in Iwade is most likely to be the heavy rainfall that was experienced across Swale and Medway at the time leading to high flows in the Iwade Stream and surface water flooding. The operation of the Wienerberger quarry is not thought to be a factor.

Following the flooding, KCC found that a flow gauge has not been installed on the outfall from the Wienerberger site, which was a requirement of the planning permission. KCC, who is the planning authority in this instance, has raised with the site operators and a flow gauge was installed in October 2018.

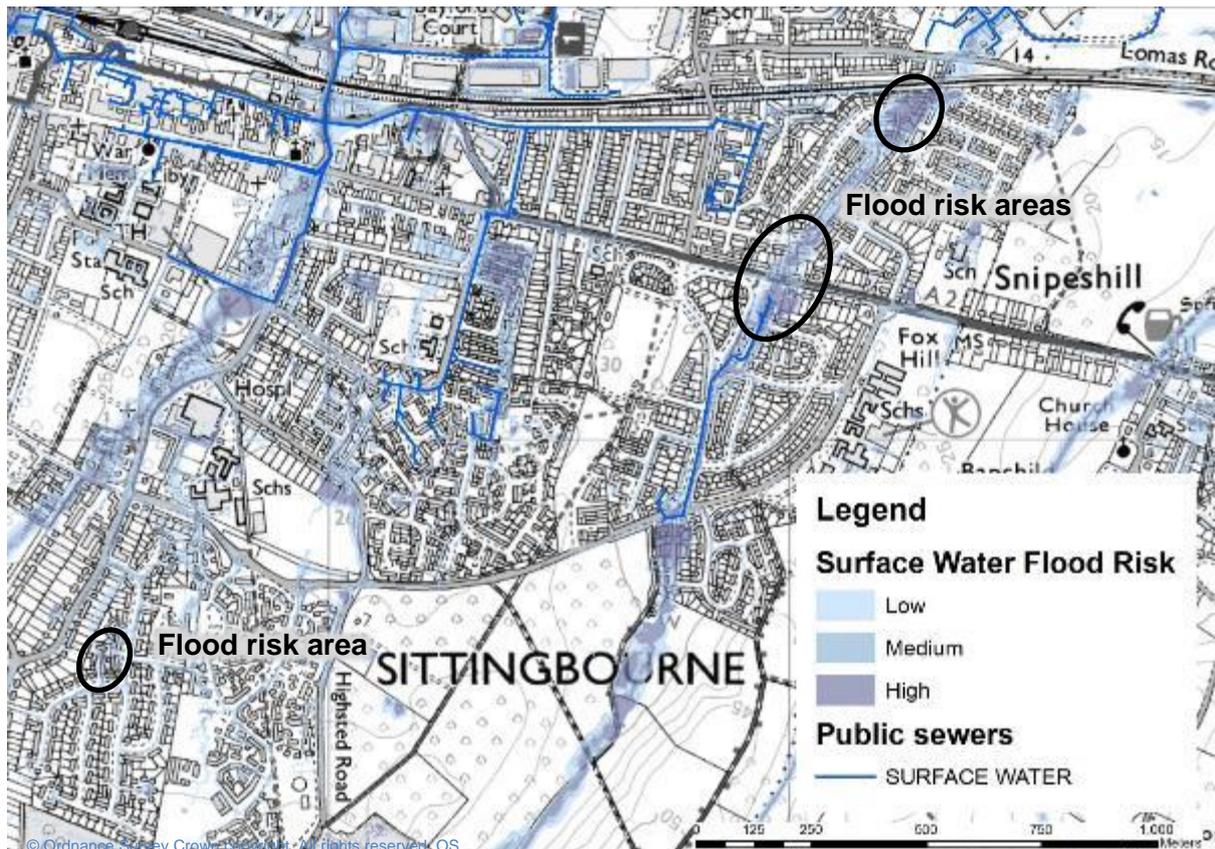
**Figure 9 Surface Water Flood Map showing flood risk at Snipeshill**

The updated Flood Map for Surface Water (uFMfSW), shown in Figure 9, is published on the Environment Agency website and provides information on areas considered risk of flooding due to surface water. The public surface water sewers are also shown in Figure 9.

The main cause of the flooding was the intensive rainfall which exceeded the capacity of drainage systems in the area. The urban areas within Sittingbourne are drained by soakaways which quickly became filled by the intense rainfall that was experienced. Once the capacity of the drainage was exceeded, runoff collected in topographical low points.

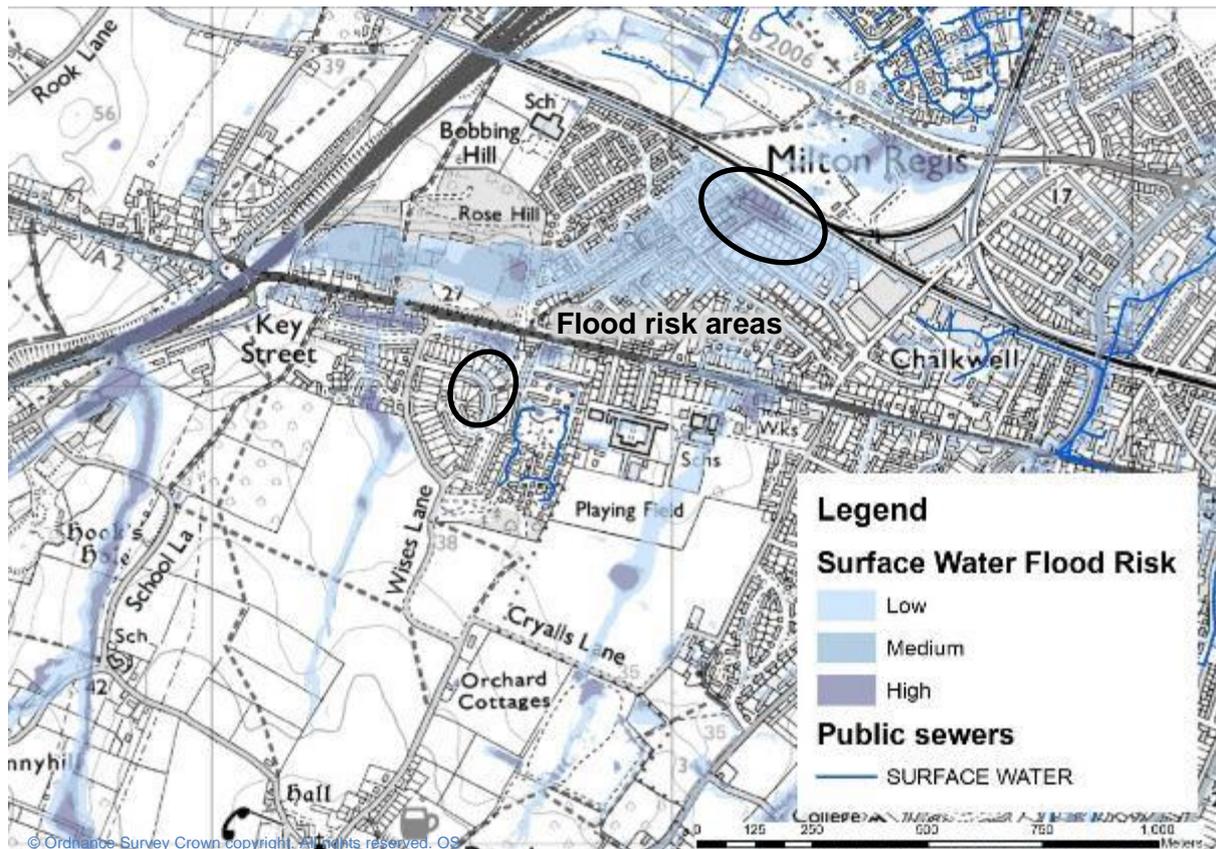
Figure 10 Surface Water Flood Map showing flood risk in the Chalkwell and Key Street area

To the south of the A2 in Chalkwell and Key Street the slope of the land is slightly steeper, but there are localised low points on the roads. The Chalkwell and Key Street area is predominantly drained by soakways.

The updated Flood Map for Surface Water (uFMfSW), shown in Figure 10 for the Chalkwell and Key Street area, is published on the Environment Agency website and provides information on areas considered risk of flooding from surface water. The public surface water sewers are also shown in Figure 10.

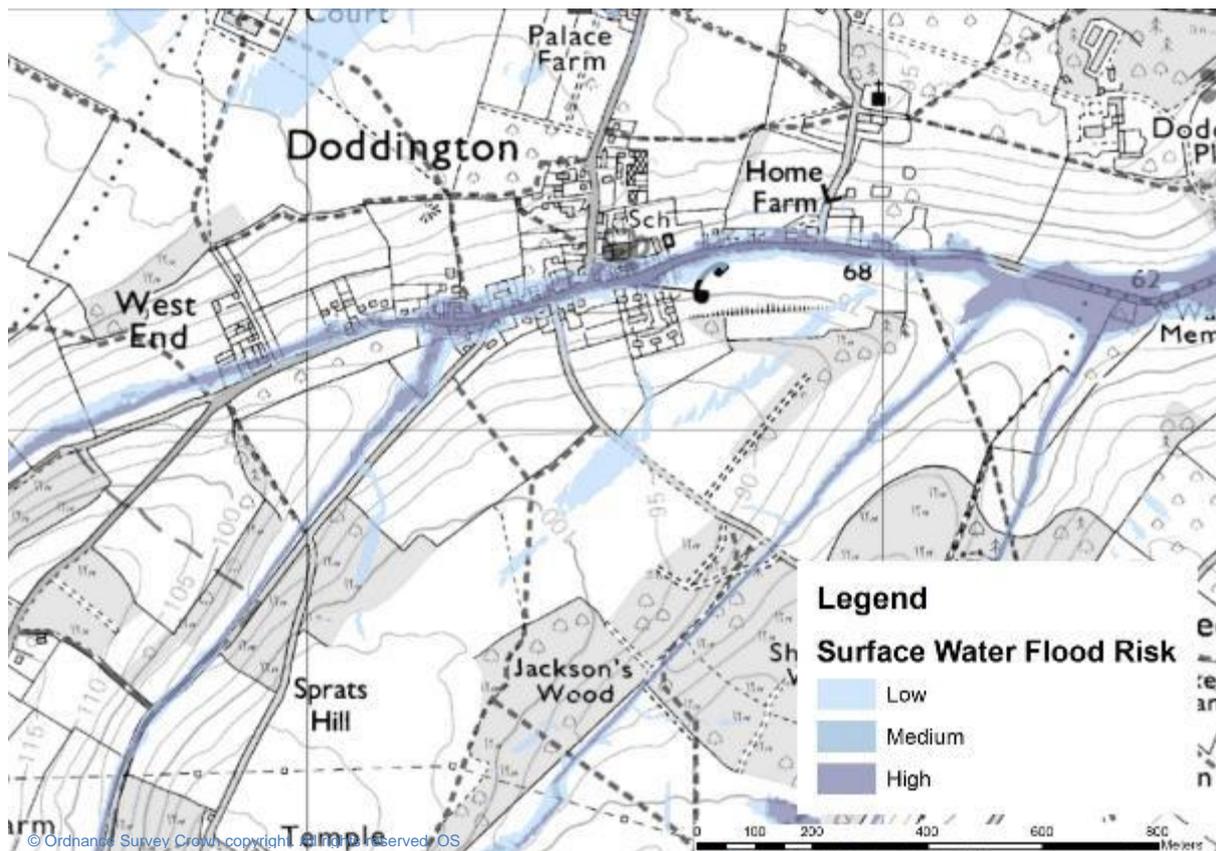
Figure 11 Surface Water Flood Map showing flood risk at Doddington

The topography of the land around Doddington means that water that is not absorbed by the ground will flow towards the village. The updated Flood Map for Surface Water (uFMfSW) shown in Figure 10 is published on the Environment Agency website, it shows The Street to be at high risk of surface water flooding.

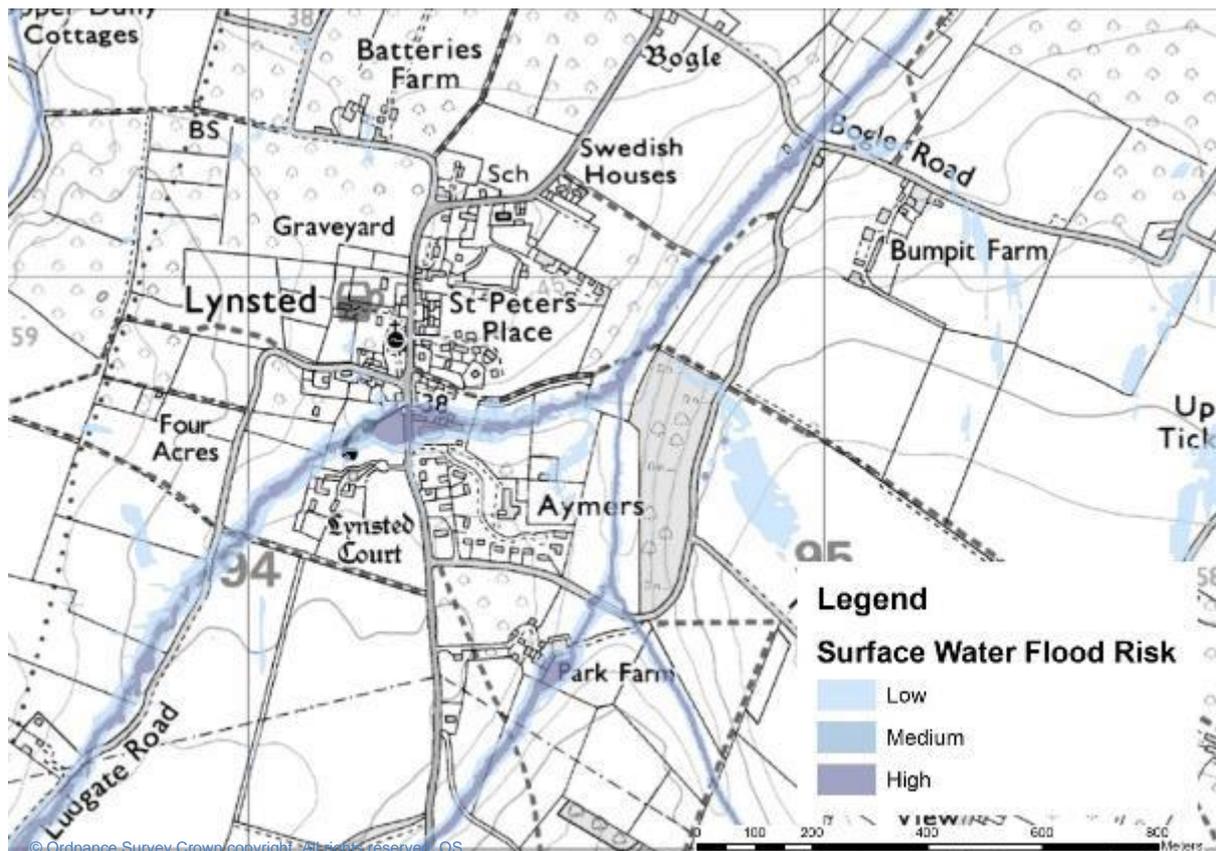
Figure 12 Surface Water Flood Map showing flood risk at Lynsted

The updated Flood Map for Surface Water (uFMfSW) shown in Figure 11 is published on the Environment Agency website, shows that the that this area is at high risk of flooding from surface water. The flow pathways come from the higher area to the west and collect within this low-lying area.

The intensity of the storm will have caused significant run-off from the surrounding fields as experienced elsewhere, this is likely to have caused water to build up quickly within the depression on The Street. The highway drainage system discharges to a near-by pond, this reached capacity and over-topped causing the highway to flood.

The Southern Water pumping station is located within depression by The Street and was infiltrated by the surface water run-off from the surrounding area, which caused the pump to loss power. As a result, the foul sewers that the pump serves began to overflow and contributed to the flooding.

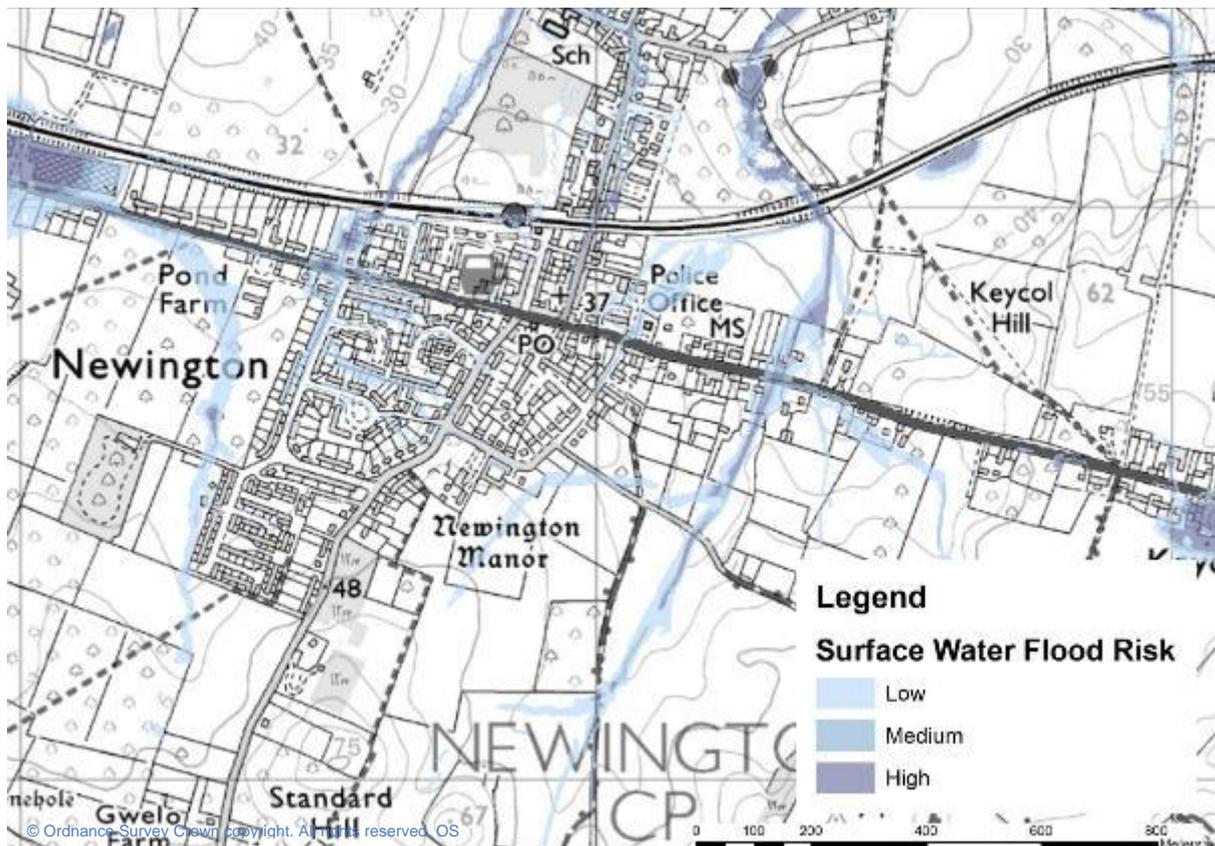
Figure 13 Surface Water Flood Map showing flood risk at Newington

The updated Flood Map for Surface Water (uFMfSW) shown in Figure 13 is published on the Environment Agency website shows the area is generally at low risk of surface water flooding, though there are areas with higher risk.

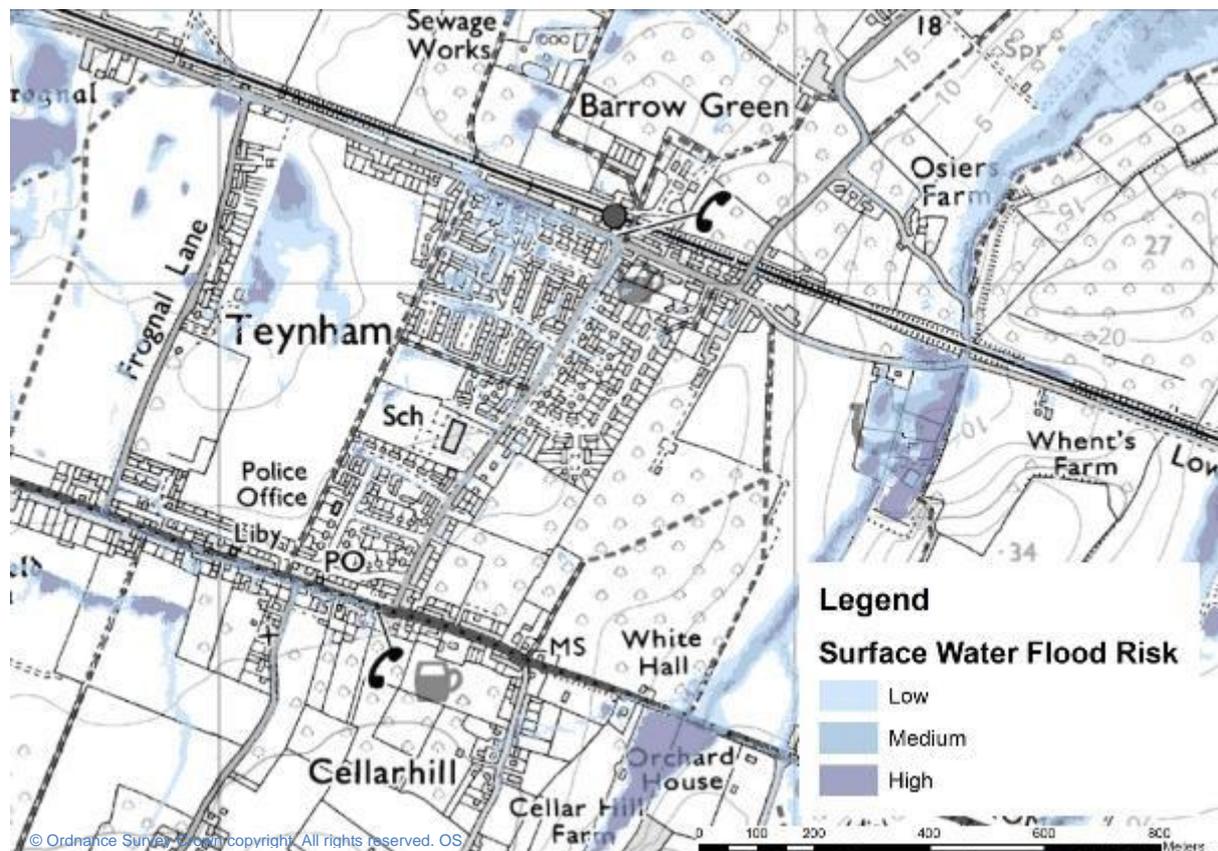
Figure 14 Surface Water Flood Map showing areas at risk within Teynham

The updated Flood Map for Surface Water (uFMfSW) shown in Figure 14 is published on the Environment Agency website shows that a number of the areas affected by flooding have a high risk of surface water flooding, however, a number of areas have a no or low risk of surface water flooding suggesting that the flooding experienced was the result of the intensity of the rainfall and the inability for surface water to drain away quickly enough.

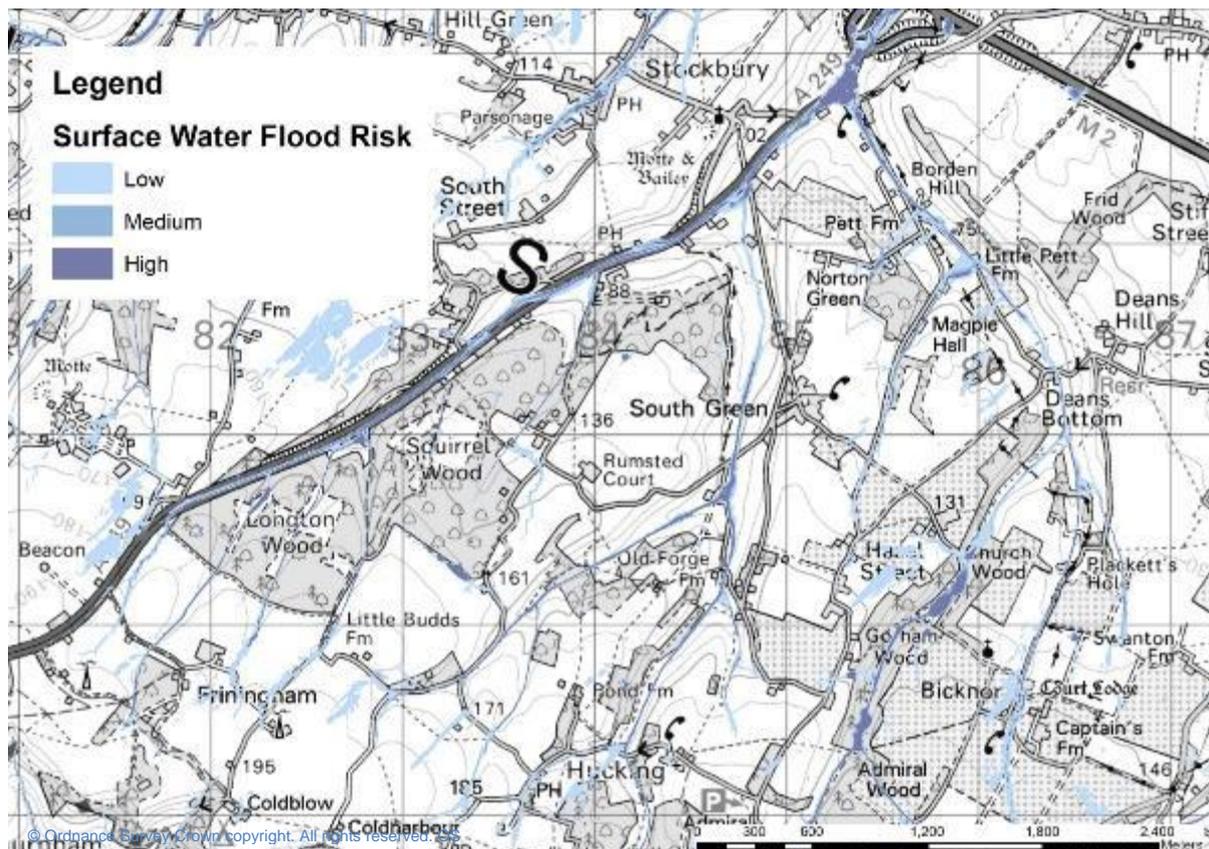
Figure 15 Surface Water Flood Map showing risk of flooding at the Stockbury Roundabout

The updated Flood Map for Surface Water (uFMfSW), shown in Figure 15, is published on the Environment Agency website, it shows that the Stockbury roundabout at the junction of the A249 and the M2 is at high risk of flooding from surface water. It also shows the flow paths from the land to the east of the A249 that join it.
