Flood Investigation Report

Location of Investigation: Bethersden

Date of incident: 25 July 2021

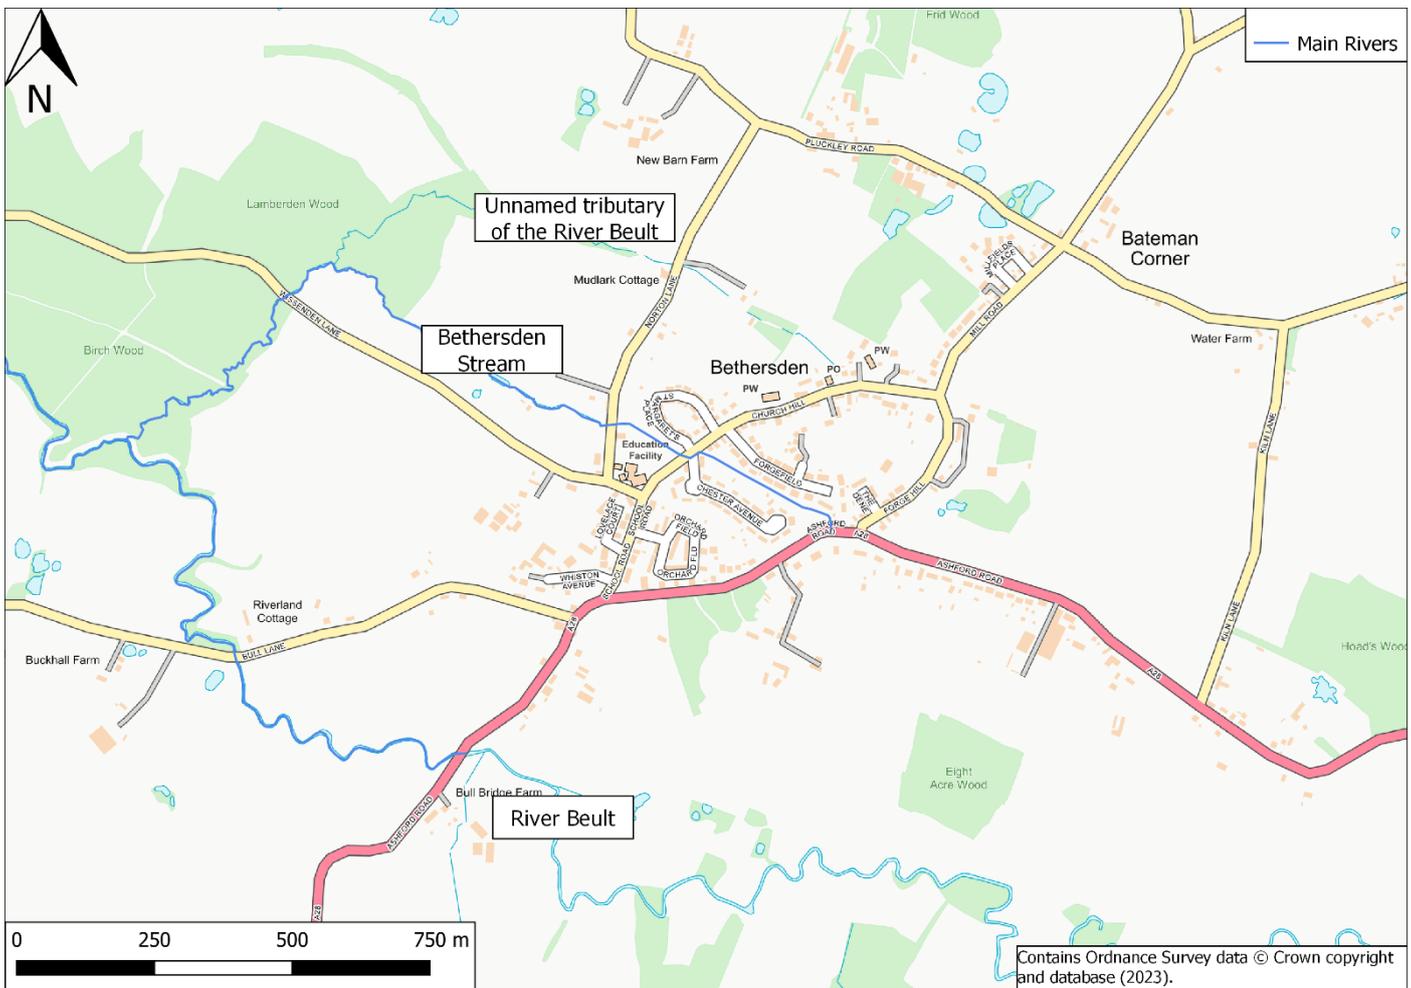
Figure 1 Map showing the watercourses within Bethersden and the surrounding area

The village of Bethersden is located approximately 7 km to the west of Ashford. The River Beult is located approximately 0.6 km to the south of the village, with two tributaries flowing through the village in an east to south-west direction. The northern unnamed tributary flows in an east to west direction, flowing beneath Norton Lane before discharging into the southern tributary just to the north of Wissenden Lane and is classified as an ordinary watercourse, regulated by the LLFA. The southern tributary is known locally as Bethersden Stream, rising upstream of Bethersden it becomes main river at Ashford Road and passes between the gardens of properties at Forge Field and Chester Avenue and flows beneath, Church Hill and Norton Lane before flowing through agricultural land before discharging into the River Beult approximately 1 km to the west of Bethersden. The Bethersden Stream and the River Beult are classified as main rivers regulated by the Environment Agency. There are also a number of ordinary watercourses which flow adjacent to field boundaries throughout Bethersden discharging into the main watercourses. Figure 1 below provides an overview of the main watercourses within Bethersden and the surrounding area.
